**Safety Review of Birchville, Korokoro and
Woollen Mills Dams**

30 June 2006
Wellington Regional Council

Issue 1

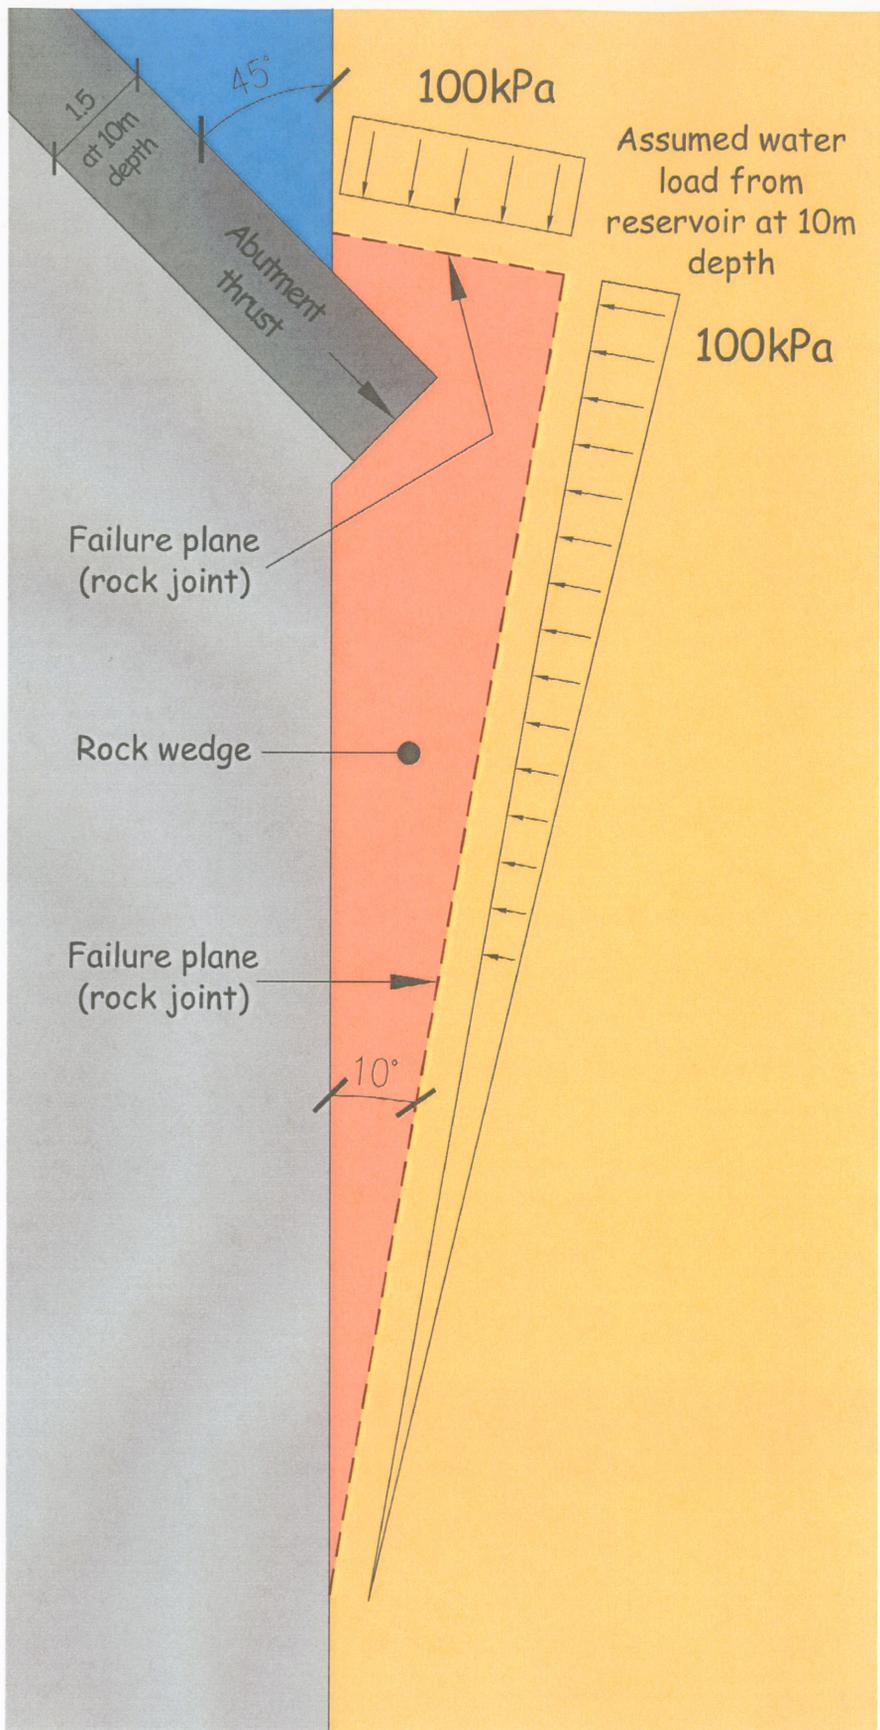
Figure 5: Birchville Arch Dam - Left Abutment
Plan section showing potential sliding of rock wedge

Birchville Dam: Further studies and improvements for a more informed understanding of the left abutment failure mechanism were identified in the 1989 report by Tonkin and Taylor. No further detailed engineering geological logging of the abutments has been undertaken as part of this study. It is recommended that a more detailed understanding of the left abutment geology is undertaken.

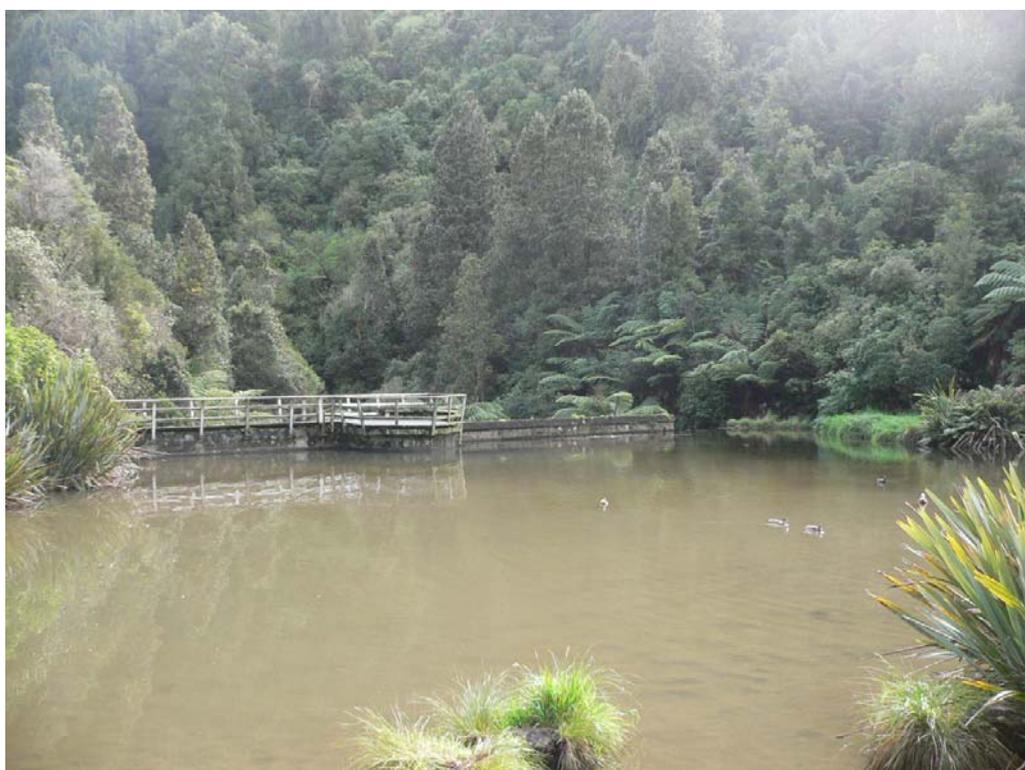
Fig. B-8: Korokoro Dam and Reservoir, 2006. Shallow depth of reservoir is clearly visible.

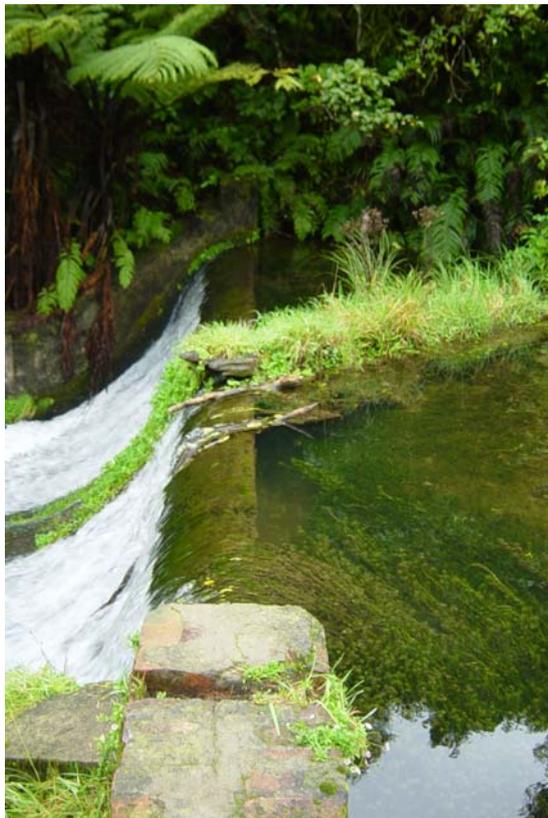
Fig. B-15: Korokoro Dam Spillway inlet.
Note: The build up of debris at the spillway inlet and missing brick on crest wall

1. Vegetation and debris build up at the spillway inlet reducing the spillway capacity – control by normal maintenance.
2. The source of erosion in the downstream toe area should be investigated. Possible sources include:
 - 150mm diameter inlet pipe on the upstream face at top water level
 - overflows over the crest – assess spillway capacity
 - seepage under / around the dam
3. The downstream toe area of the dam is not adequately drained back to the stream with ponding identified and damage to the existing drainage system, for example an existing clay pipe for toe drainage has collapsed.
4. Some minor scouring observed under the spillway outlet step.
5. Missing bricks in coping on crest could lead to further erosion of the coping in the event of floods overtopping the crest.

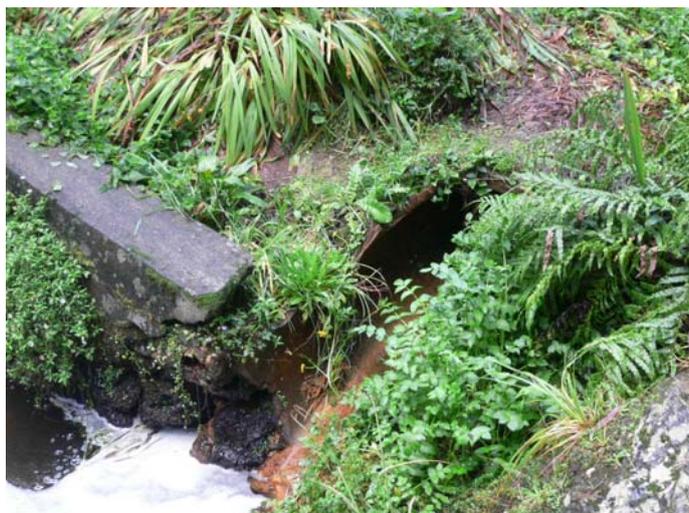
Fig. B-17: Damaged drain outlet pipe from downstream area to spillway plunge pool.

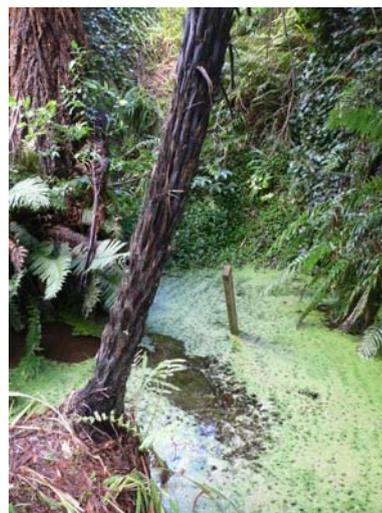
Fig. B-18: Ponding in downstream toe area

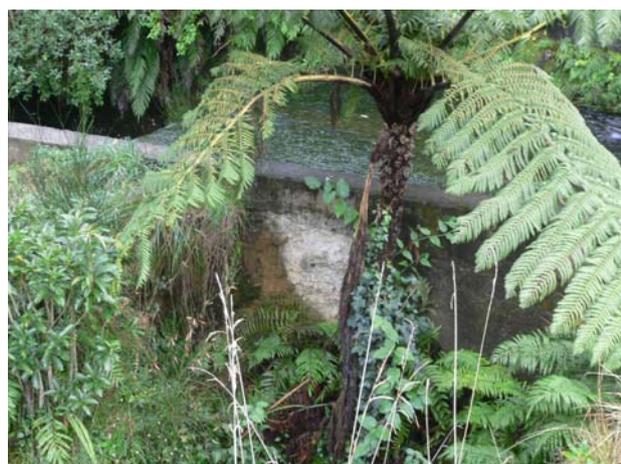
Fig. B-19: Signs of erosion at downstream toe area behind spillway wall(refer to Fig. B-4)

Erosion of the toe areas needs to be regularly monitored and if frequent floods lead to deterioration the area will require robust repairs.

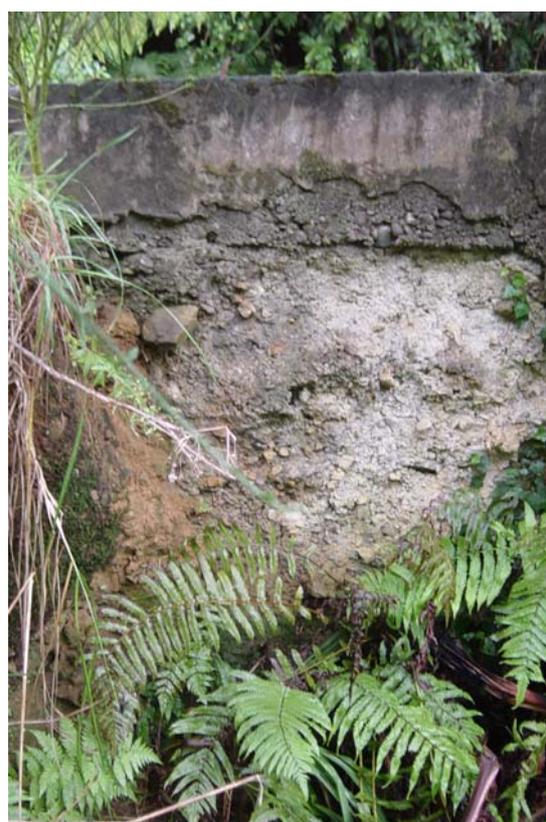
Fig. B-20: Closer view of erosion behind spillway wall, at Fig. B-19

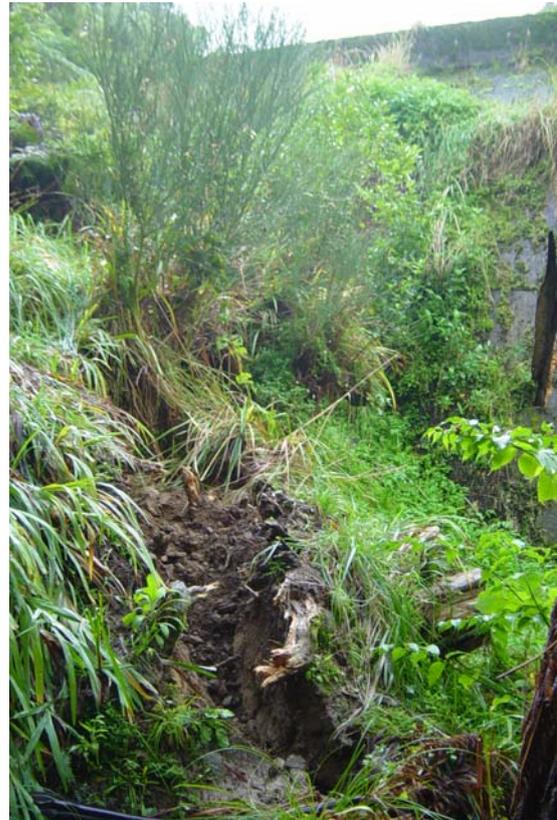
Fig. B-21: Further signs of erosion at downstream area of Korokoro Dam, ground slip in remaining filled area.

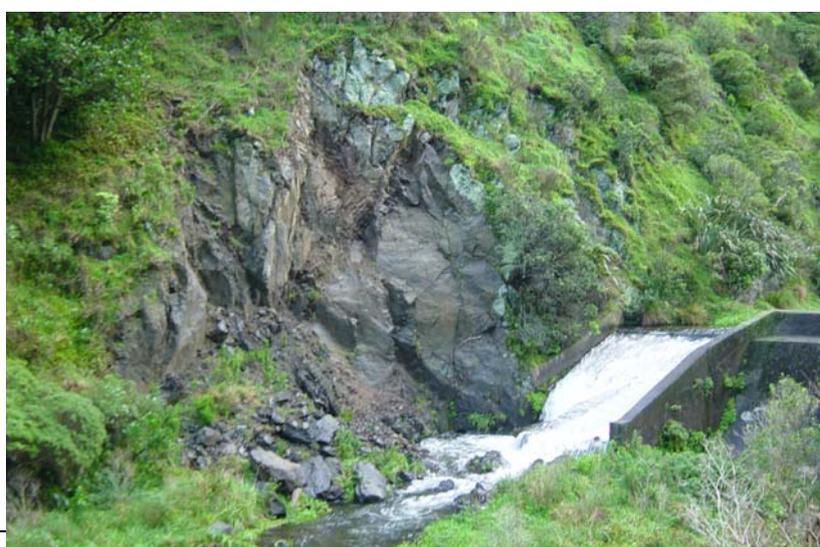
Fig. B-25: Significant rock slip due to flood event in 2004 /05.

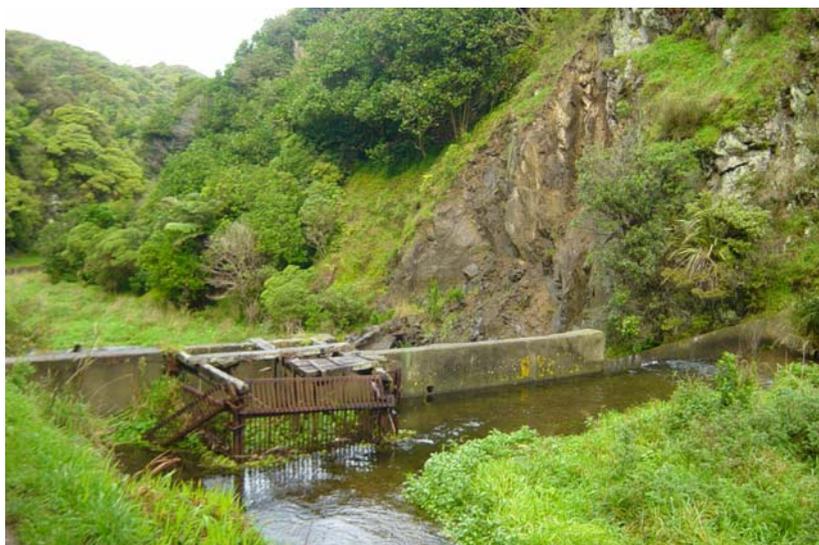
Fig. B-27: Woollen Mills Dam impoundment – high level of deposited material can be seen.

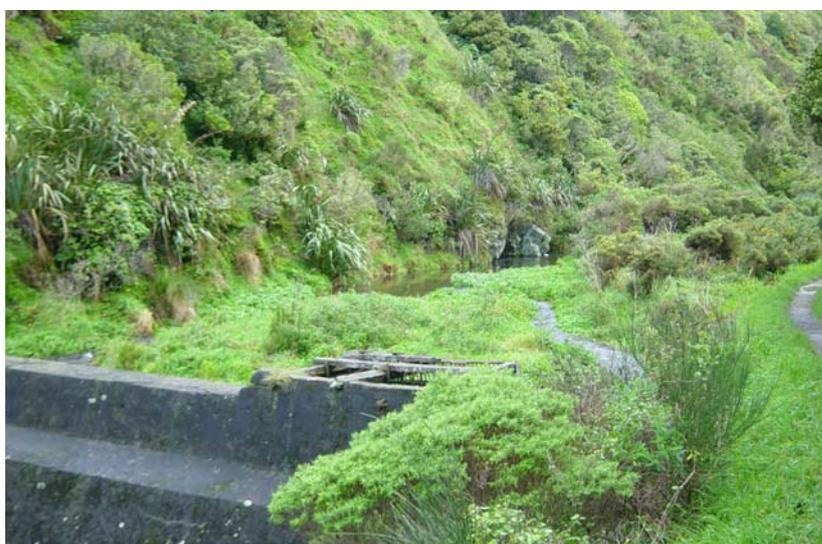
Fig. B-28: Downstream toe area permanently submerged.

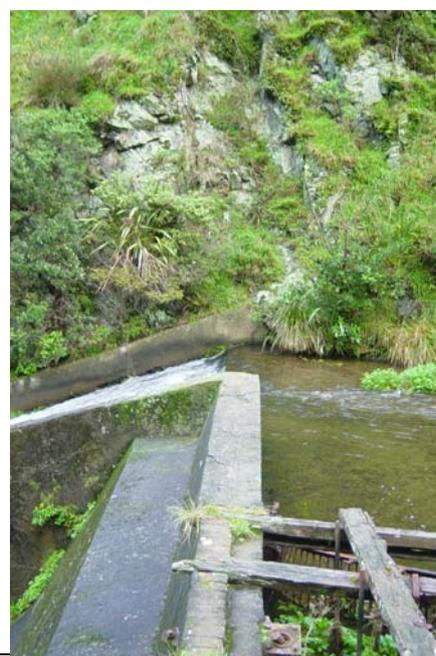
1. Scouring of spillway and downstream channel immediately below the dam.
2. Spillway performance and dam stability following loss of part of the spillway structure in 2004/05 flood event.
3. Seep observed through the spillway wall is minor and does not represent a dam safety issue.

Fig. B-31: Flood damage to spillway

The Woollen Mills dam has been subjected to significant flooding and erosion in recent years resulting in scouring of the spillway and downstream channel immediately below the dam. The spillway performance and dam stability following loss of part of the spillway structure in 2004/05 flood event should be further investigated and repaired.

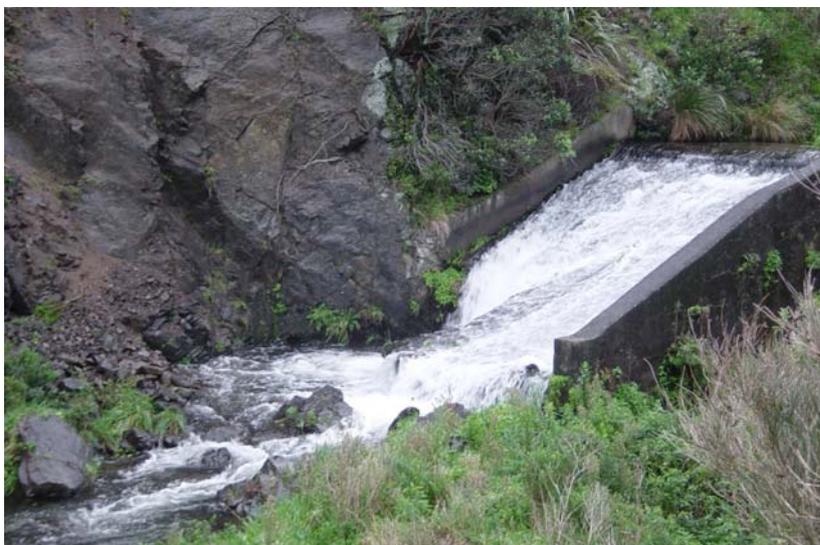
Fig. B-32: Flood damage to spillway

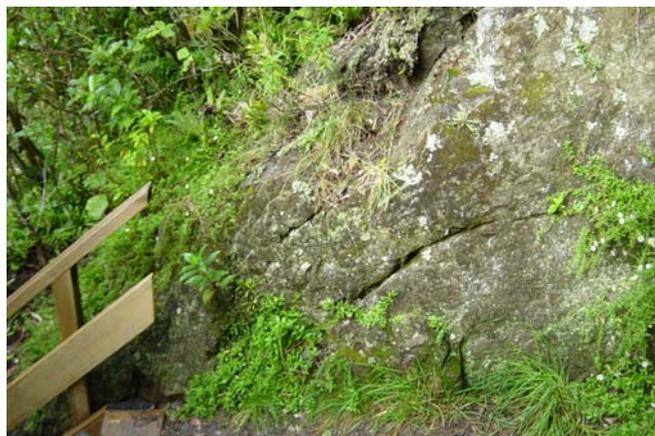
Fig. C-5: Right abutment – open joints in rock

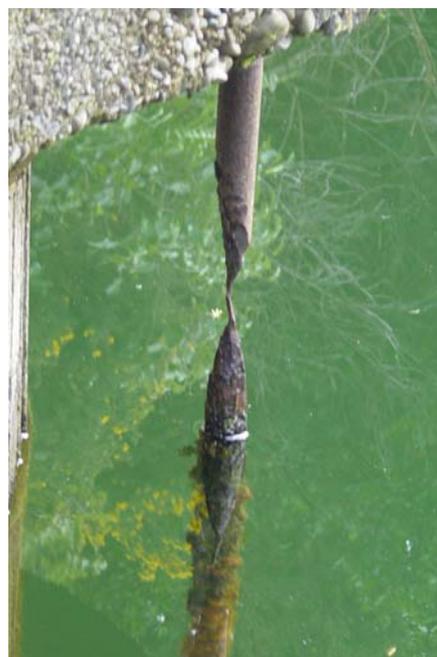
Fig. C-11: Badly corroded control valve spindle

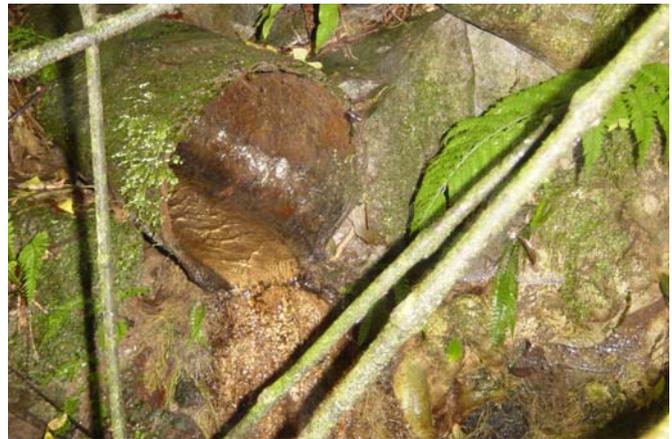
Fig. C-13: 375mm dia. cast iron by-pass pipe outlet, some continuous leakage is occurring in the pipe.
