HUTT RIVER - PEER REVIEW AUDIT
AUGUST 2006

1. Introduction

An inspection of the Hutt River was carried out on 7 August 2006, by staff members from the Flood Protection Department (Wairarapa).

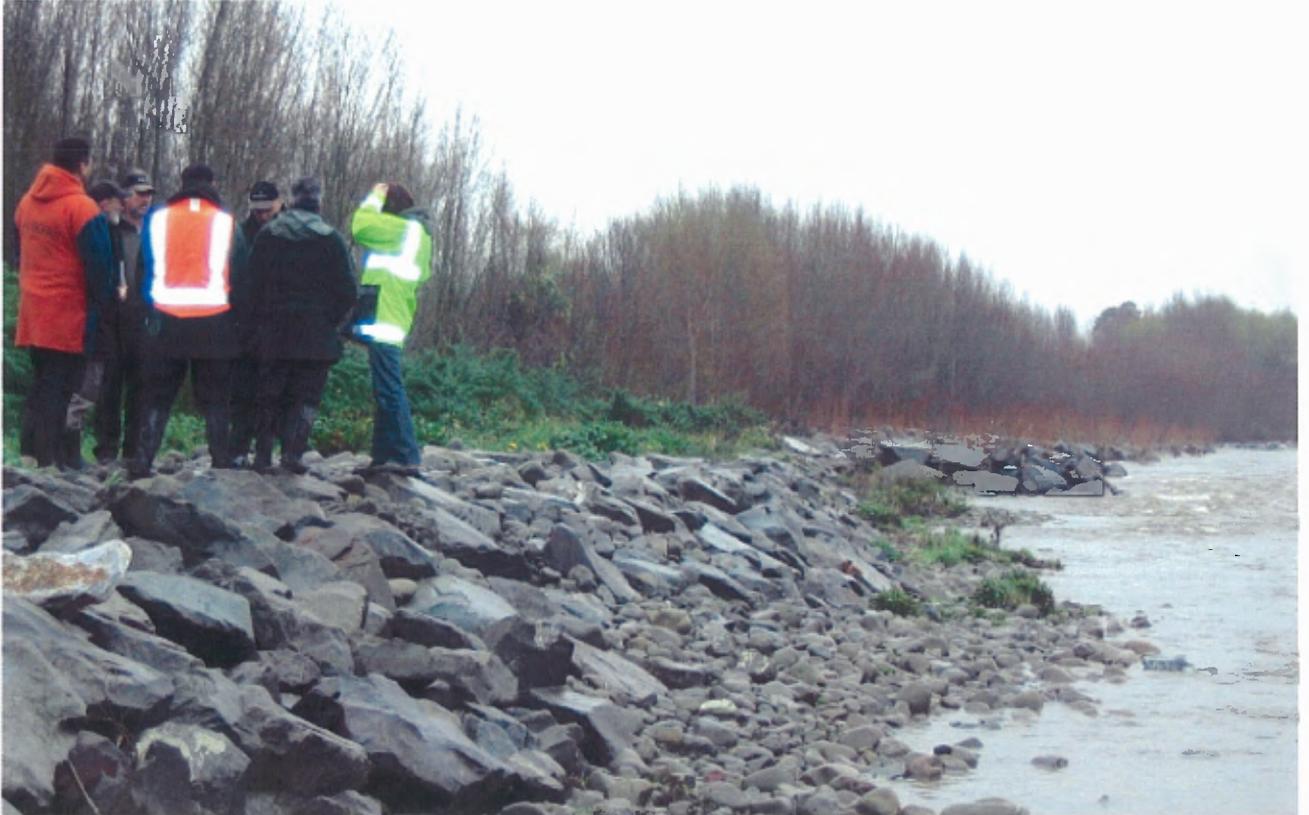
This site is located in the Avalon area (Hutt River-Left Bank), and is comprised of 4 Debris Rail Fences with Rock Heads. The end rails of these fences were destroyed due to high water velocities and bed degradation following the January 2005 flood event. Rather than replace the debris fences totally with rock, a cost effective measure was to repair the fences by re-driving the rails and re-enforcing the heads with rock. Each rock head is comprised of approx.400 tonnes of grade C rock.

Also of note was the protection of the eroded bank by using linear rock lining. Here the bank edge is left to erode until it reaches the desired design channel alignment, then rock is placed along the eroded bank, reinforcing the design edge.

Linear Rock Lining with Debris Fences and Rock heads in background.

The Reviewers agreed with the current approach, to maintain the use of existing fences and strengthening the ends with rock heads.

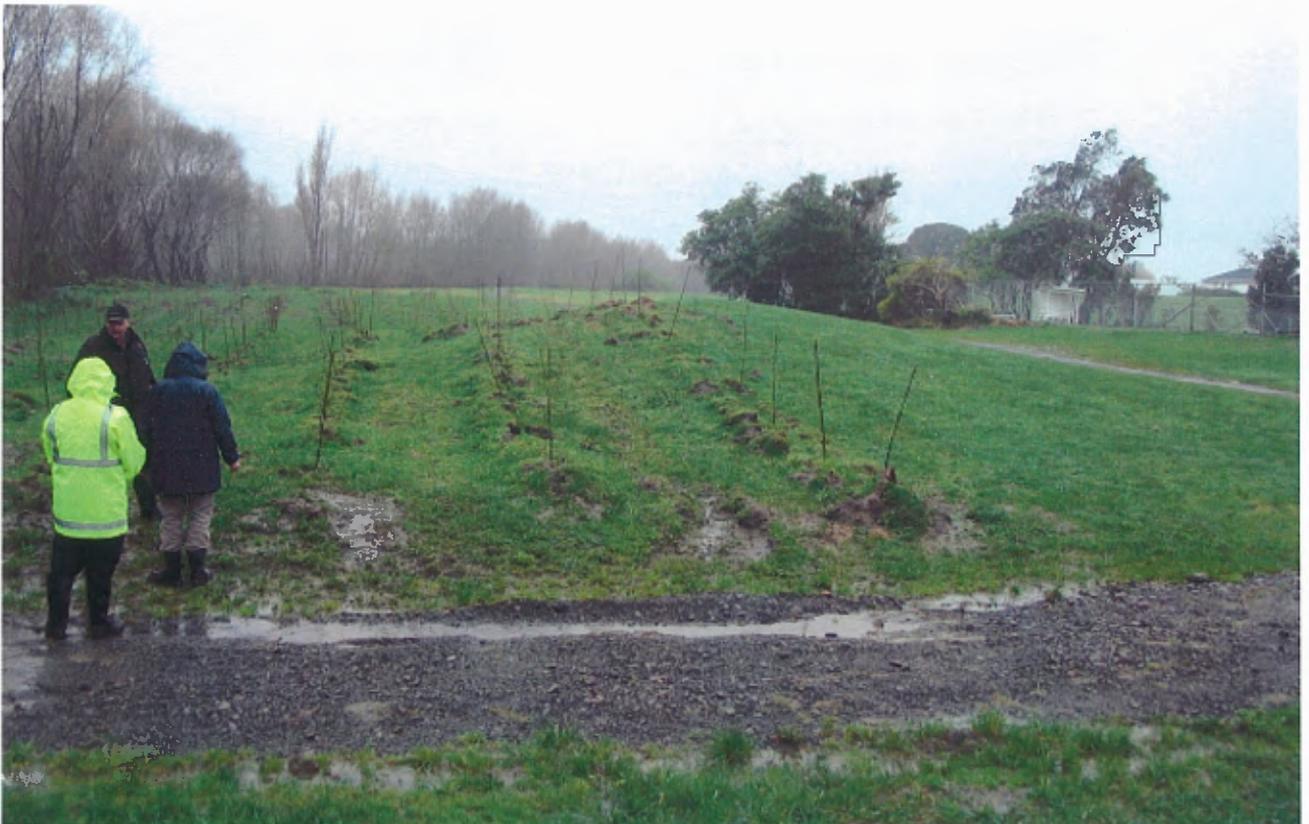
This area of the river has the Croquet Club situated on the river berm, between the bank edge and stopbank. Also older established willows encroach into the design channel, narrowing the river channel at this point. The approach to improve capacity of flood flows on the berm at this site during flood events, as well as achieving desired channel design width is to;

New buffer plantings, with Croquet Club infrastructure to be removed in the background.

- Start the process of removing the Croquet Club infrastructure
- Plant a new willow buffer zone
- Progressively remove older willow stock and allow the bank edge to erode to the design channel alignment.

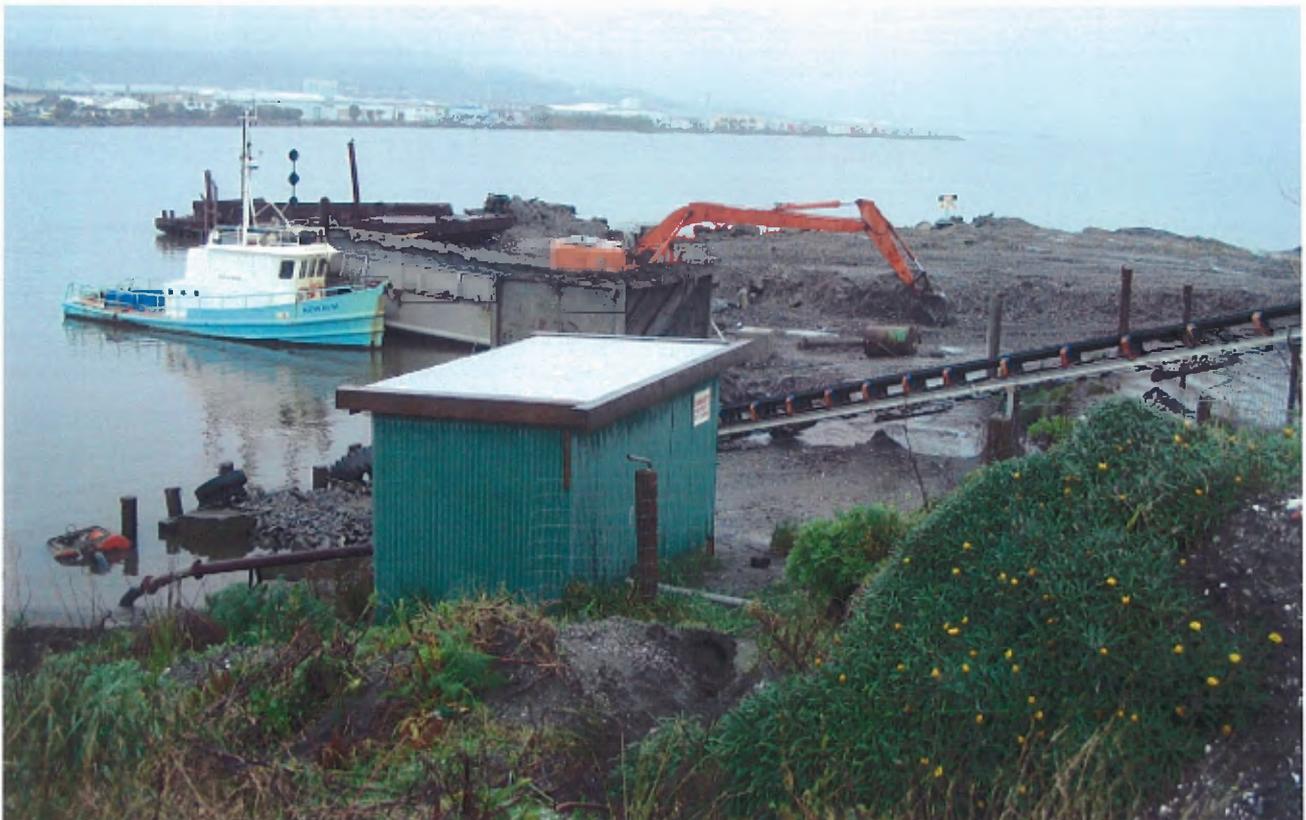
A major problem with the Hutt River is aggradation of bed level at its river mouth, which reduces the cross-sectional area. Bed load carried by floods down the river mixes with the sea resulting in reduced water velocities causing deposition of material in the estuary area. To prevent the aggradation of river material in this area, dredging must be carried out. The annual extraction of approximately 45,000 cubic metres per year is required to keep the river mouth open. The resource consent for extraction is held by Flood Protection, the actual dredging is carried out by a contractor who sells the reclaimed material, and disposes of waste by product material onsite and at sea.

The review team had no comment to add on this operation, but were happy to see some site beautification taking place in the form of bank planting and general site tidiness.

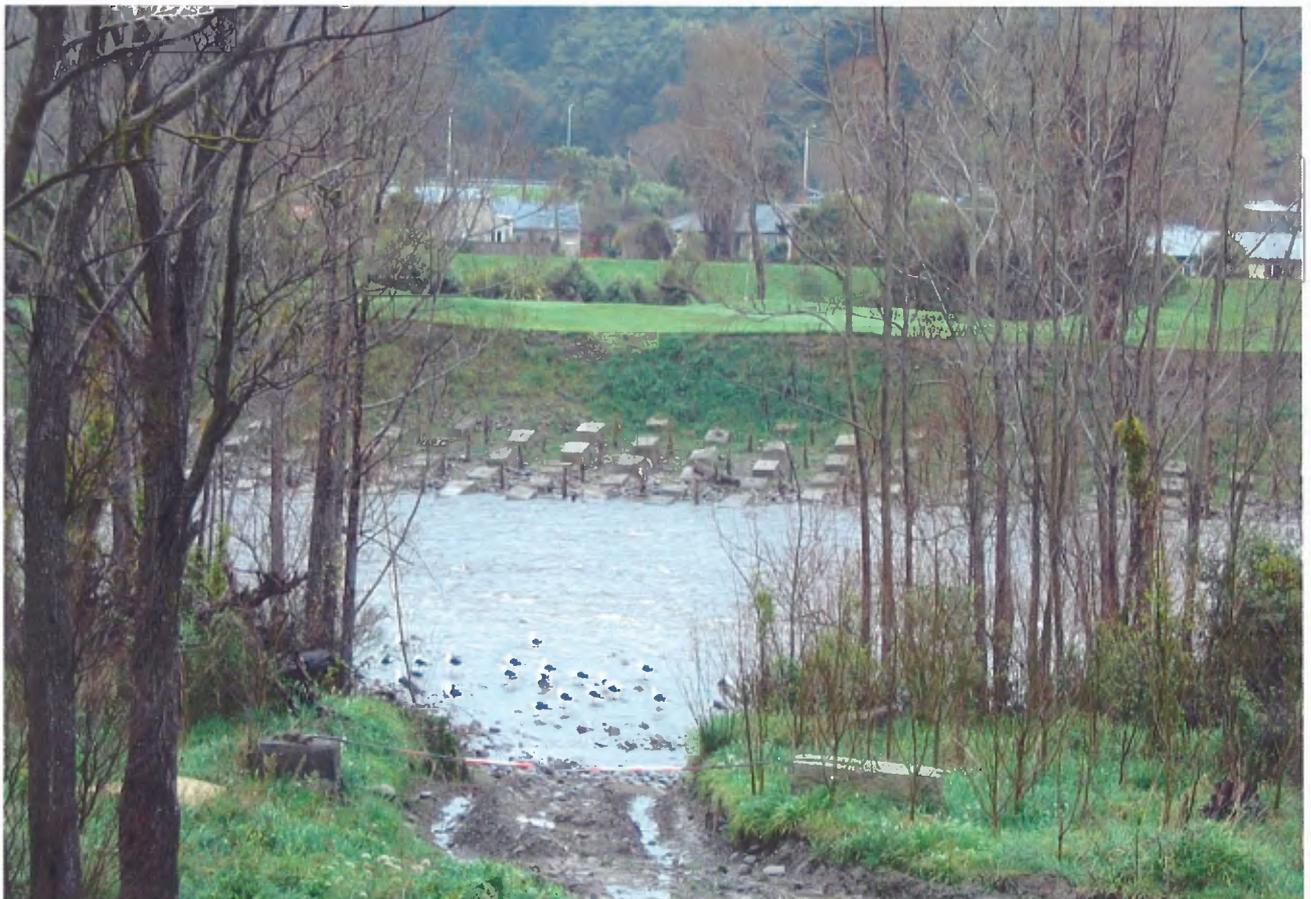
The structure involves the placing of a 3 tonne concrete block on a prepared batter slope. The blocks are set-out in a grid pattern and interlinked with wire ropes through pre-cast holes in each block. Willow poles are planted in rows between the blocks. The grid pattern creates a roughness along the bank edge resulting in reducing water velocities and the deposition of bed material. It is a proven method and has been used before at other sites in the Hutt River.

Newly erected Block Grid Pattern and Willow pole structure.

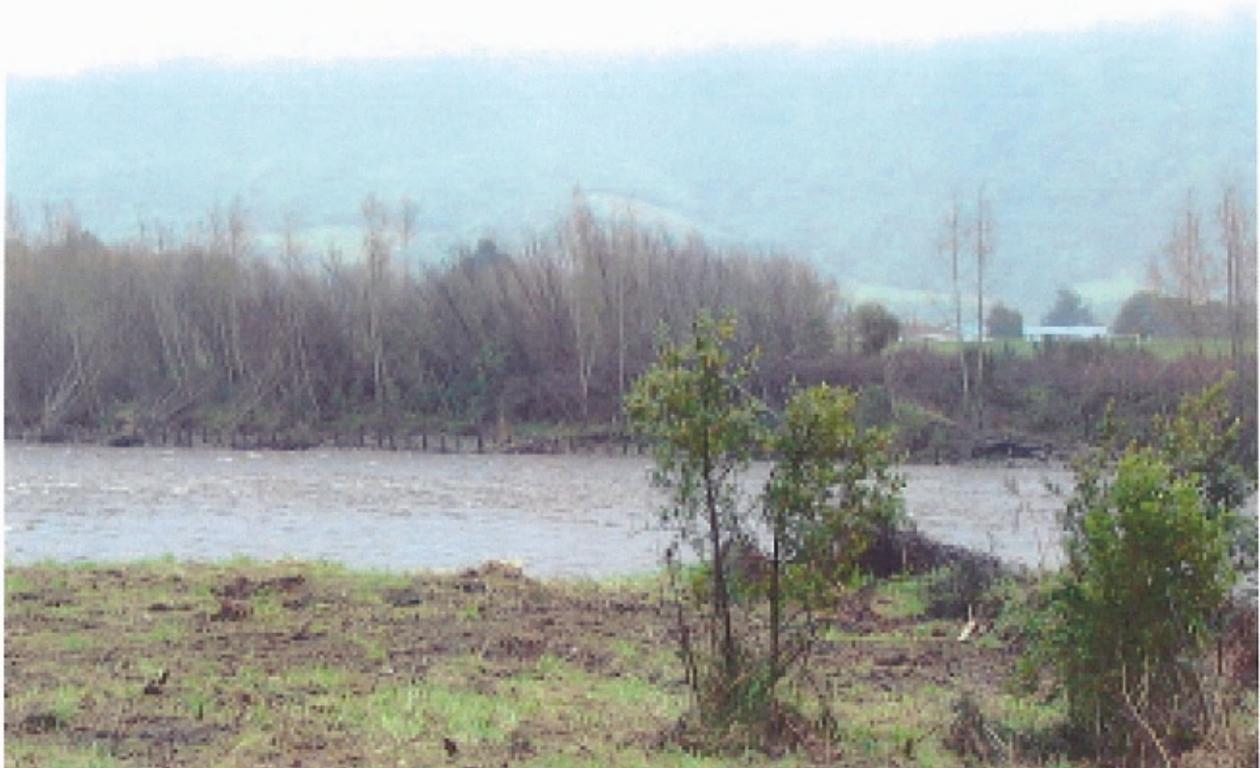
Along the right bank of the Hutt River upstream of the Totara Park Bridge an old longitudinal debris fence has failed along its entire length. The main cause of failure is degradation of the river bed which has undermined some of the shorter 4.5 metre length rails, driven along the fence line. This undermining has resulted in the erosion of willows trees and bank edge from behind the fence.

Photo showing undermined fence, and eroded bank edge.

The works have been temporarily repaired by pushing gravels onto the failed structure. An investigation into why the riverbed is degrading through this reach is programmed to take place this financial year.

The reviewers noted that this reach of river is degrading and an option would be to place rock stub groynes along the bank edge where the most damage is occurring. This area would need to be monitored and Rock stub groynes may need to be placed annually as ongoing damage occurs

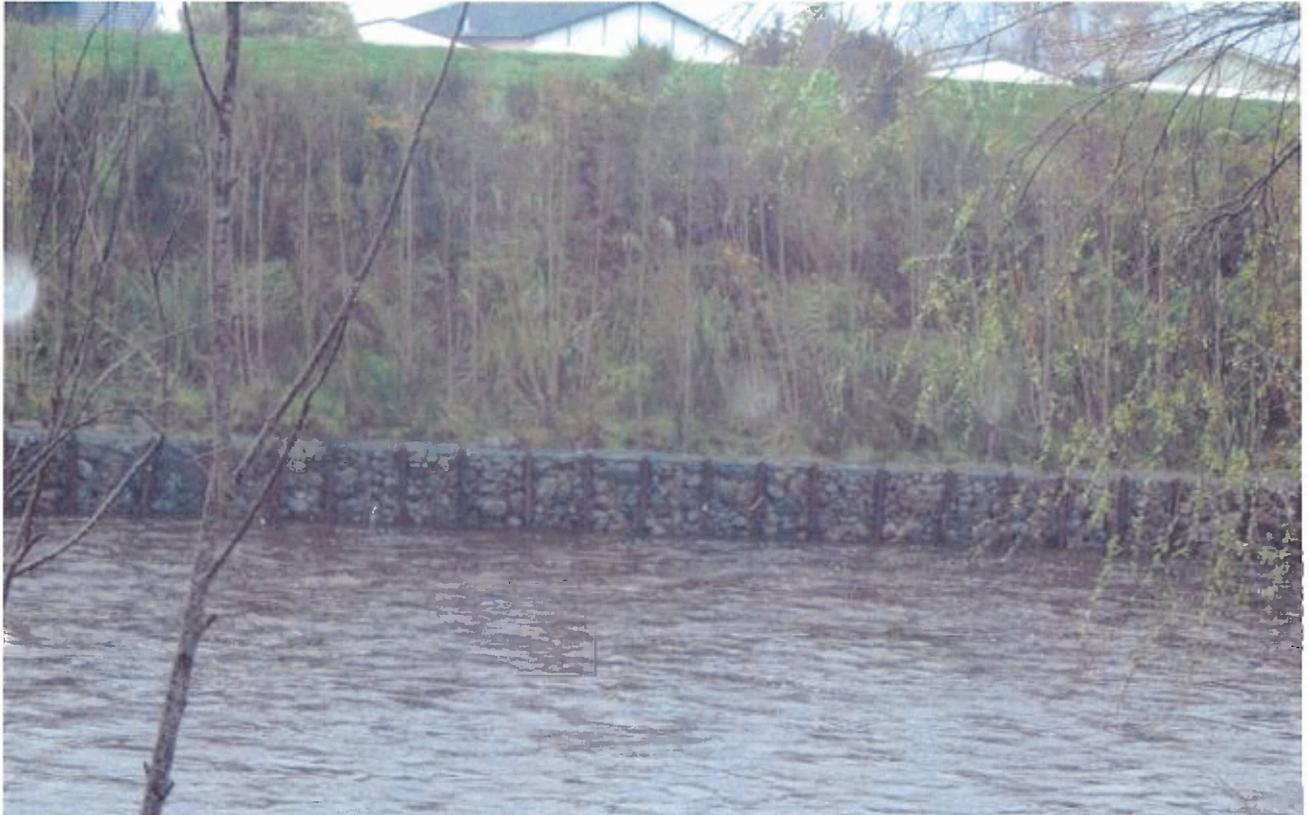
A Longitudinal gabion basket and driven rail iron Fence has been erected along both the right and left banks. This fence is very successful in providing stability to the bank edge although failure through degradation has occurred in some places.

Longitudinal fence with no undermining.

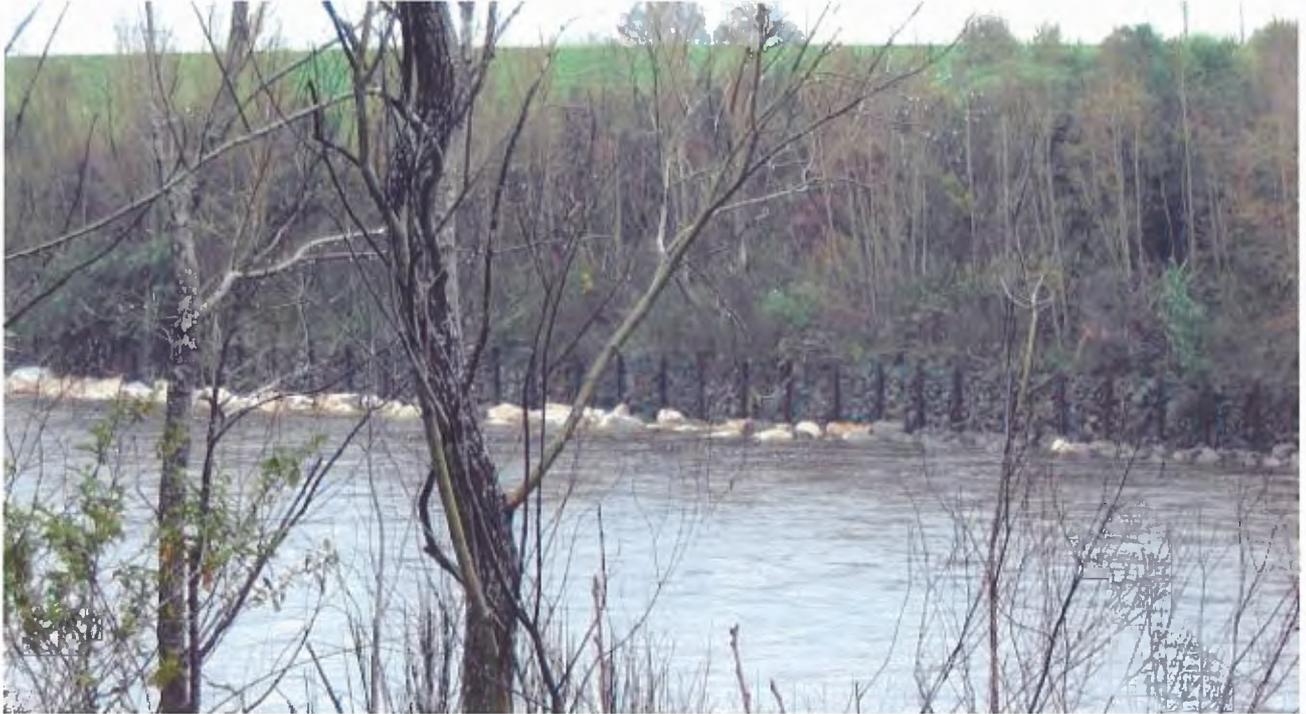
Longitudinal fence with rock placed along base.

- Line the base of the gabion basket fence with Rock; this is suitable where the fence hasn't failed but is undermining.

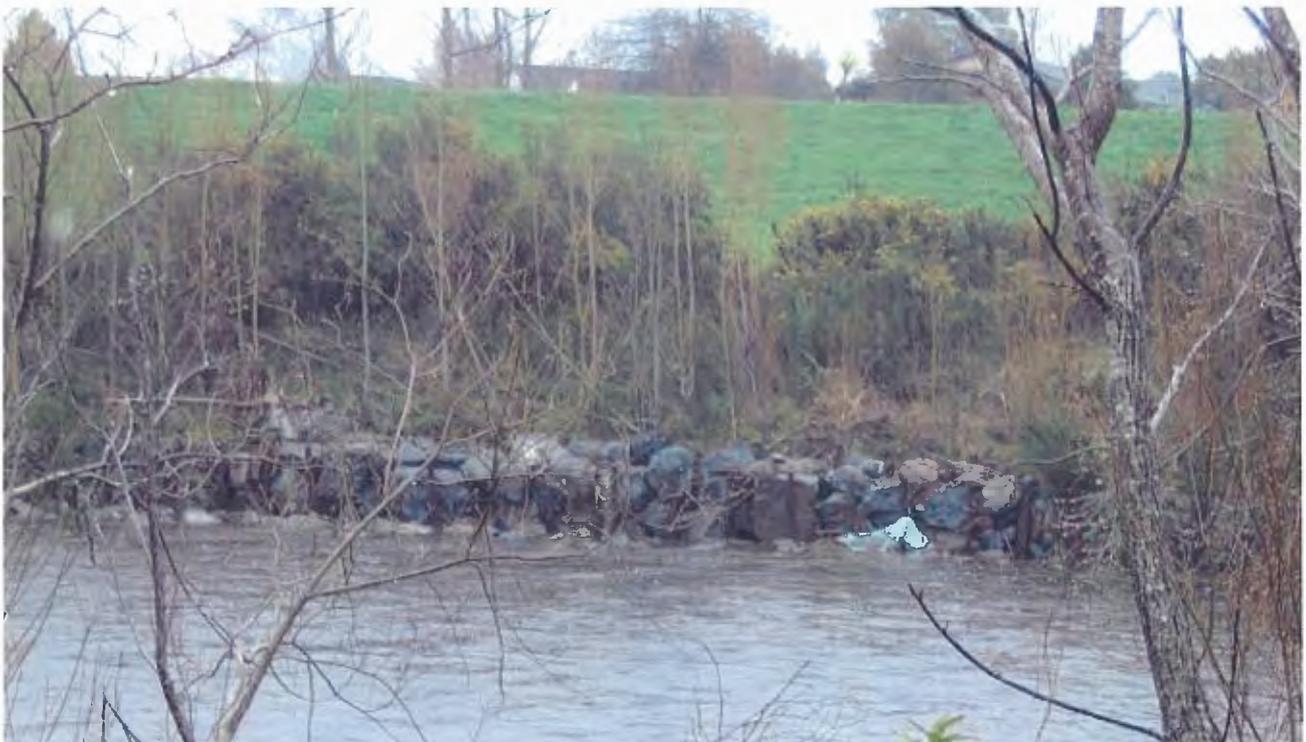
Longitudinal fence with rock backfill.

- Where the fence has failed completely, remove all damage i.e. mesh, rails, fill material and erect rail and rope fence and backfill with rock.
