***Condition and Remedial Action
Report***

**Baring Head Lighthouse Compound
February 2014**

IAN BOWMAN
Architect and Conservator
BOYDEN EVANS
Landscape Architect

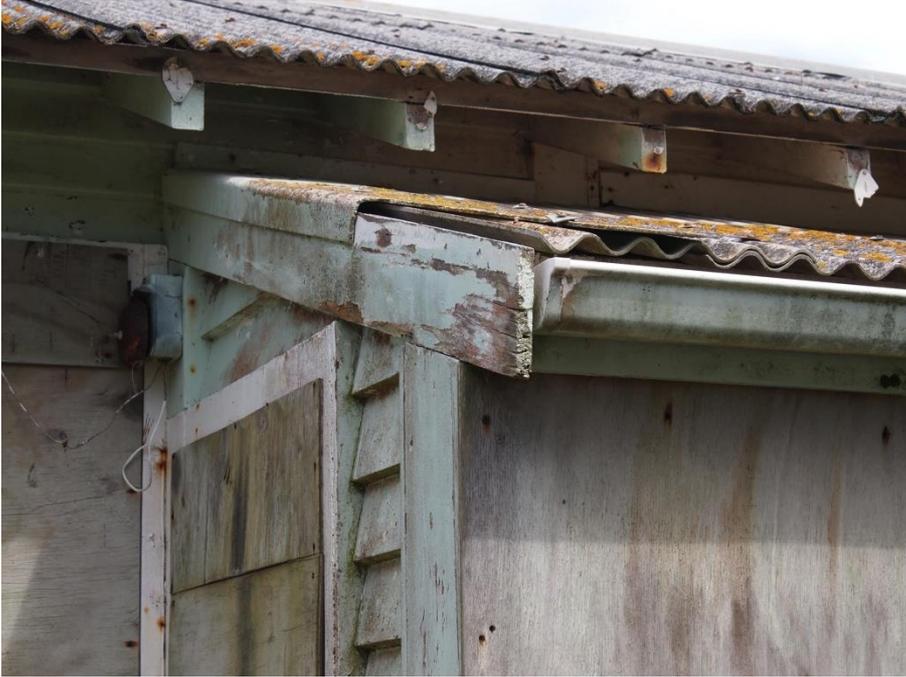
Paint peeling, cracked asbestos roofing, algae growth - typical of all elevations

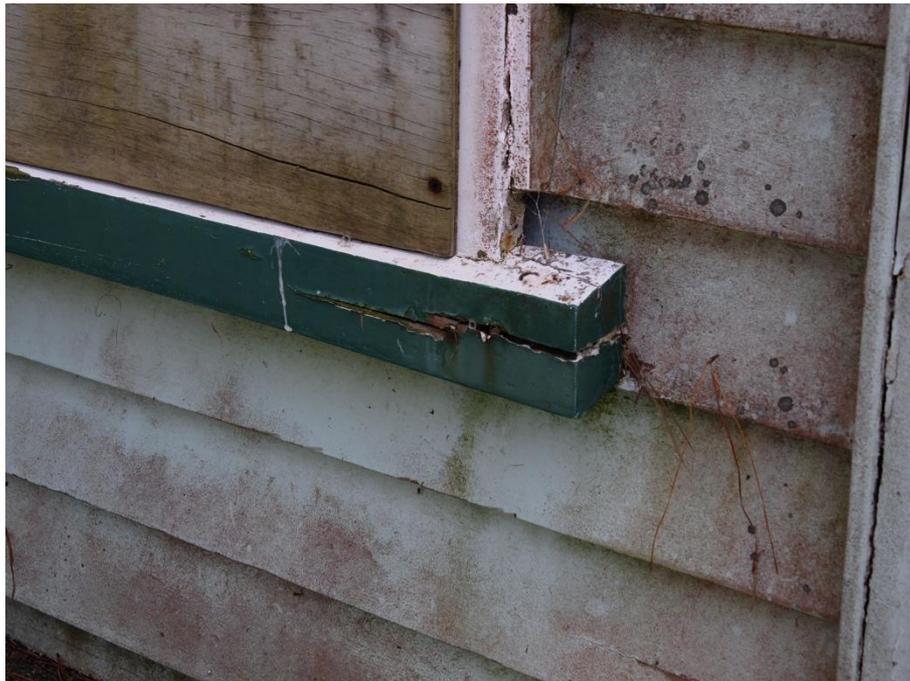
East elevation splitting sill

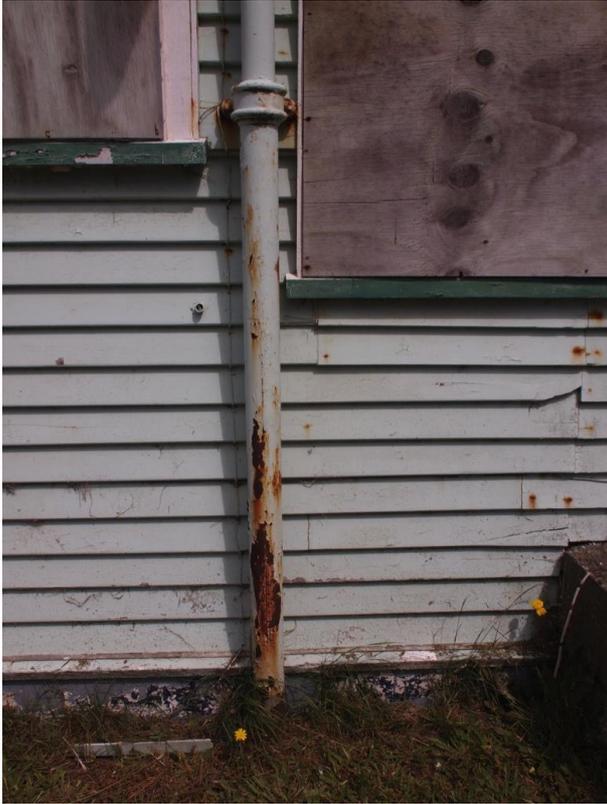
Rusting vent pipe, rusting nails and split and damaged weatherboards – east elevation

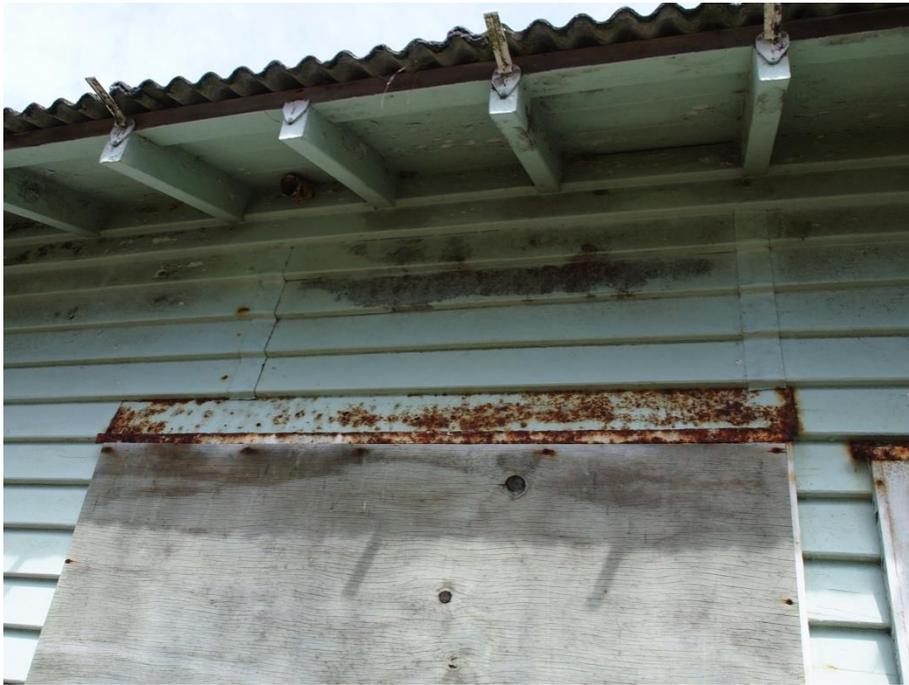
Rusting head flashings, missing guttering, fraying corrugated asbestos roofing edging – east elevation

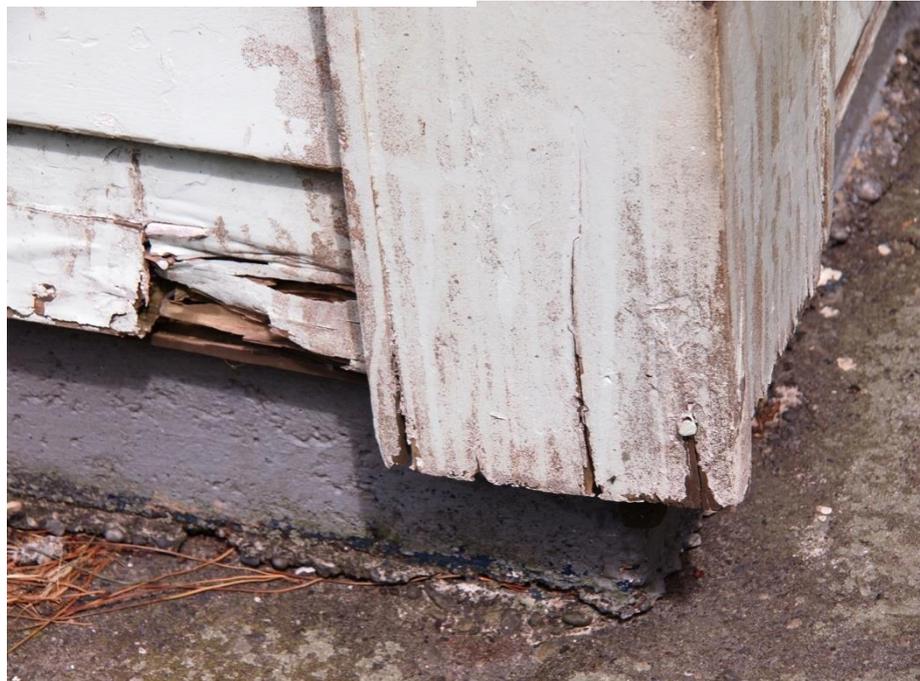
Rot in the north east corner

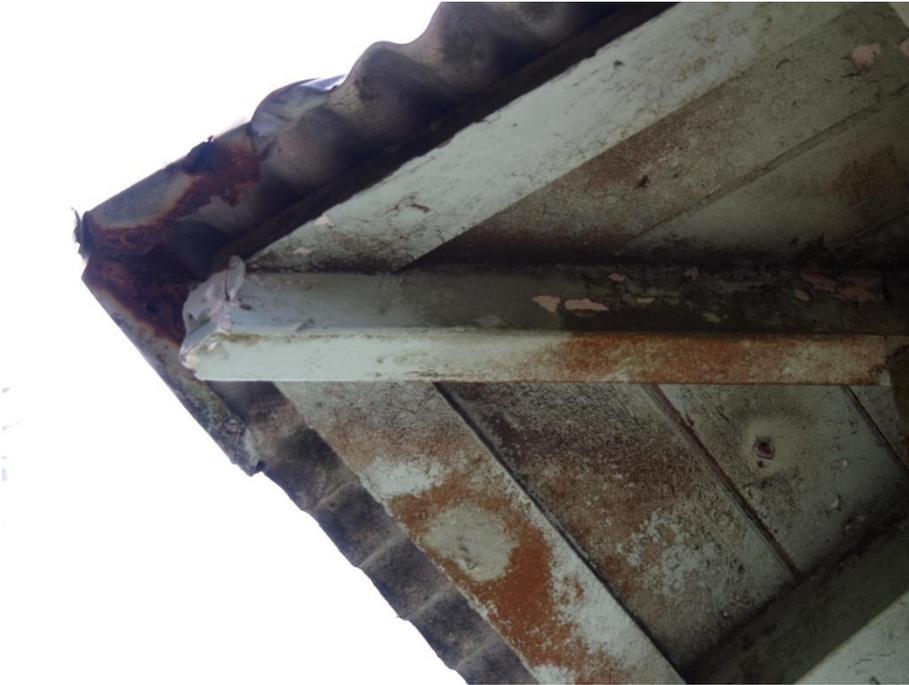
Rusting under side of corrugated steel ridge flashing – west elevation

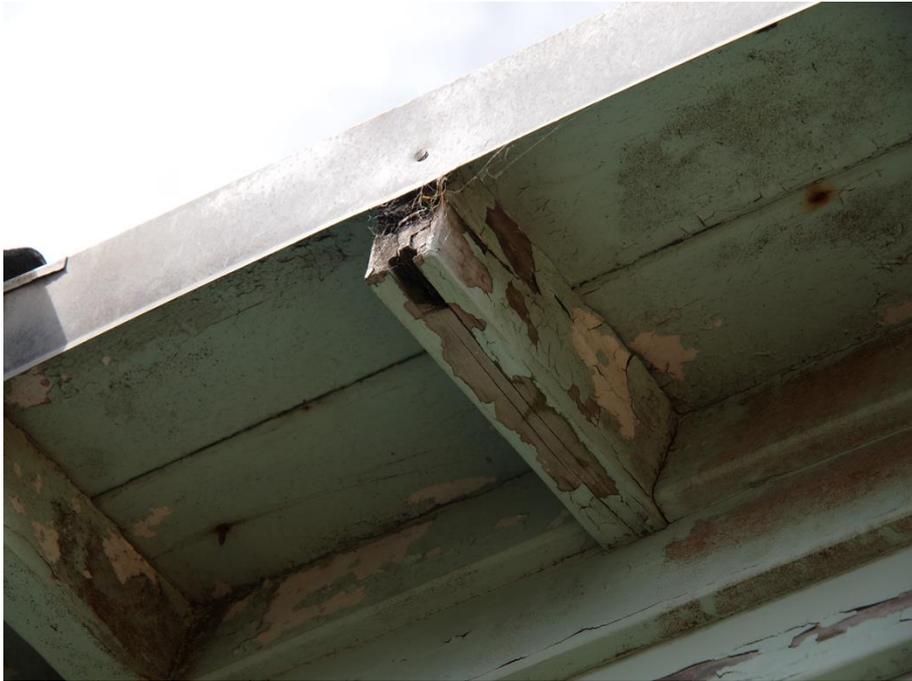
Rotten rafter end, rusting nails, peeling paintwork – west elevation

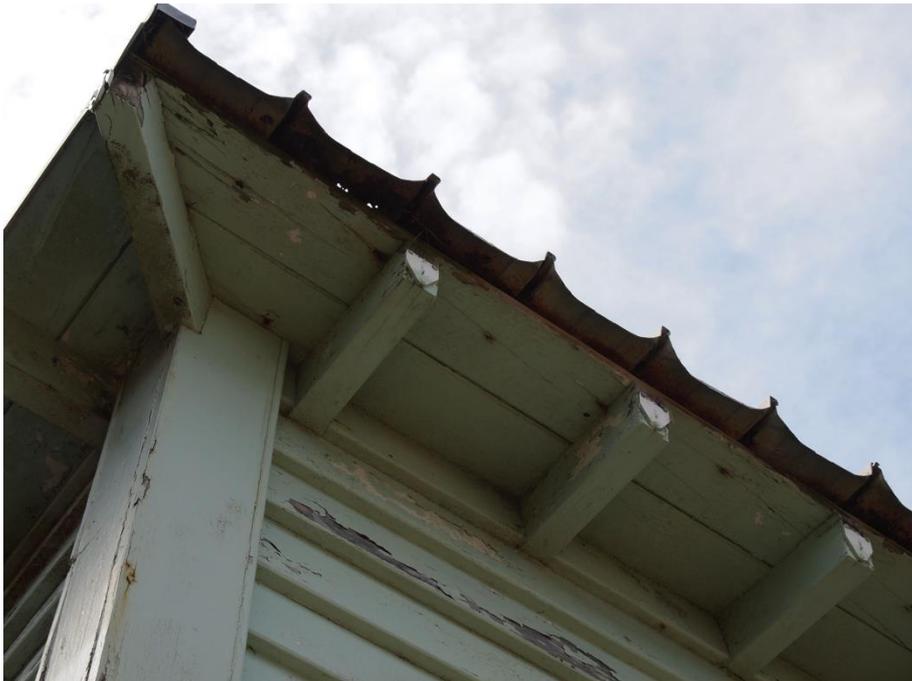
Rusting underside of the trough section roofing – south west corner

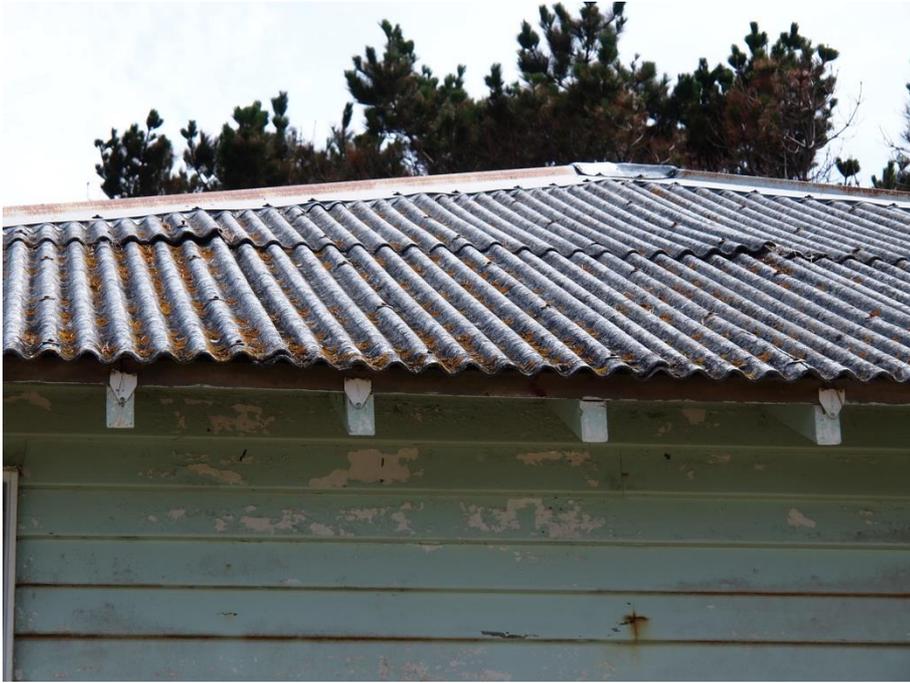
Lifting asbestos roofing – east elevation

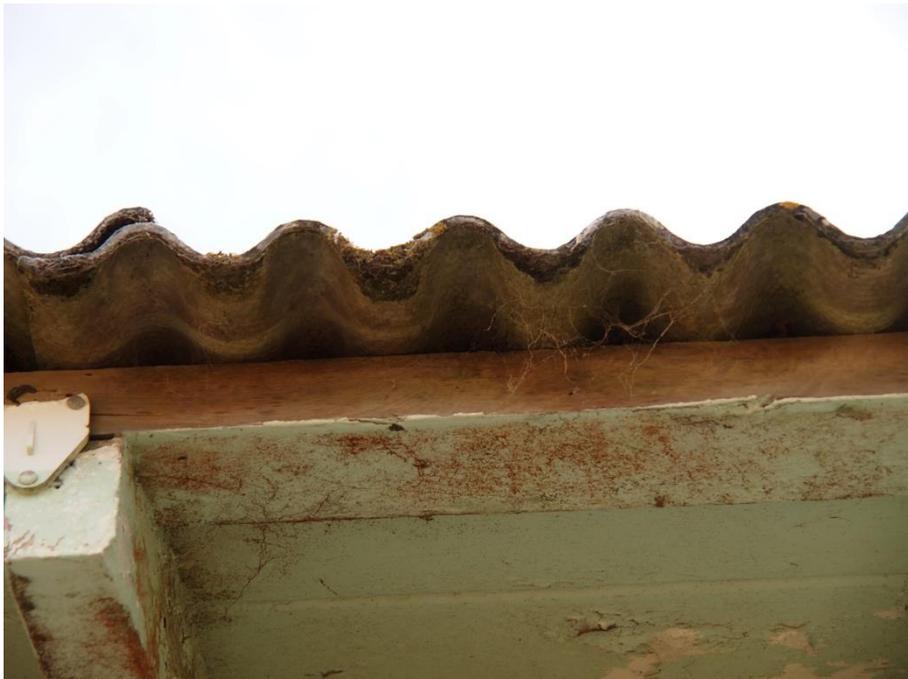
Fraying cut edges to roofing – east elevation

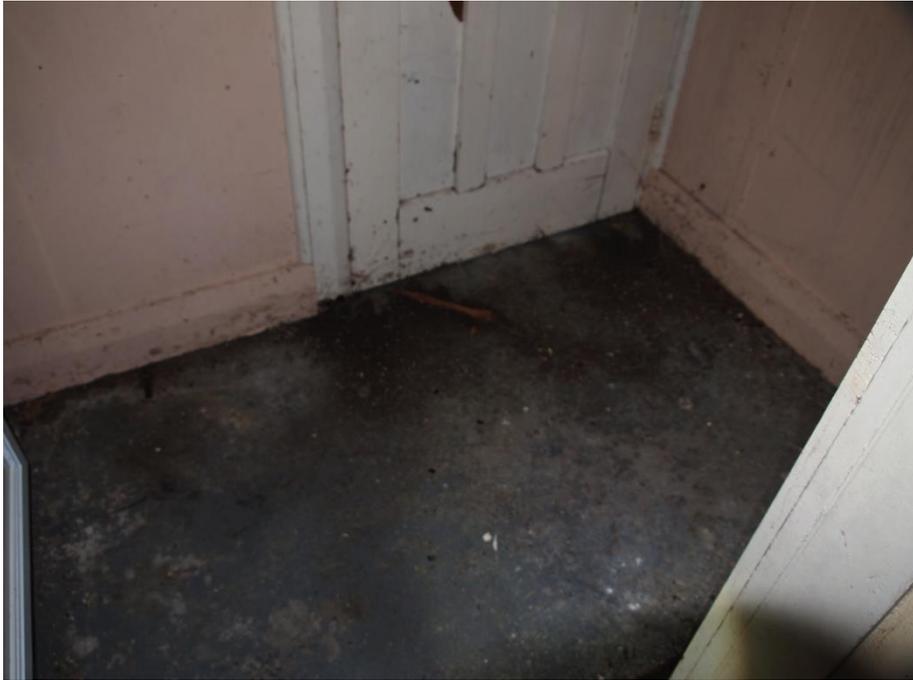
Damaged flooring to kitchen

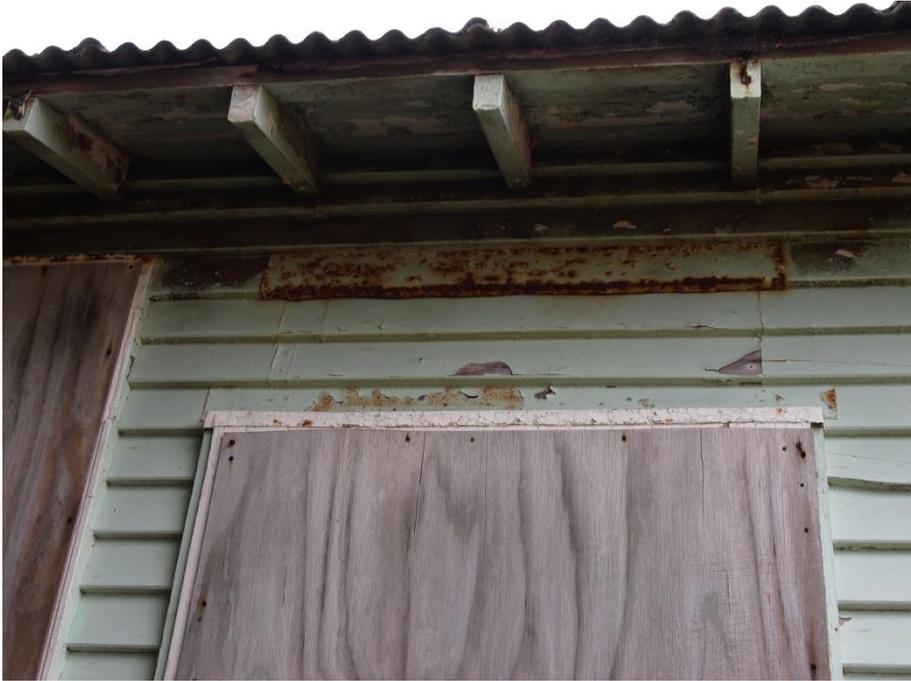
Rusting head flashings, peeling paint, missing guttering – typical of all elevations

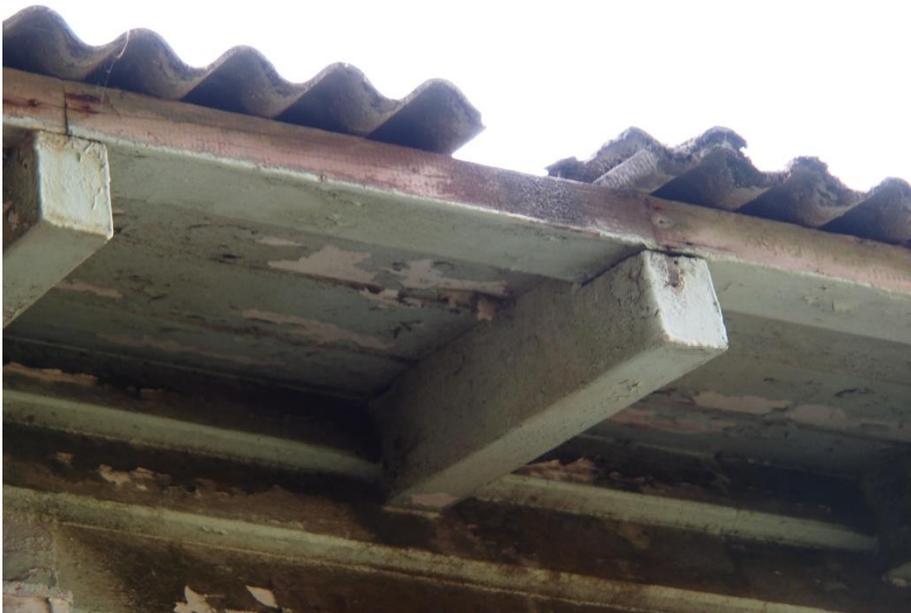
Damaged asbestos roofing - west elevation

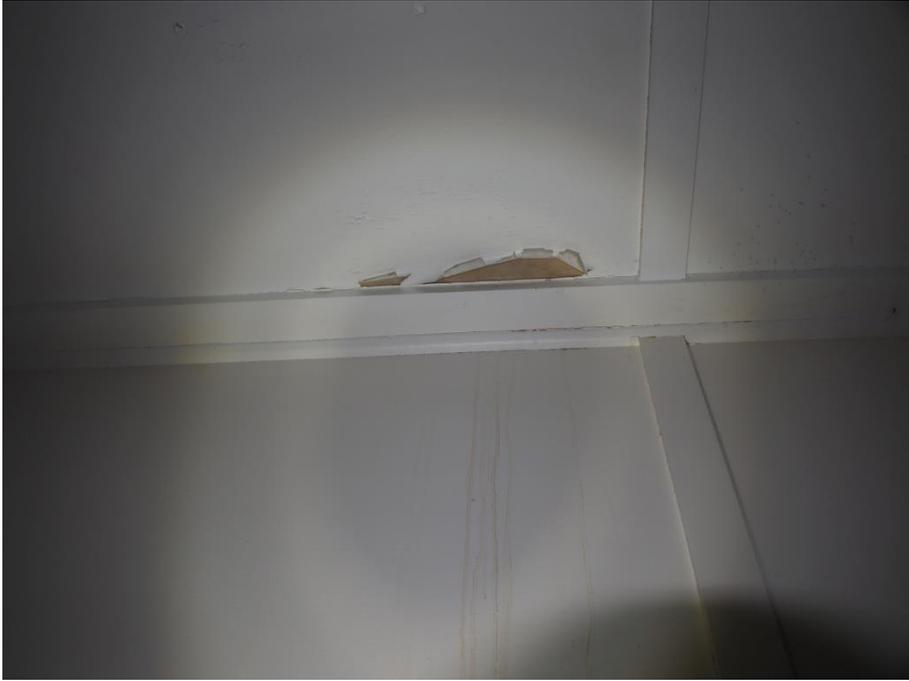
Peeling paint, dining room

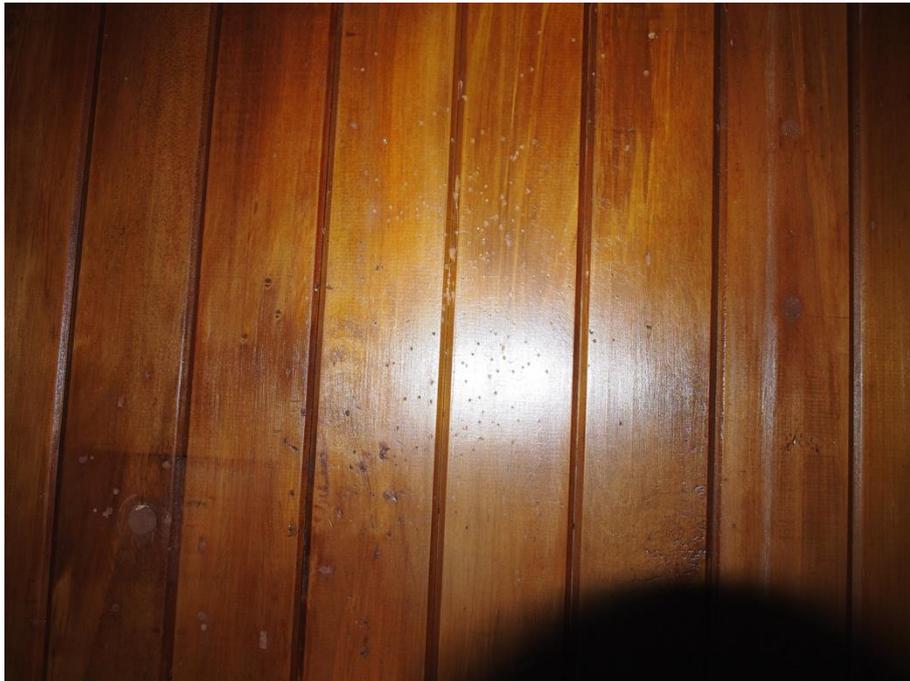
Borer in living room paneling

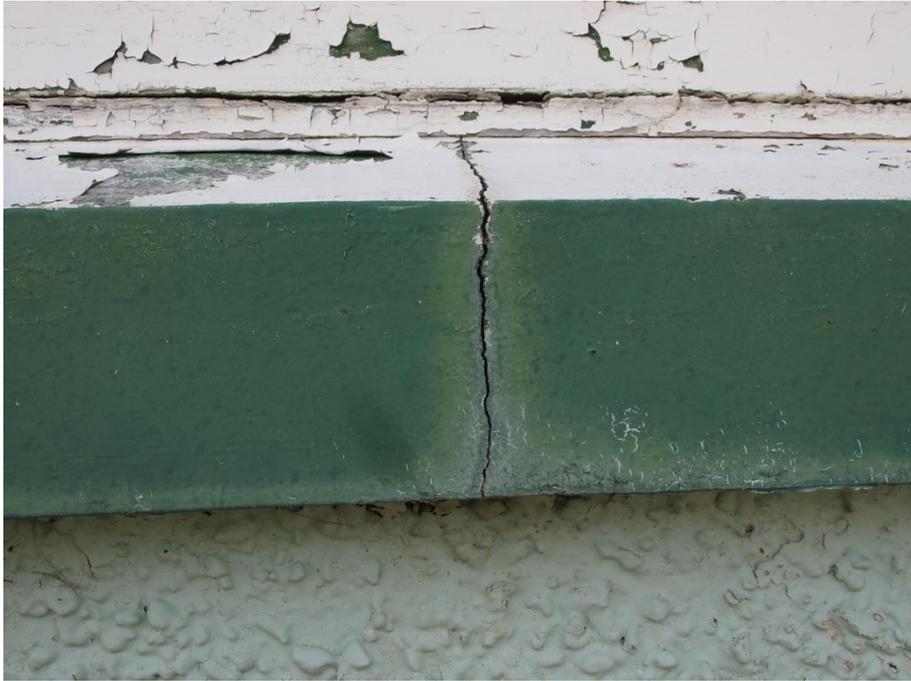
Cracked sill, west elevation

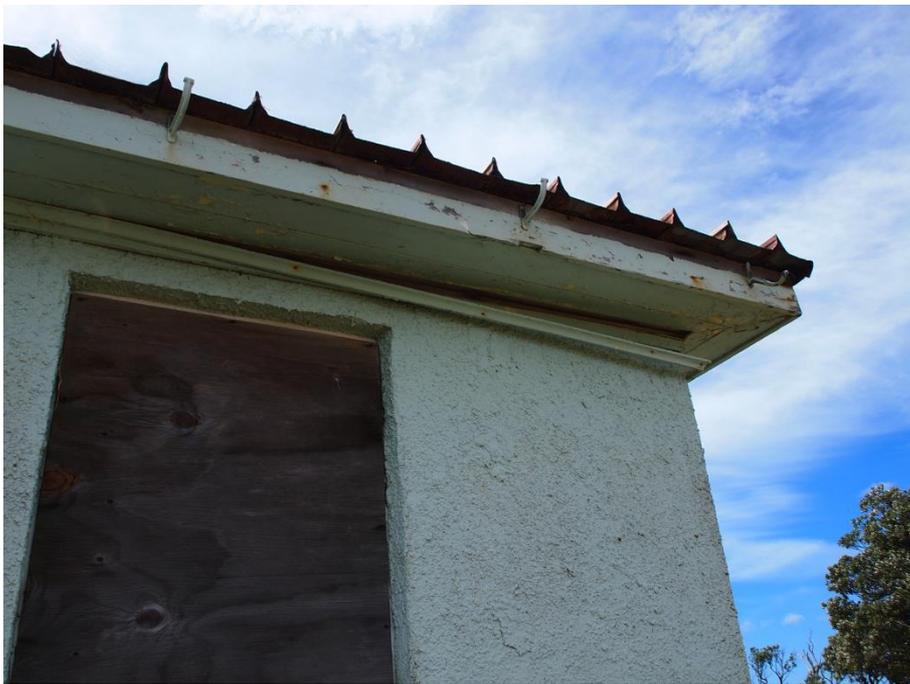
Loose molding, rusting trough section roofing

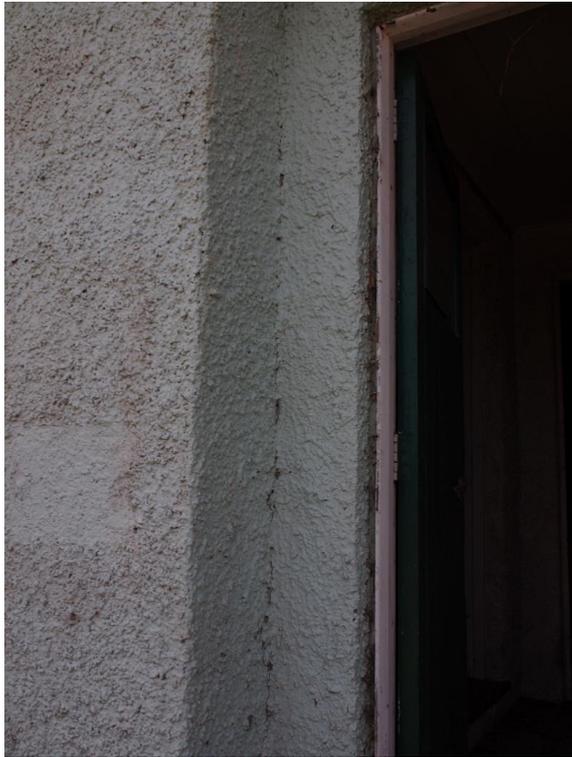
Cracking to corner, west elevation

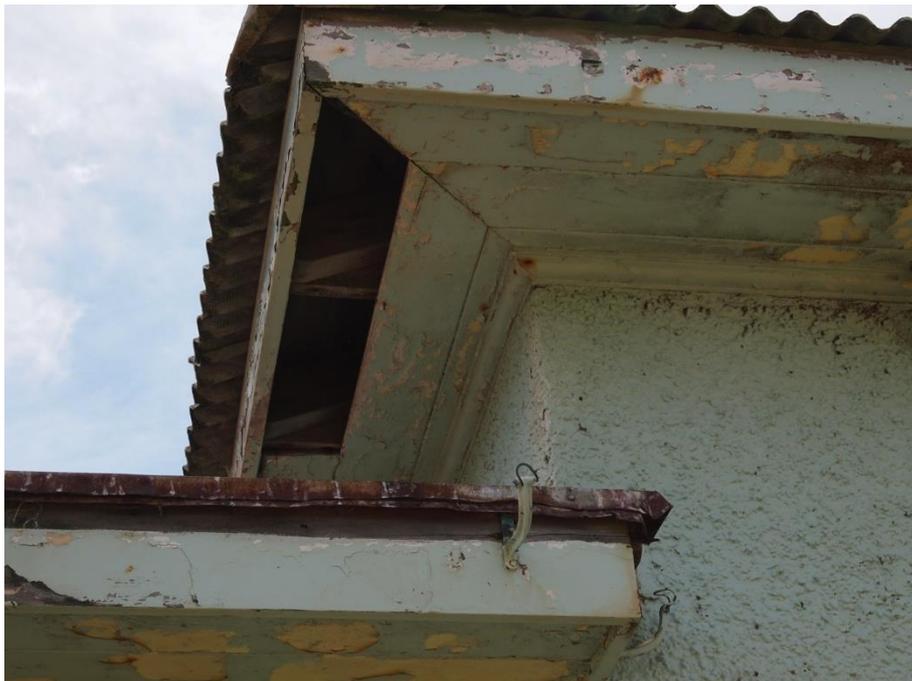
Missing section of eaves, south west corner

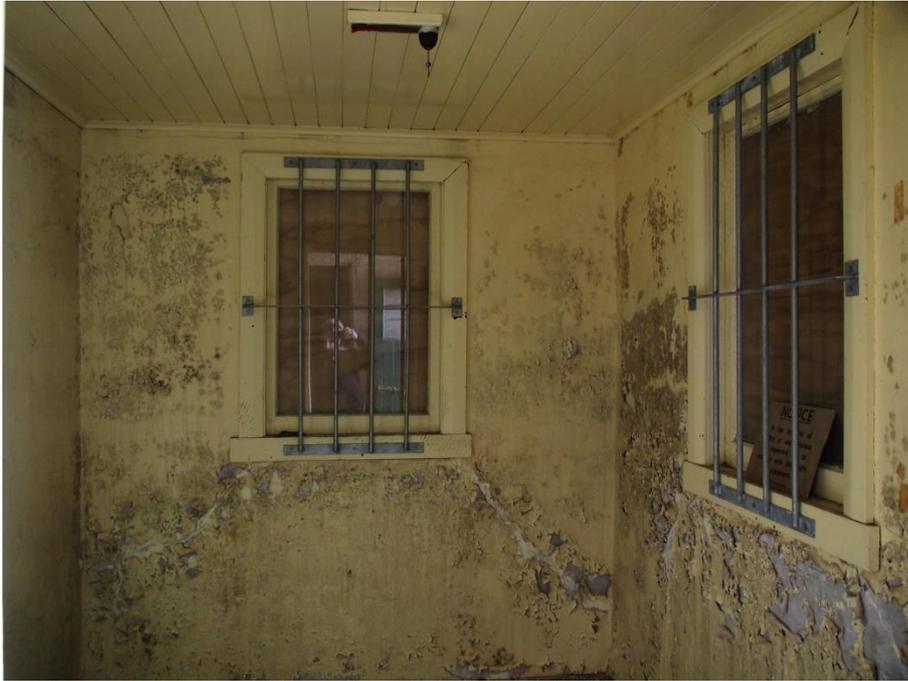
South west corner room, peeling paint and cracked plaster

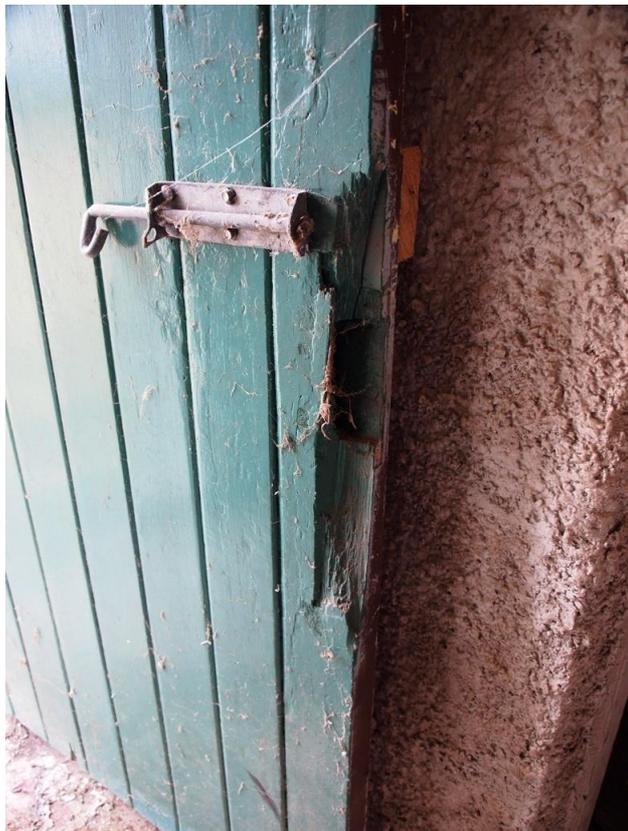
Damaged front door

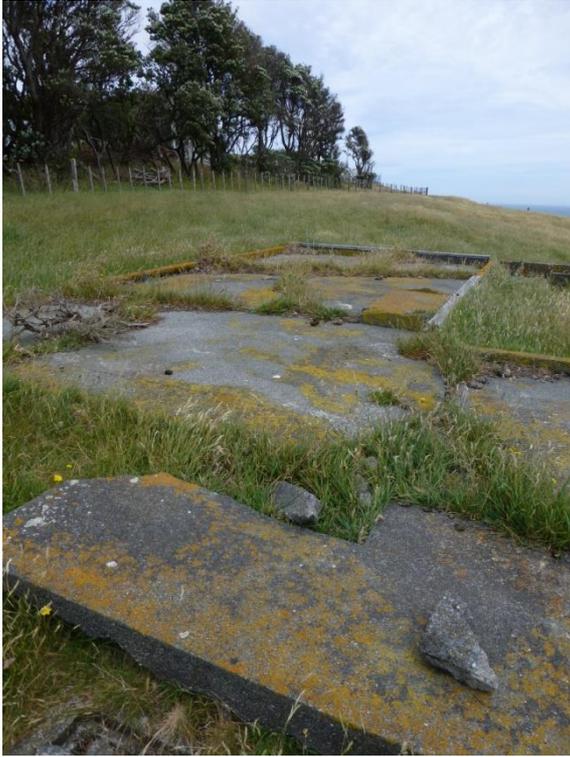
Figure 22 lichen and mold on concrete foundation

Elevation	Element	Fabric	Type	Condition	Remedial Action	Timeframe
Foundations	Foundations	Concrete, remains of timber bottom plates	Hf	Weeds, moss and lichen growth	Apply biocide, cut weeds	N
				Rotting, splitting timberwork	Treat with zinc naphthenate	U
				Rusting fixings	Apply fish oil	U
				Cracked and broken concrete	Monitor	N

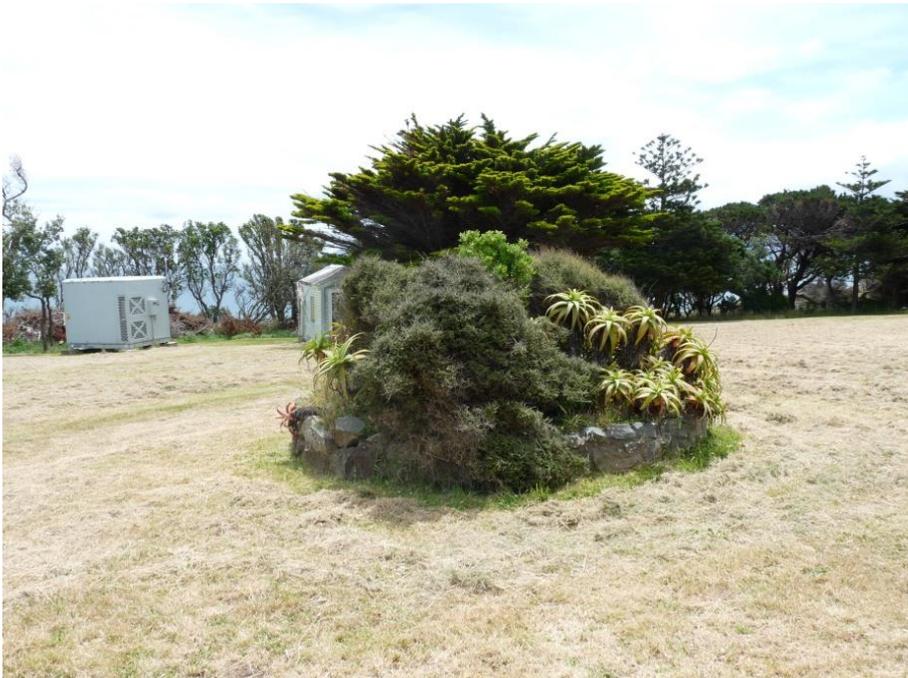
Rock garden remains largely intact, requiring only minor maintenance

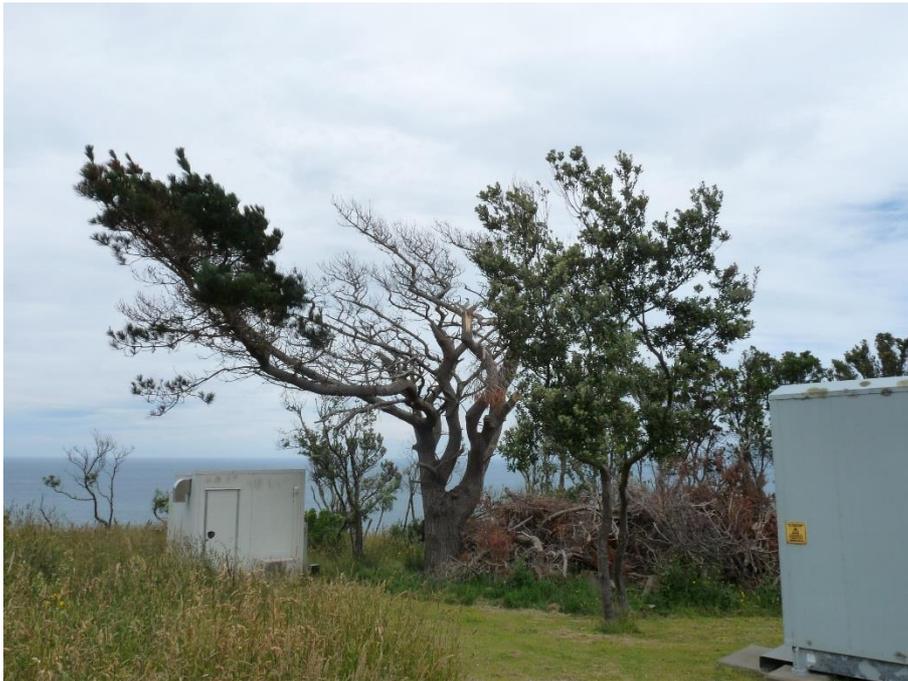
Shelterbelt has suffered storm damage in places requiring remedial arboricultural attention

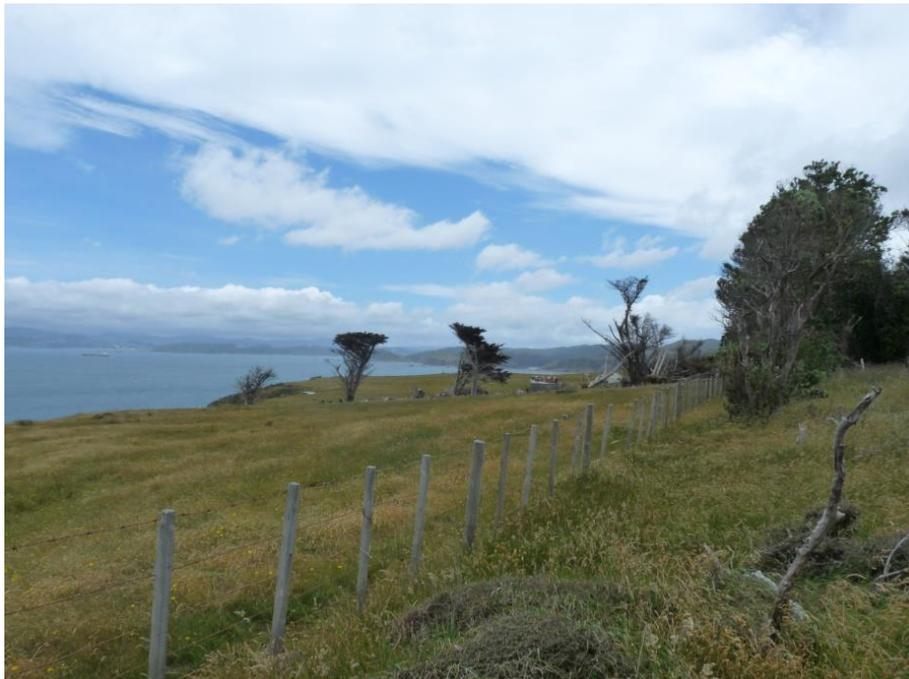
Only a few straggly trees that were part of the original shelterbelt between the north-western boundary and the escarpment remain

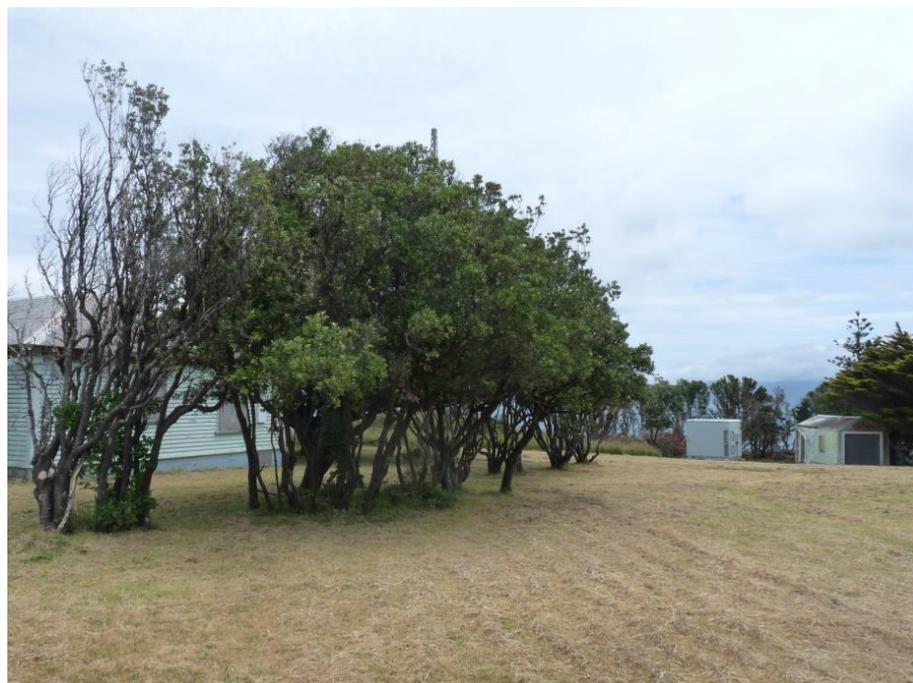
Some tree removal and arboricultural management required for plantings within the compound

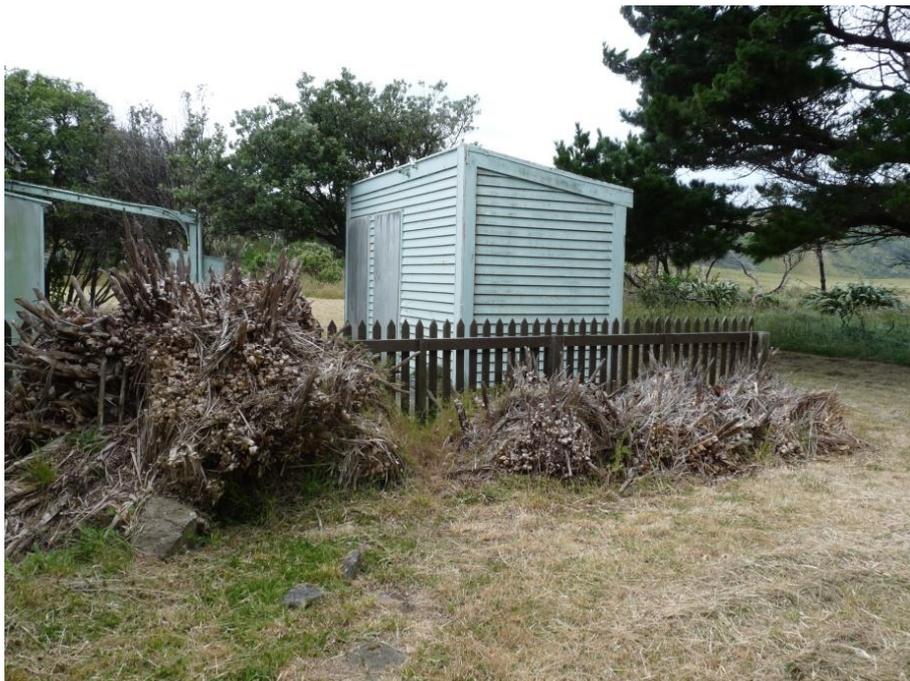
Remnants of the original picket fencing remain in a few places

Picket fence	Variable, some in reasonable condition while others damaged	Offers template for reinstatement	D
--------------	---	-----------------------------------	---

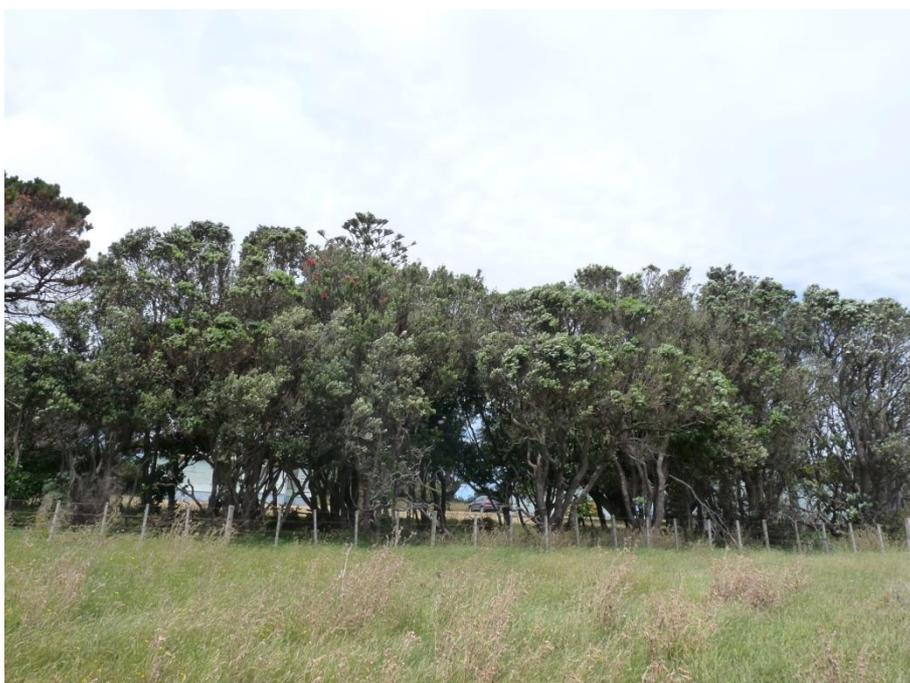
Shelterbelt viewed from outside the compound, noting pohutukawa along the outer edge with macrocarpa and pine contributing the main structural elements
