*Condition and Remedial Action
Report*

**Baring Head Lighthouse Compound
February 2014**

IAN BOWMAN
Architect and Conservator
BOYDEN EVANS
Landscape Architect

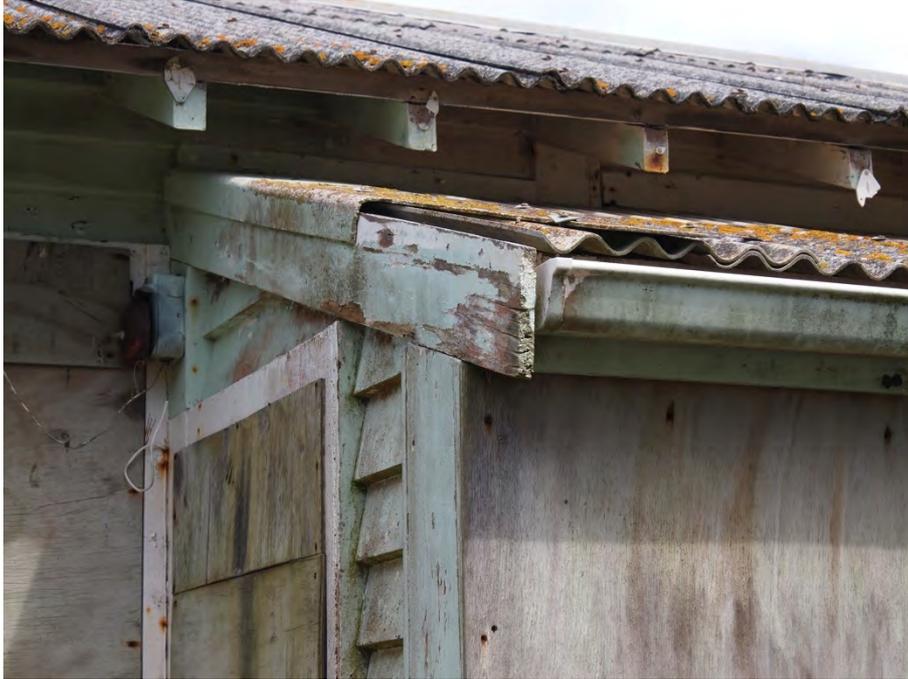
Paint peeling, cracked asbestos roofing, algae growth - typical of all elevations

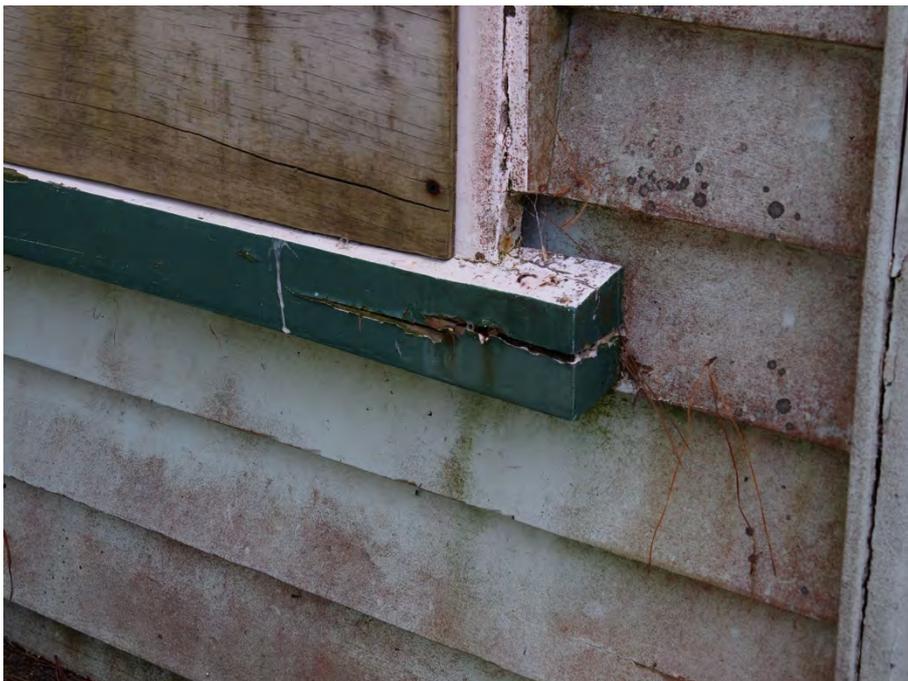
East elevation splitting sill

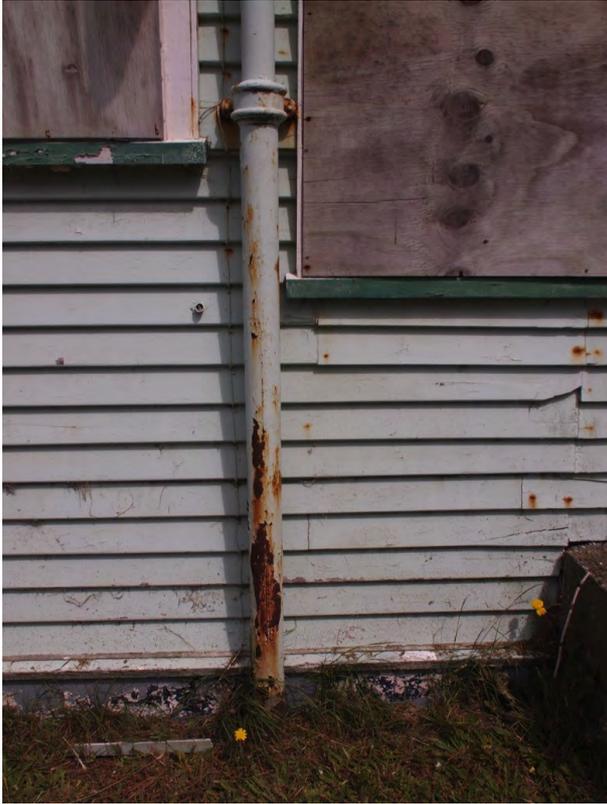
Rusting vent pipe, rusting nails and split and damaged weatherboards – east elevation

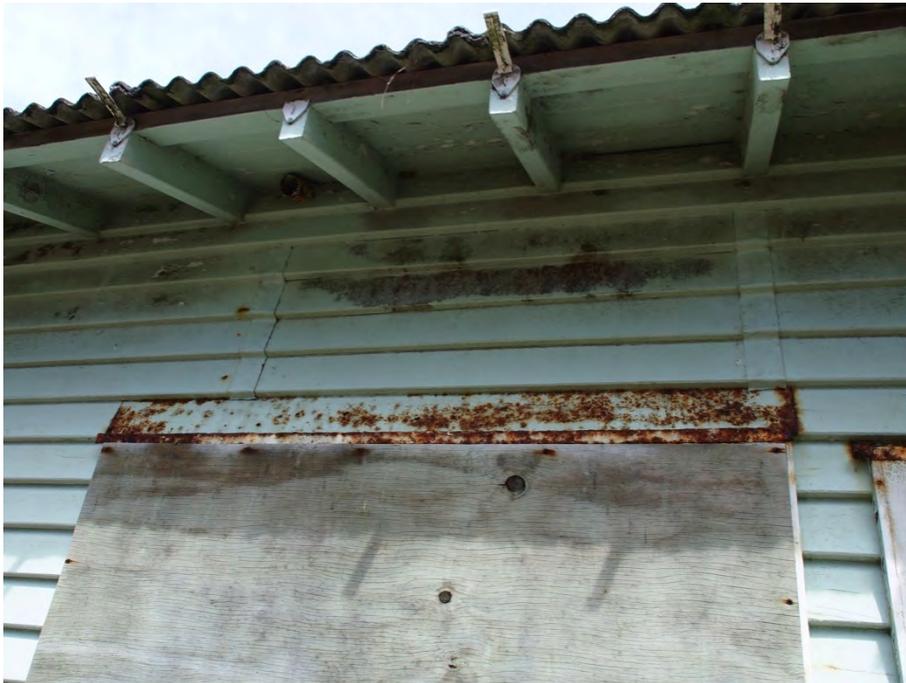
Rusting head flashings, missing guttering, fraying corrugated asbestos roofing edging – east elevation

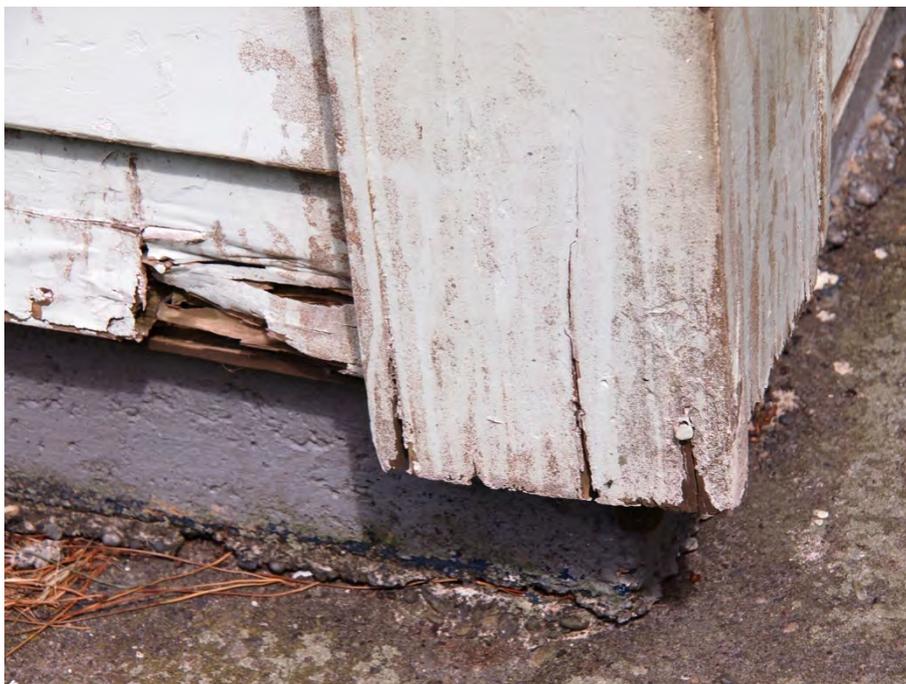
Rot in the north east corner

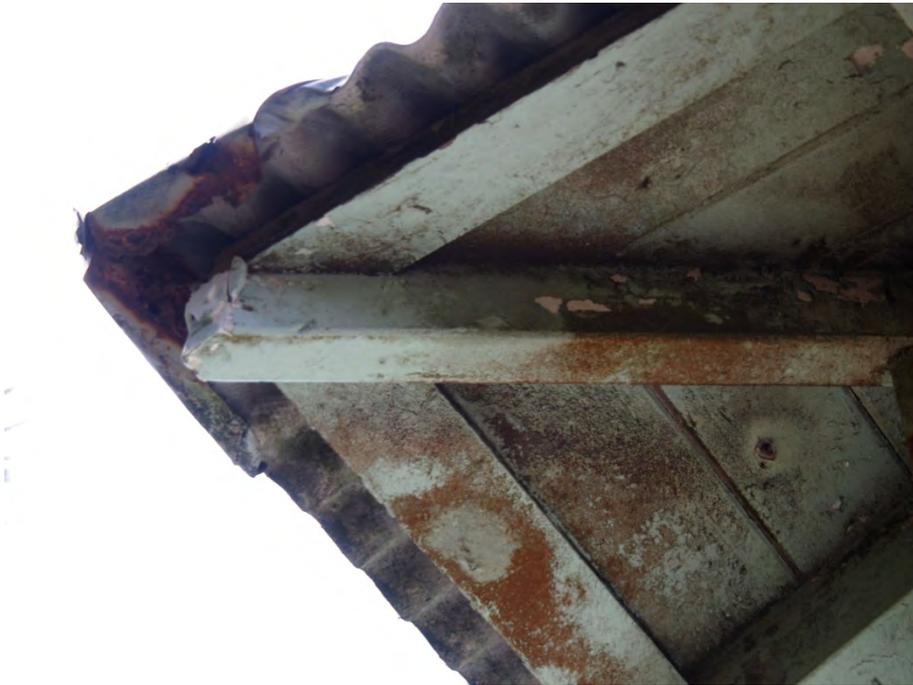
Rusting under side of corrugated steel ridge flashing – west elevation

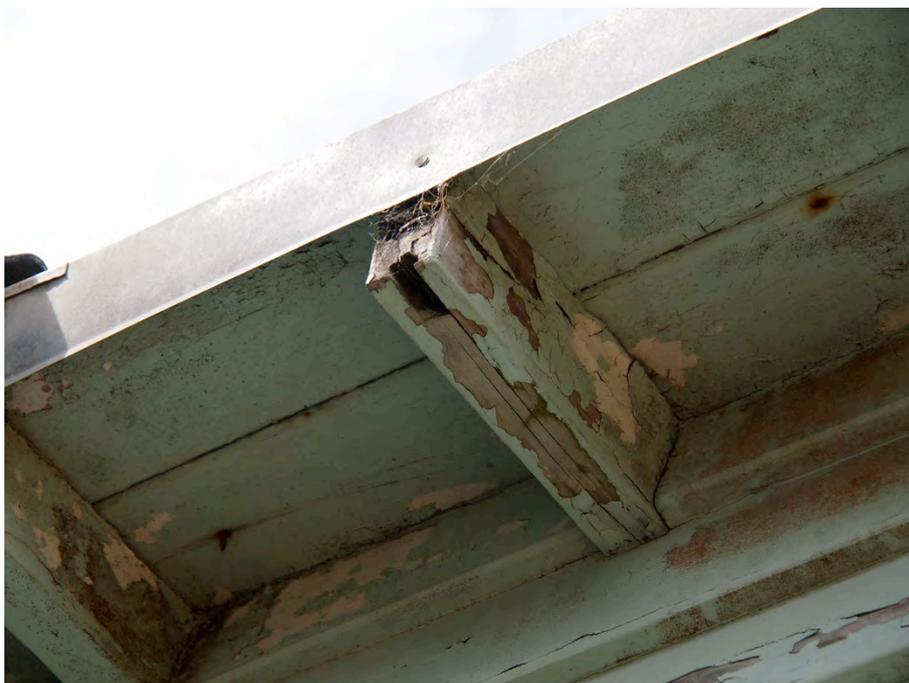
Rotten rafter end, rusting nails, peeling paintwork – west elevation

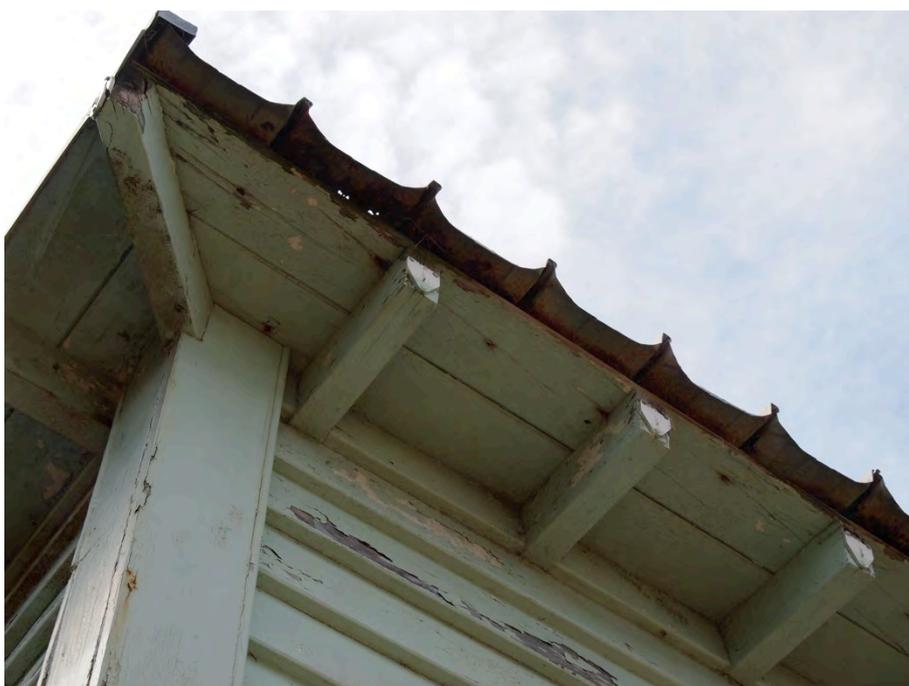
Rusting underside of the trough section roofing – south west corner

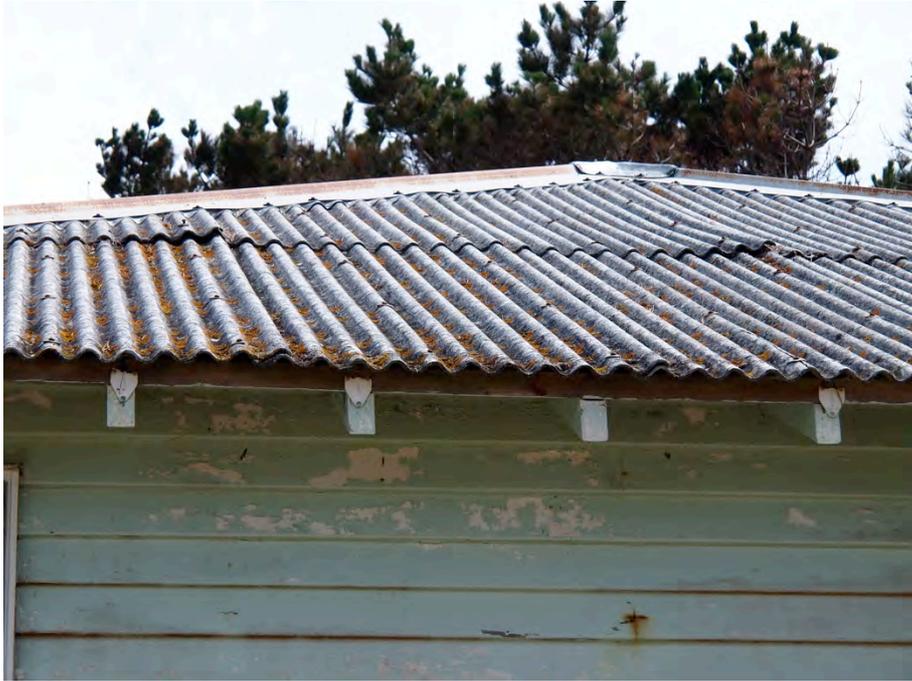
Lifting asbestos roofing – east elevation

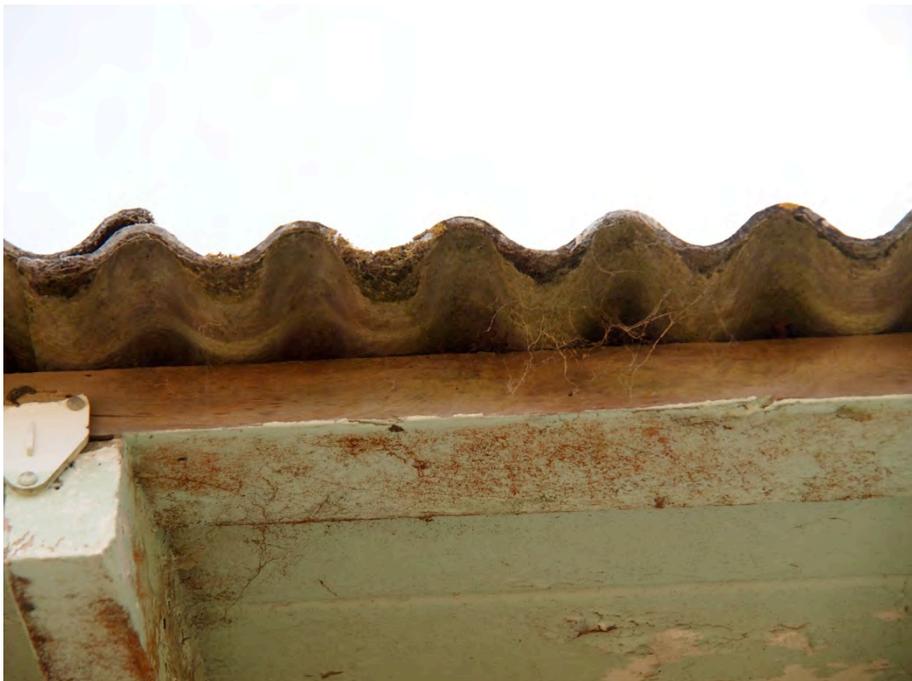
Fraying cut edges to roofing – east elevation

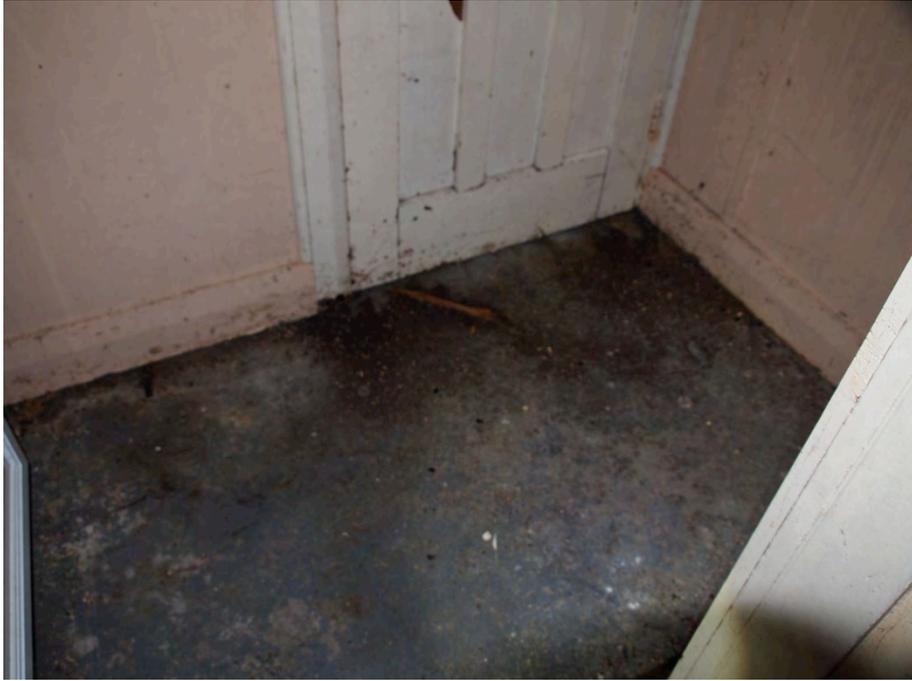
Damaged flooring to kitchen

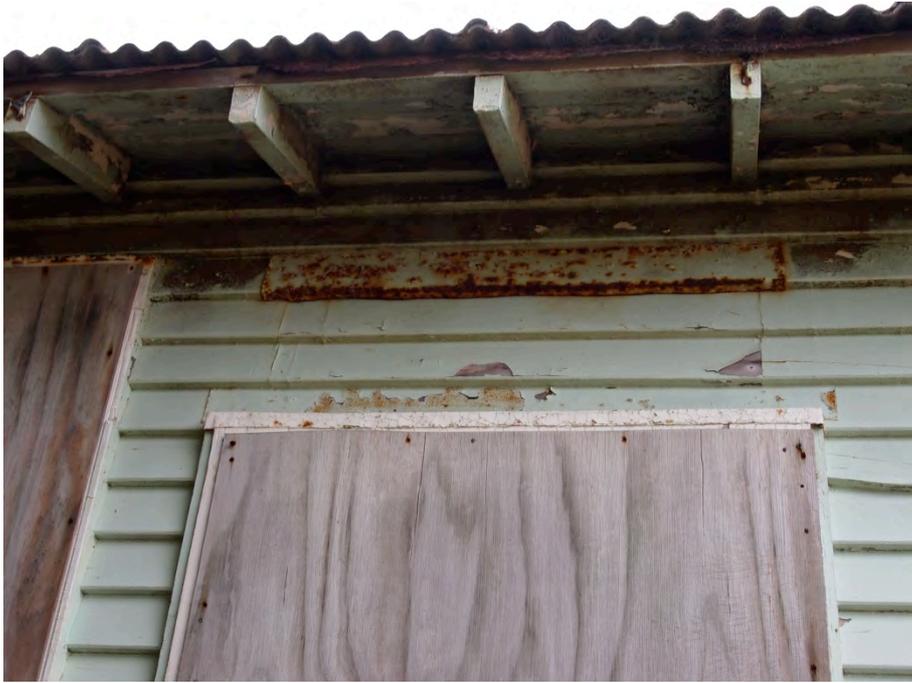
Rusting head flashings, peeling paint, missing guttering – typical of all elevations

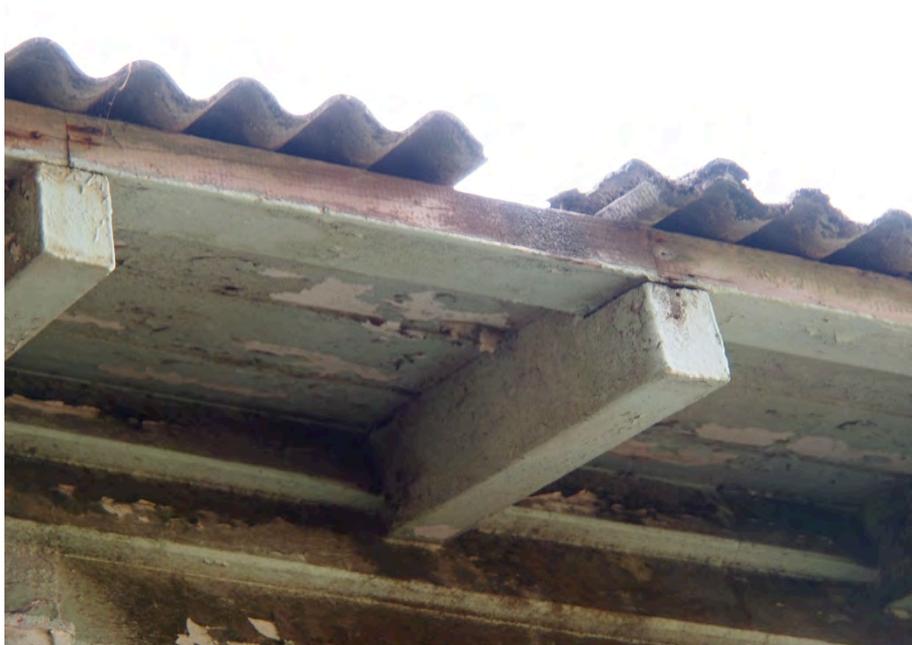
Damaged asbestos roofing - west elevation

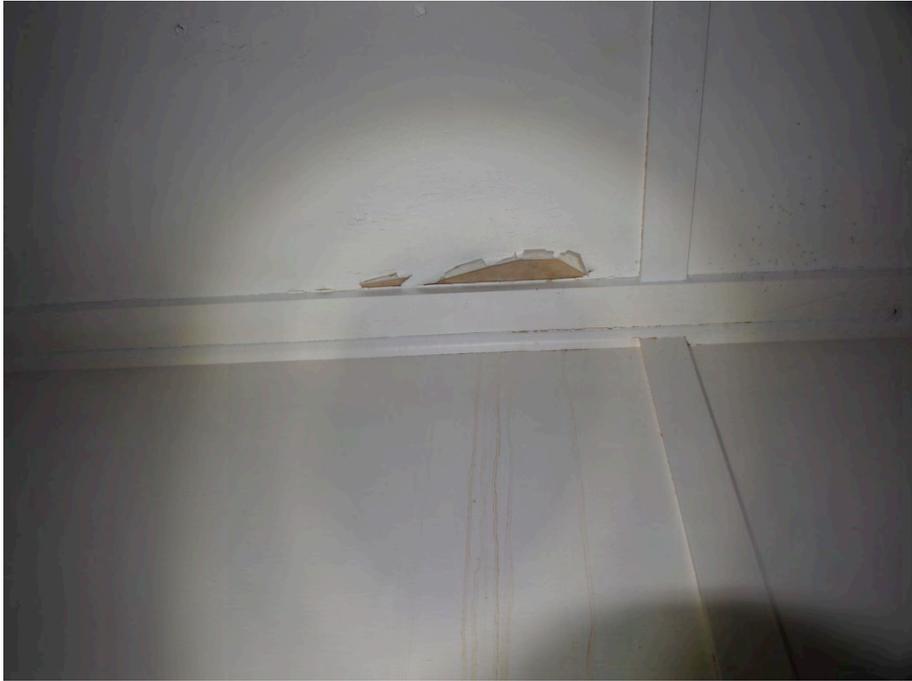
Peeling paint, dining room

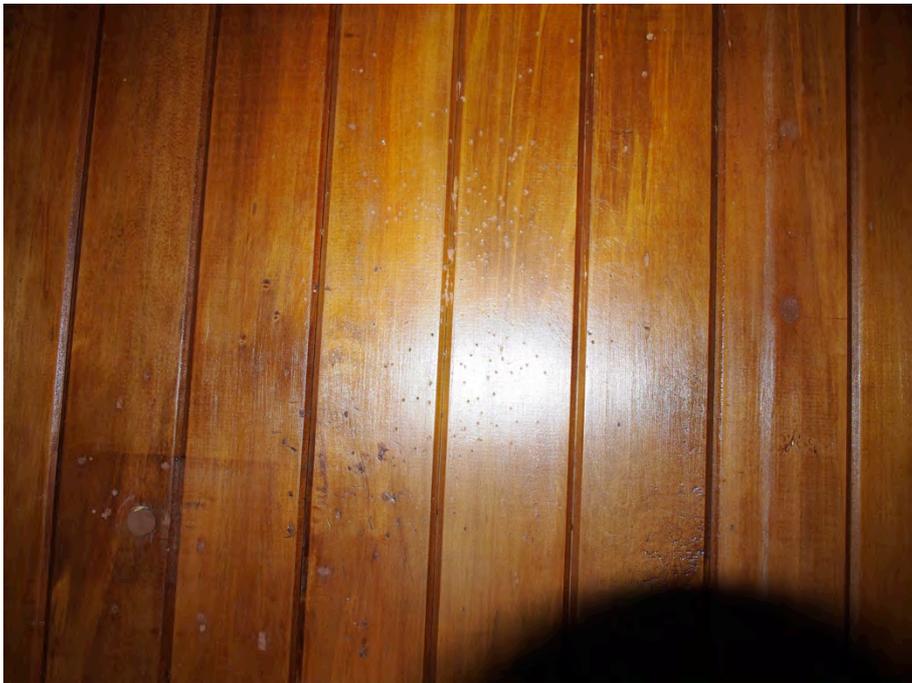
Borer in living room paneling

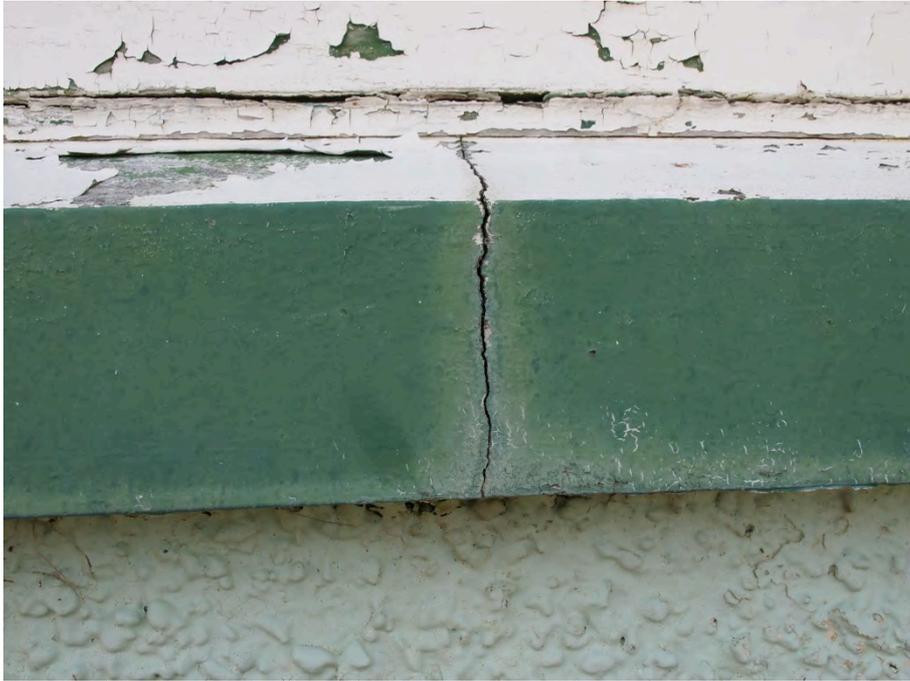
Cracked sill, west elevation

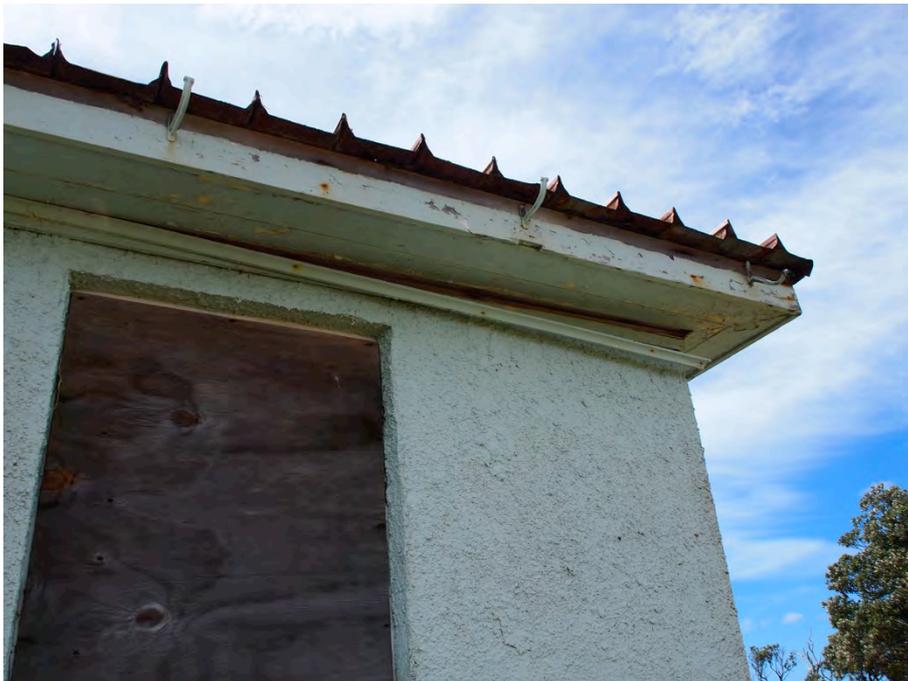
Loose molding, rusting trough section roofing

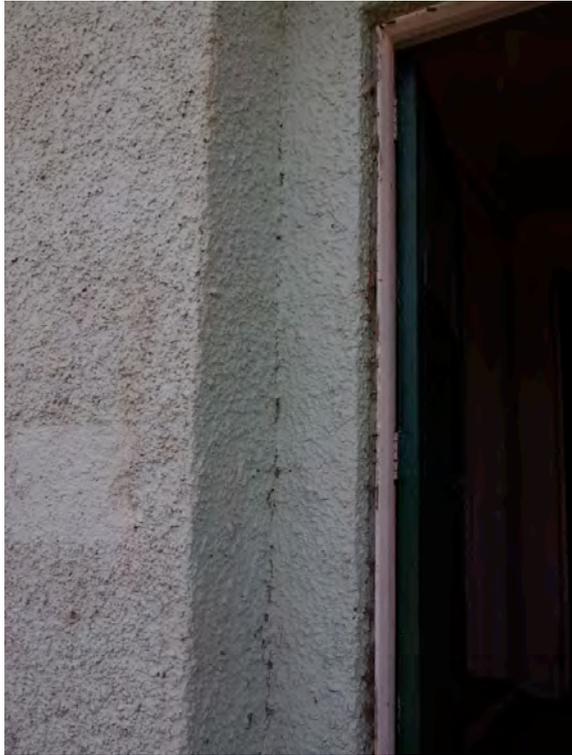
Cracking to corner, west elevation

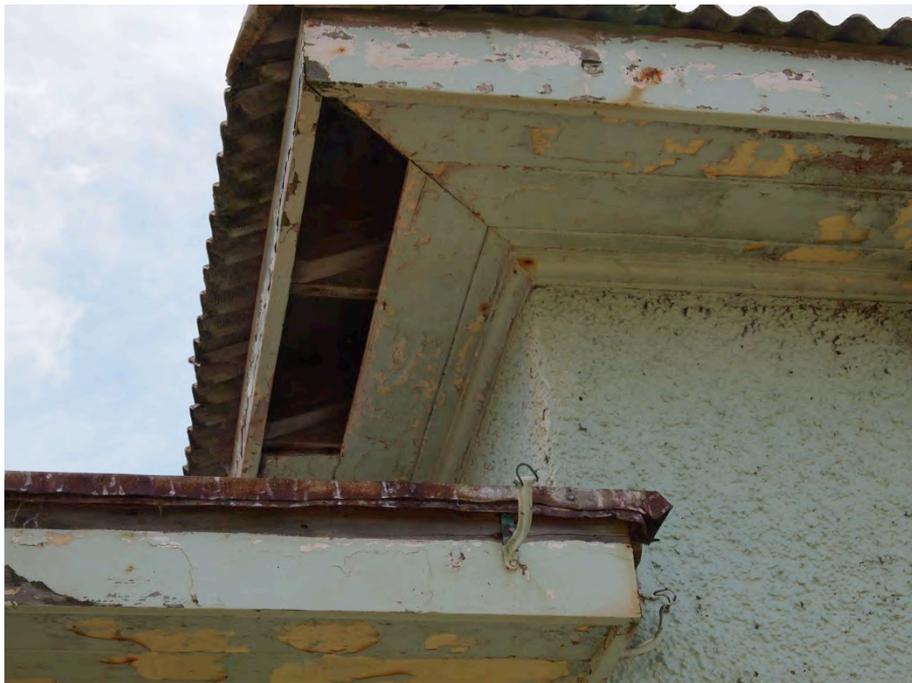
Missing section of eaves, south west corner

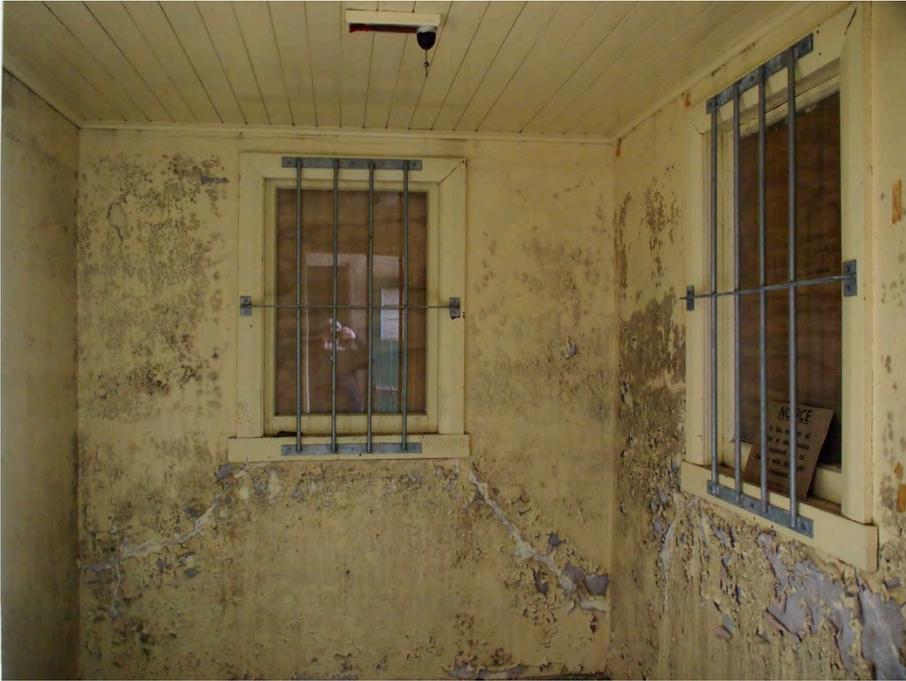
South west corner room, peeling paint and cracked plaster

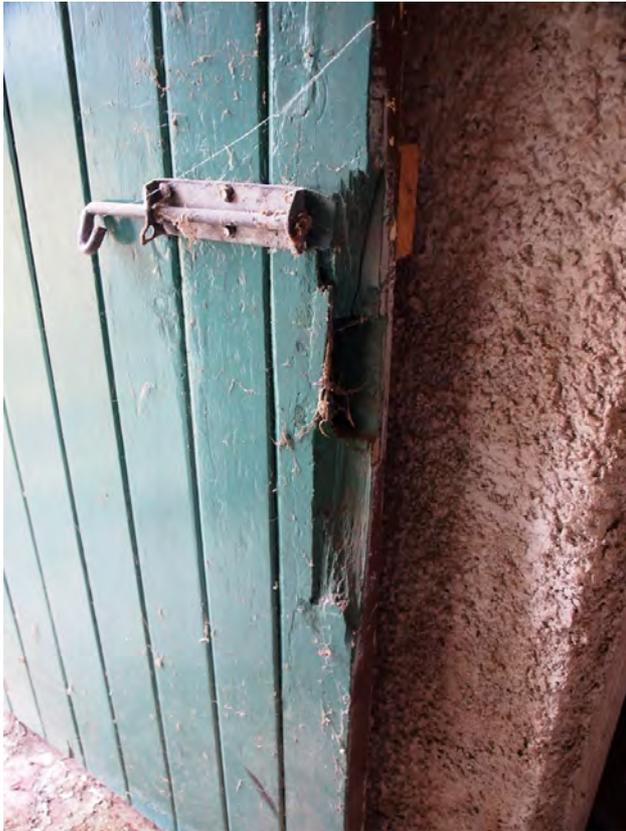
Damaged front door

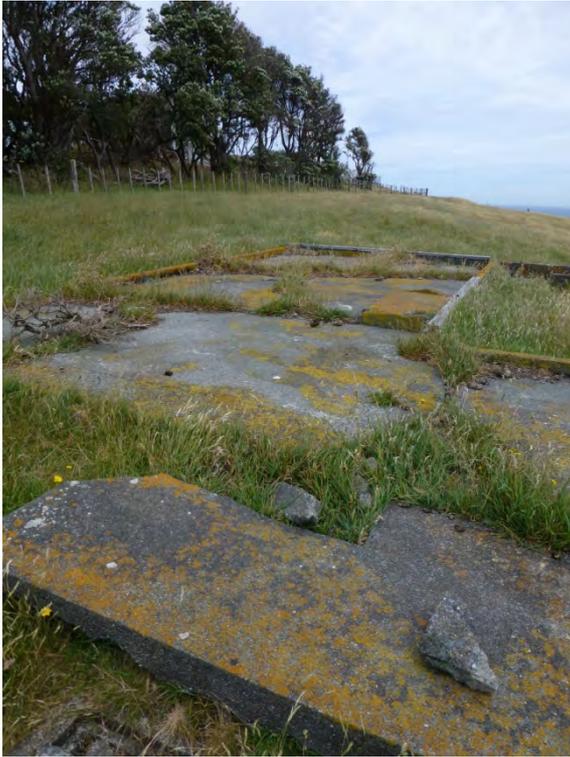
Lichen and mold on concrete foundation

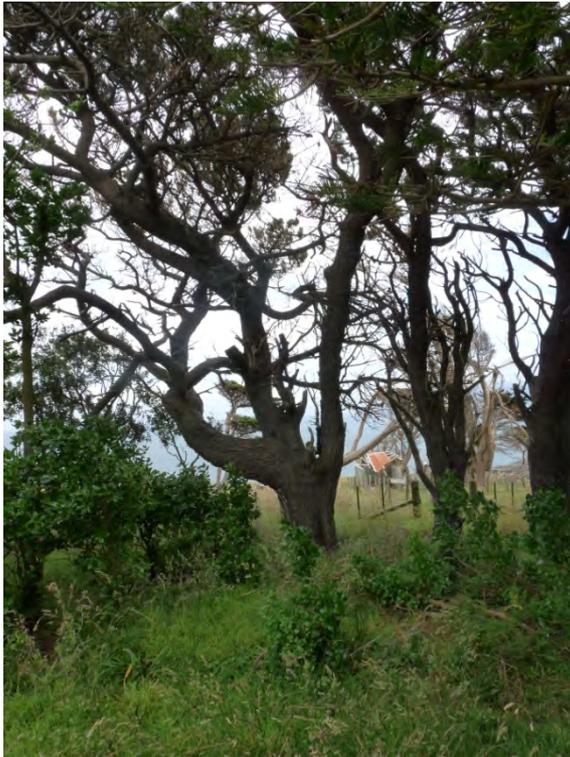
Shelterbelt would benefit from remedial work to improve longevity

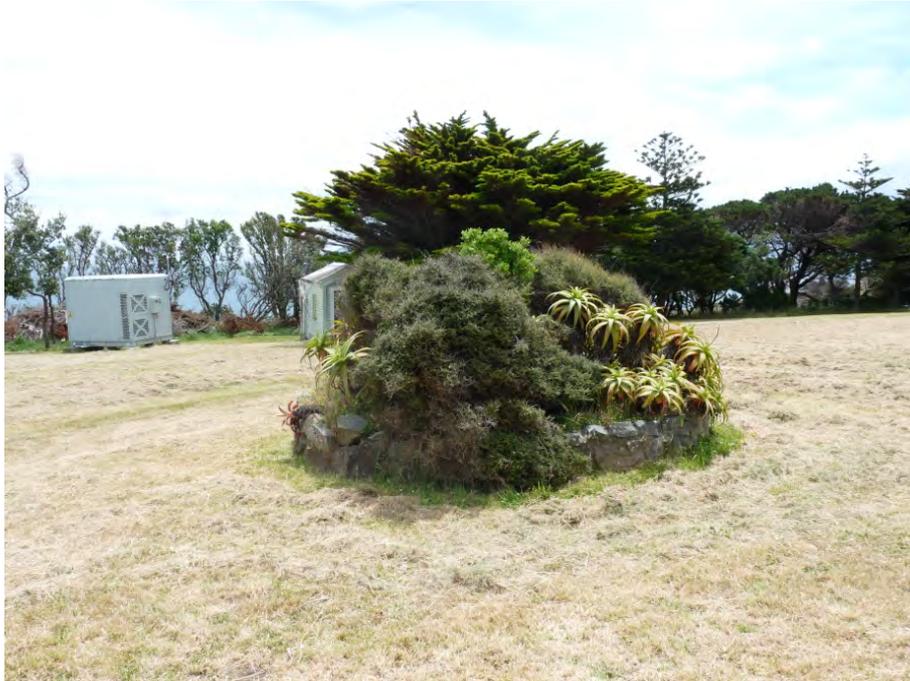
Rock garden remains largely intact, requiring only minor maintenance

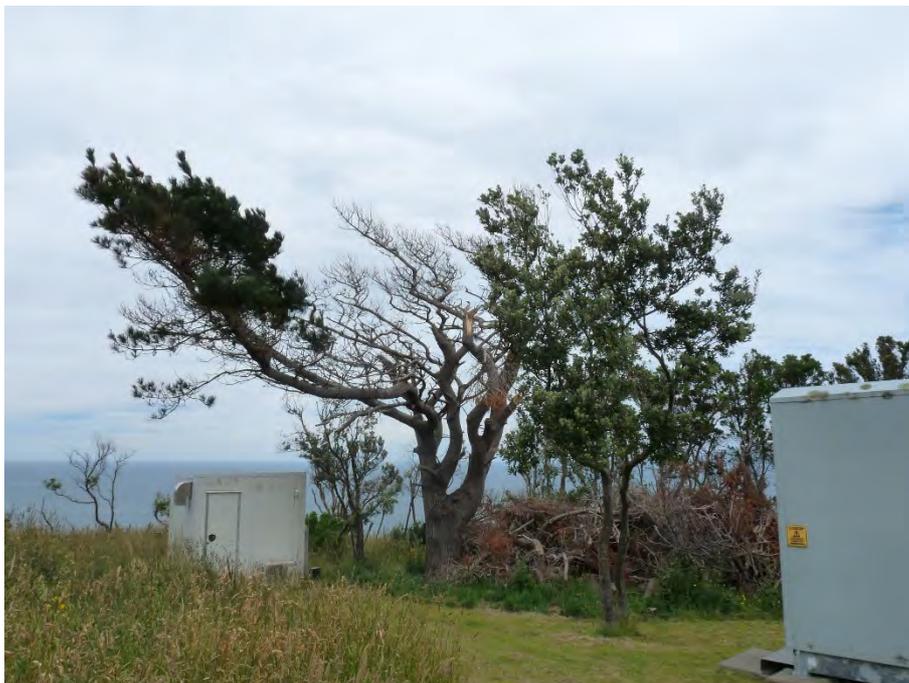
Shelterbelt has suffered storm damage in places requiring remedial arboricultural attention

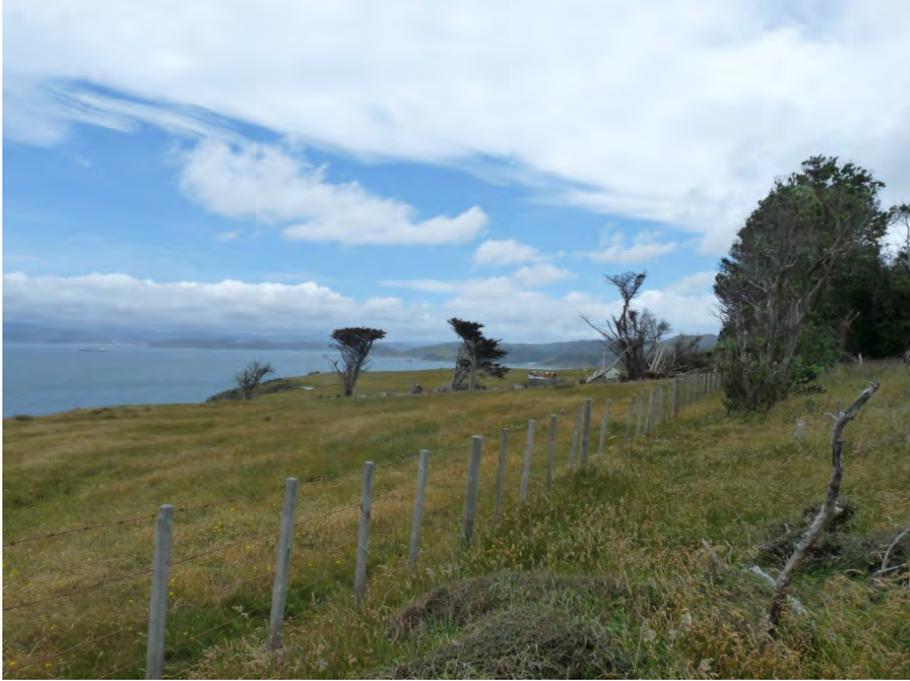
Only a few straggly trees that were part of the original shelterbelt between the north-western boundary and the escarpment remain

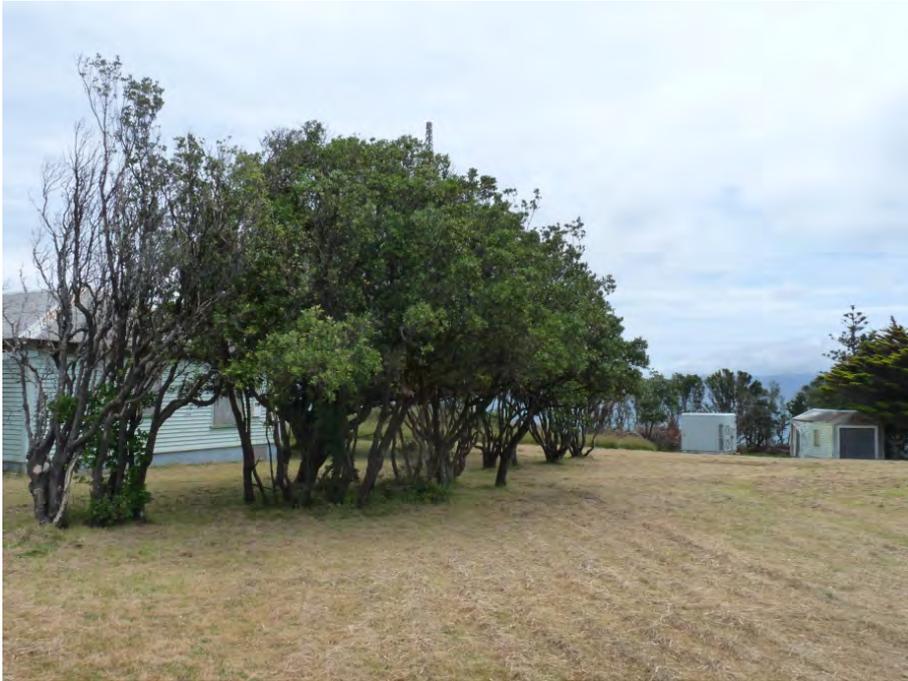
Some tree removal and arboricultural management required for plantings within the compound

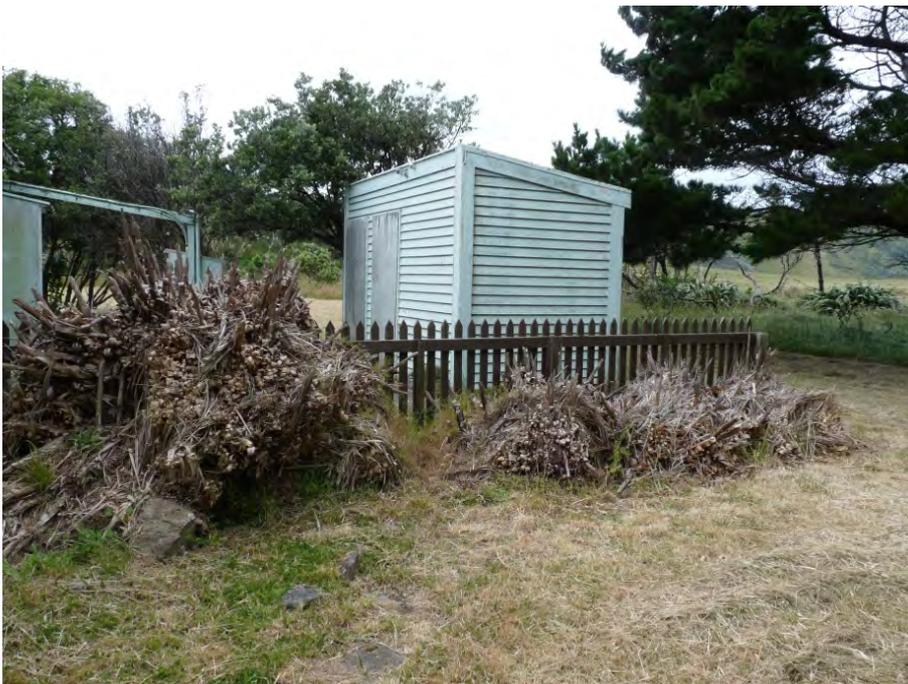
Remnants of the original picket fencing remain in a few places
