Lyall Bay Five Year Dune Restoration Plan

Prepared for Wellington City Council and Greater Wellington

June 30th 2009

Report Number: CCERL/R27-28/02/2009

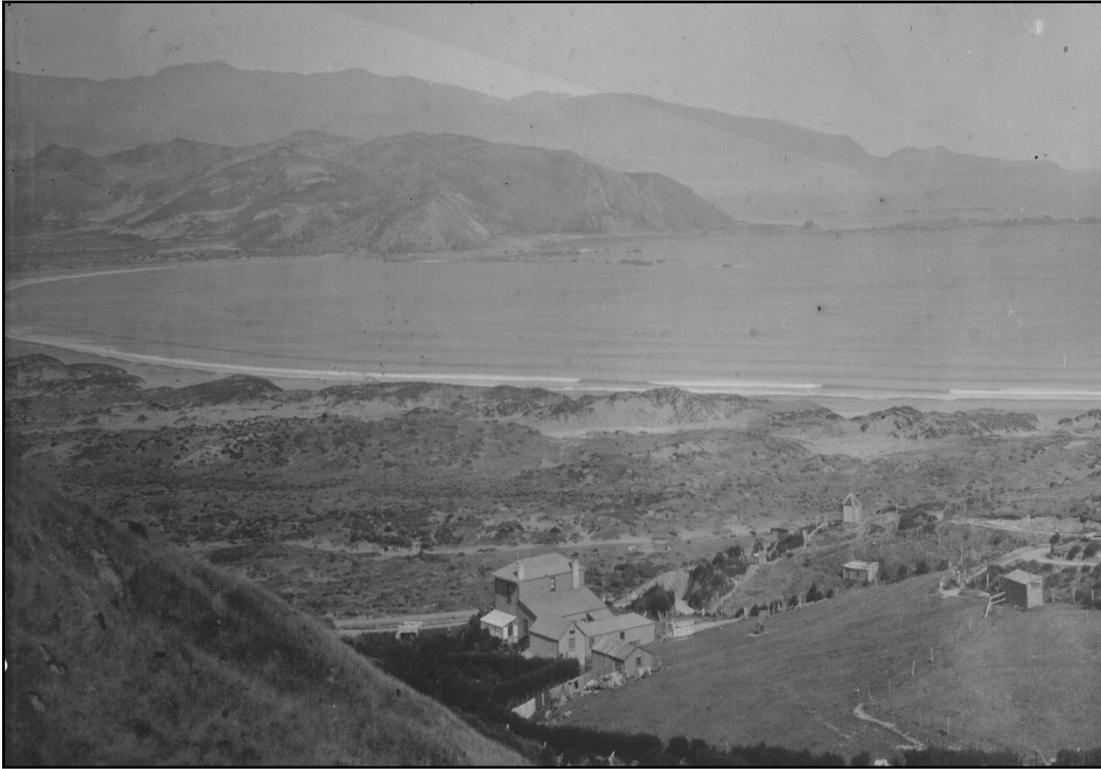
*Figure 2: Lyall Bay circa 1895 showing a significant dynamic dune field comprising mostly well vegetated dunes likely to be a mixture of lighter coloured spinifex (*Spinifex sericeus*) and darker coloured pingao (*Desmoschoenus spiralis*). Some development in the foreground is a foretaste of the significant modification to come that will see all the dune system under housing (WCC archives photograph Ref. No. 00138:0:11593).*

Almost all the relatively flat land behind the beach consisted of a wide undeveloped dune field before 1900 (Figures 2 and 3).

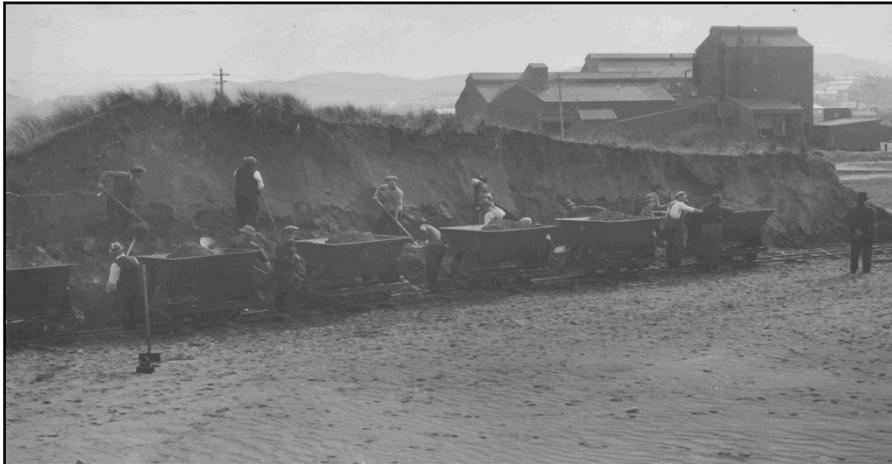
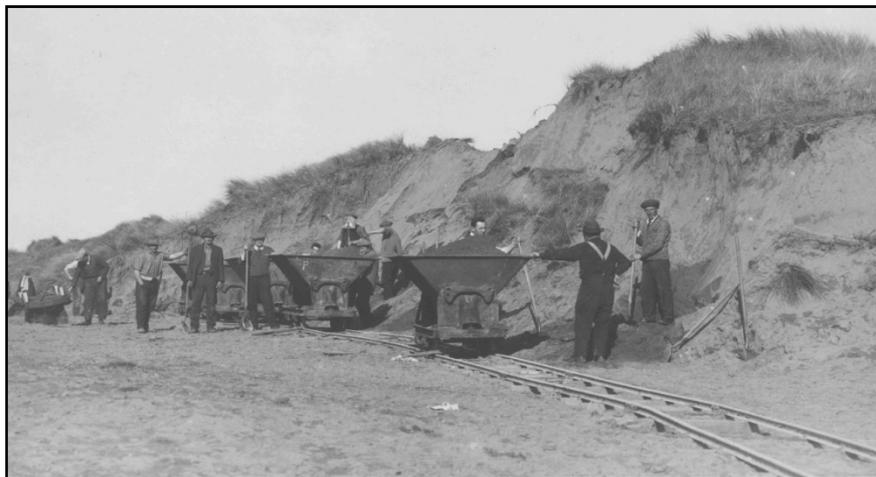
Figure 4a and 4b: Large volumes of sand are being removed directly from Lyall Bay fore-dunes during the 1930s using tramways. Note the dense cover of sand-binding grasses on the dunes that are highly likely to be a mixture of spinifex and pingao (WCC archive photographs).

During the development of the Maranui and Rongotai area most of the extensive dune field was buried under the houses, roads and other infrastructure. It appears that significant volumes of sand were specifically removed from the dune areas closest to the beach (Figures 4a and 4b)

Once the sand dunes (a critical part of any naturally functioning beach system) had been removed, the foreshore development including Lyall Parade and the seawall were constructed. The overall impact of this process was to separate the beach from its natural source of sand and to place an artificial barrier within the active foredune zone.

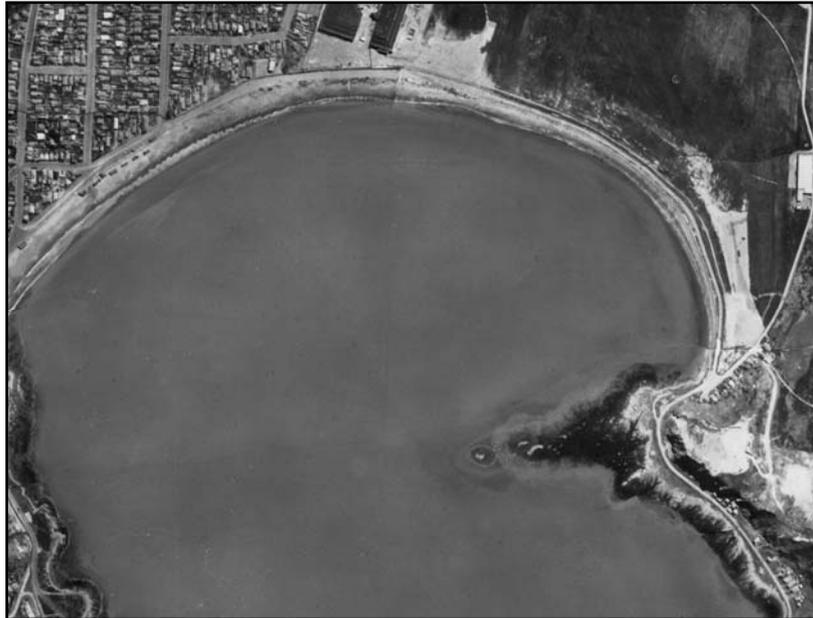
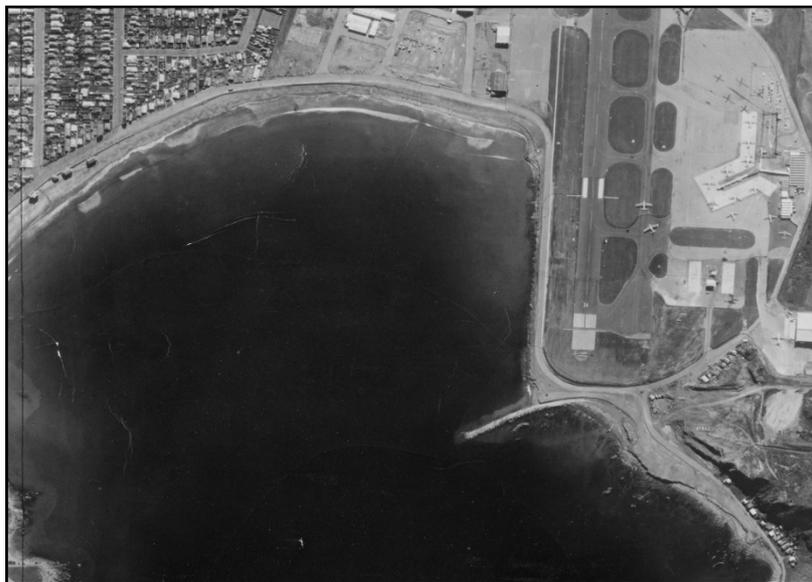
Figure 5a and 5b: Aerial photographs taken in 1945 (top) and in 1962 (below) indicating the significant reclamation undertaken to accommodate the Wellington airport along the eastern end of Lyall Bay (Photograph WCC).

During the construction of the airport approximately 850m of the eastern end of the beach was buried. The associated riprap protection works is likely to have substantially altered the wave climate for the bay. Figures 5a and 5b illustrate the impact of the airport construction and associated shoreline works on the outline of the natural coastline at Lyall Bay.

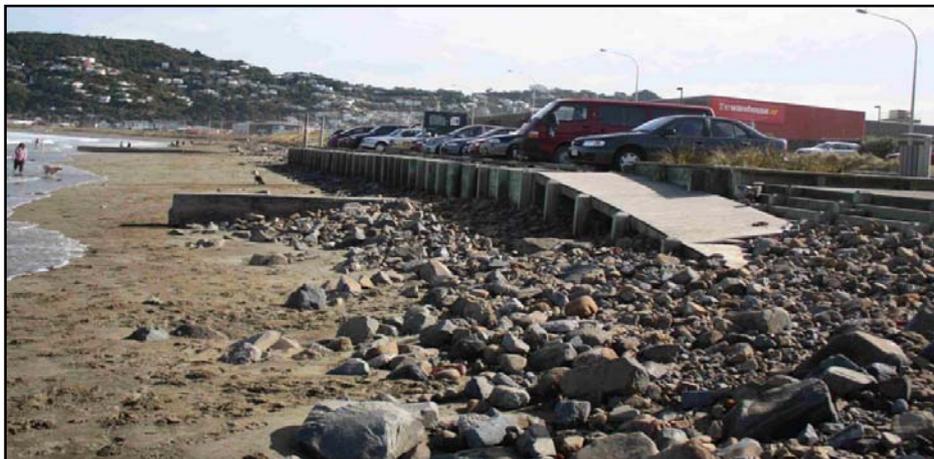
- Approximately 120 metres in length of coastline located at the airport end of the beach.
- Carpark has been progressively reclaimed since 1975 and is now located on the active beach zone comprising a wooden/concrete wall, rocks placed on the beach and a stormwater drainage outflow pipe.
- There is no dune vegetation within this area.
- High water mark is at the base of the carpark seawall.

Figure 7: Reclaimed car park located at the eastern (airport) end of Lyall Bay within the active beach zone and consequently there is no build up of sand and foredune vegetation.

- This is a popular parking area with uninterrupted views of the bay.
- Because the car park extends to, or even beyond, the high water mark, storm waves break over the wall.
- There is no scope to establish a sand binding foredune without removing the reclaimed seaward extension of the car park.
- Maintain amenity plantings around car park with native coastal species.
- Low priority for restoration over the next five years unless there is a desire to relocate the car park.

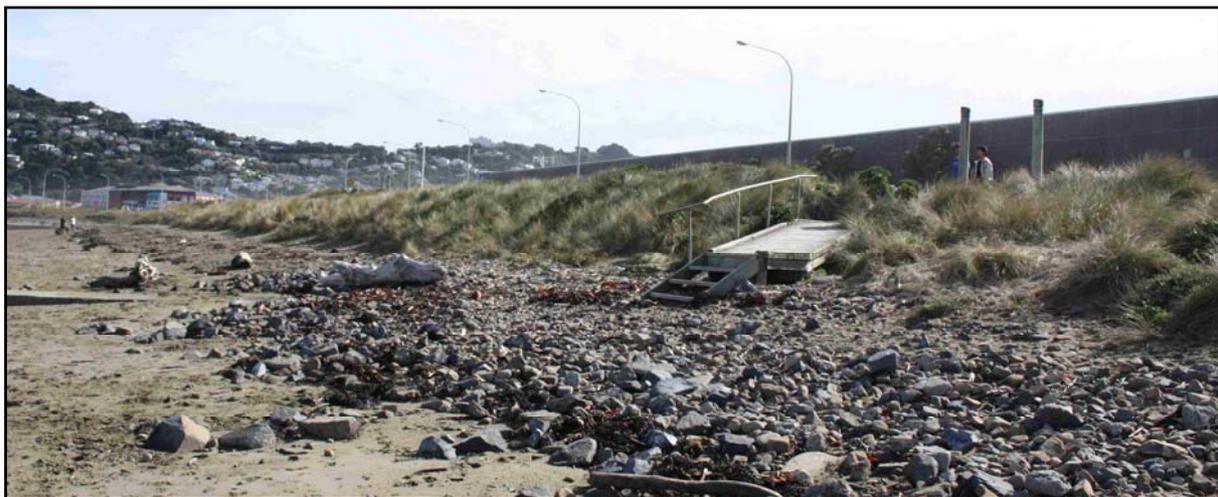
- Area extends approximately 200m from eastern car park to the roundabout at the end of Tirangi Road.
- Comprises a zone 7-8 m wide of vegetated foredune dominated by marram grass with scattered pingao and occasional patches of ice-plant. Pingao concentrated along toe of dune.
- Bollards are placed along the roadway landward of a small dune dominated by marram grass that has built up along the side of path.
- Loose rock is scattered between the car park and a stormwater outlet to the west.
- Access-ways, including a solid wood access-way, leading directly to the beach are allowing sand from the beach to be blown onto the footpath and road.

Figure 8: AREA B showing loose rock on beach and timber access way.

- Remove loose rock scattered on beach in the vicinity of the wooden access way and stormwater outfall near the car park.

- All access-ways to be angled to prevailing onshore winds or doglegged to reduce windblown sand onto the road.

- Signposts for access to beach are only indicated along the road end of each access-way. Some access-ways are not as obvious from the beach as others. Posts could be placed at seaward ends of each access-way to indicate formal access to and from beach and to reduce use of informal access-ways.
- Further formal access-ways are required where desire lines are consistently used by beach users.
- Avoid use of solid structures for access-ways, particularly at the toe of the foredune.
- Use fencing to guide pedestrians along access-ways and ensure fencing ends at the toe of the dune.

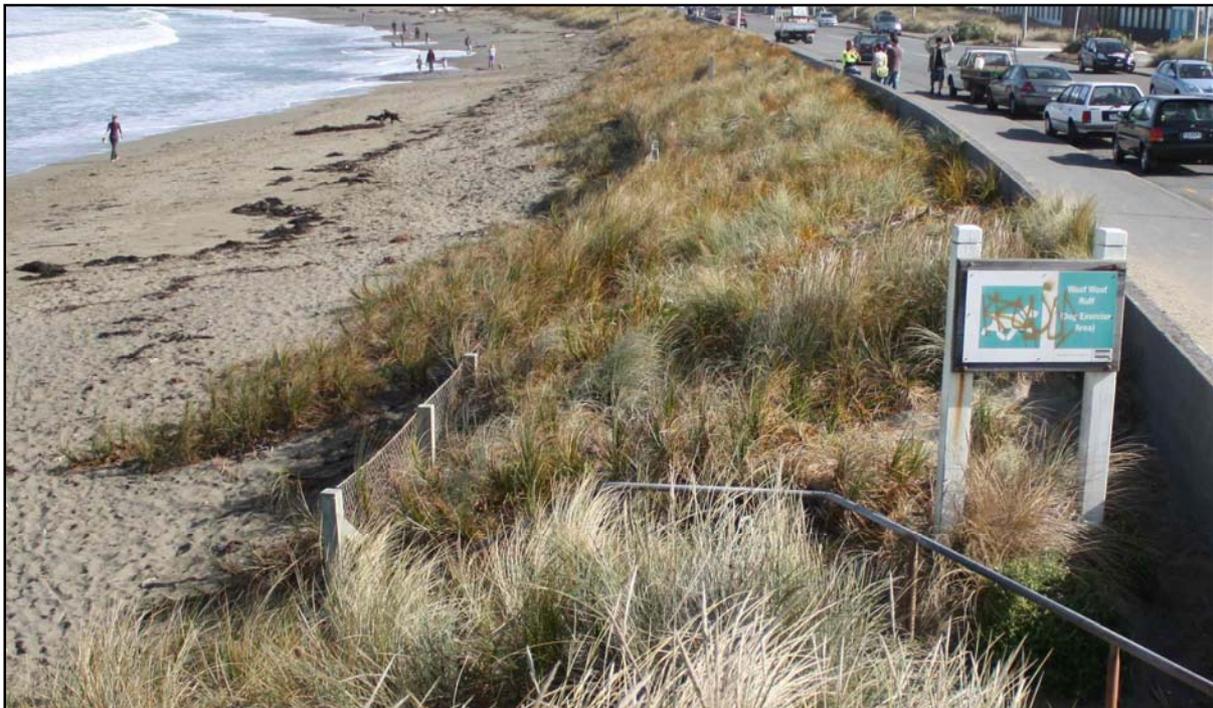
- Partially buried chain-link wire netting fence is set back up to three metres from toe of vegetated dune along eastern portion of this area. This suggests there has been expansion of dune vegetation seaward and sand accretion within the dune since the fence was established. The fence was probably constructed to protect earlier plantings of pingao. The fence is now not providing any current benefit to pingao other than reducing use of informal access-ways.

- The western portion of this area does not have any fencing and yet pingao is as dense and vigorous as in the fenced area.
- *There are a greater number of informal access-ways along non-fenced portion.*

Figure 9: AREA C showing chain-link wire fencing and foredune vegetation dominated by pingao particularly along the toe of the dune. Note the pingao extending seaward of the fence indicating significant growth since the fence was erected probably to protect newly planted sand binders.

- Substantial and elaborate fence constructions such as cyclone netting are difficult to remove from built-up dunes and their use should be avoided.
- While fencing is recommended to protect new plantings from trampling by beach users, fences can be constructed of lighter materials (e.g. posts with one or two ropes or plastic cords). Avoid wire and steel waratahs as these rust and can become a potential health and safety issue.

- Provide more formal signposted access-ways between the footpath and the beach using the desire lines already established.
- Angle access-ways to prevailing onshore winds and provide basic fencing to guide pedestrians.

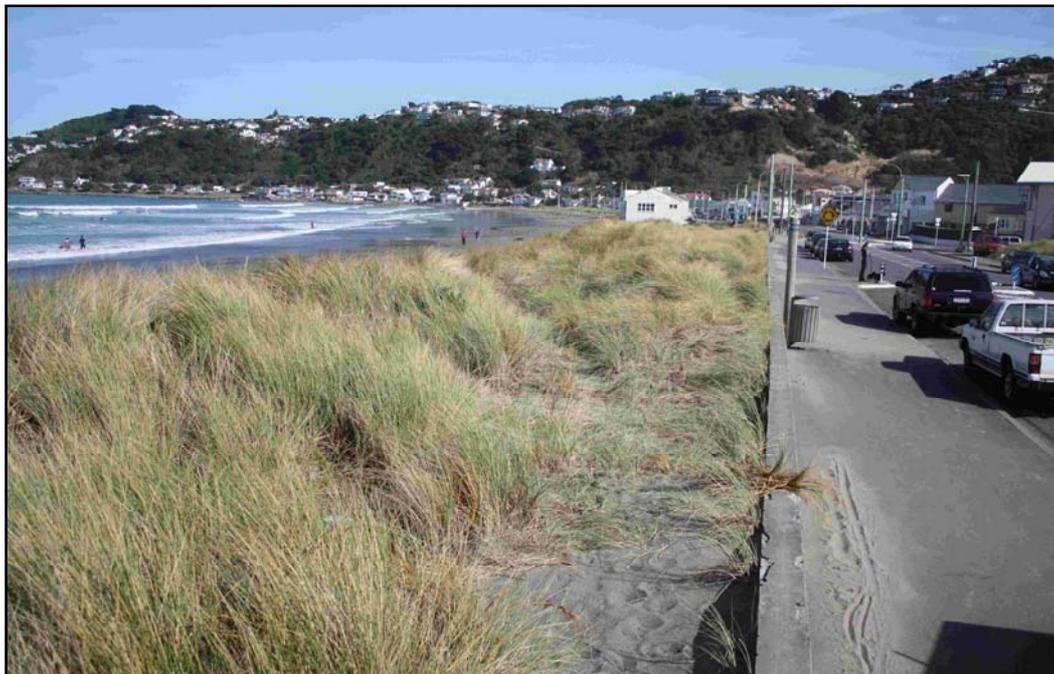
- Dune width varies from relatively narrow five to six metres vegetated dune along parts of the eastern portion to up to ten metres wide along parts of the western portion.

Figure 10: Area D showing seawall, windblown sand on the footpath and the marram grass dominated foredune.

- A major access-way via wide concrete steps in particular has created a major gap in the foredune vegetation with consequent loss of sand onto the road and onto inland properties. It is recommended that sand is pushed into the gap immediately seaward of steps using a machine to create a low-angle foredune. Reinststate an access-way at an angle over the new dune with guide fencing. Blanket plant with spinifex and pingao and protect with temporary lightly-constructed fencing.

- Progressively reduce dominance of marram grass in favour of naturally spreading pingao and planting pingao and spinifex as for Areas B and C.
- Significant dieback of dense populations of pingao within this section (Figure 12) is common. This dieback has been observed in other regions; the reasons for its occurrence are not entirely known although often it is associated with trampling by beach users. At Lyall Bay foot traffic is likely to contribute to the problem.
- Providing regular access-ways and planting a mixture of sand binders (pingao, spinifex) on foredune faces and other species further landward (e.g., sand tussock (*Austrofestuca littoralis*), *Carex testacea*, wiwi) is therefore recommended to provide a diverse community of complementary species and reduce the impact of dieback of any one species.

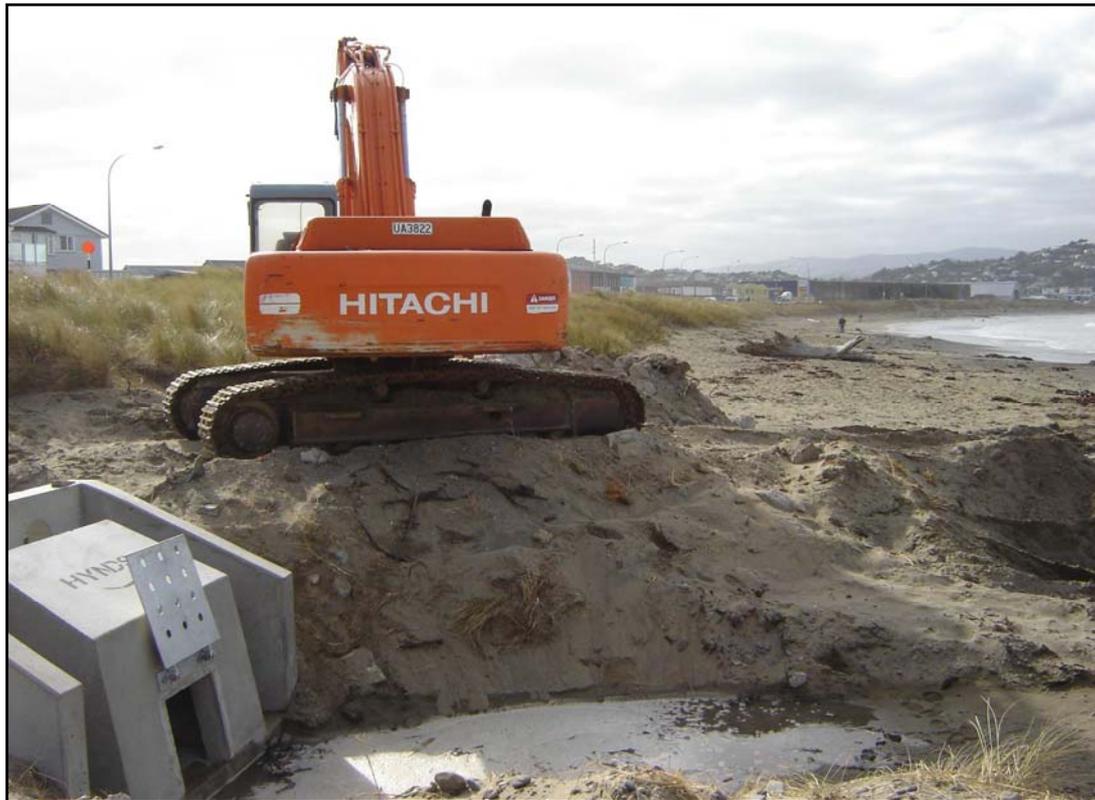
- Most access-ways are acting as wind funnels resulting in loss of sand from the beach to the road.
- A recently upgraded stormwater outlet (including large concrete box with trap doors) has been installed within the existing foredune some six metres landward of the current vegetated toe of the foredune. This is highly likely to maintain a low beach level at this point and lead to a permanent indent in the foredune and its' vegetation cover. Management of vegetation and sand movement will be an ongoing problem (Figure 11).

Figure 11: Stormwater pipe upgrade construction underway in April 2009. Note the stormwater outlet is several metres landward of the vegetated toe of the foredune visible in the background.

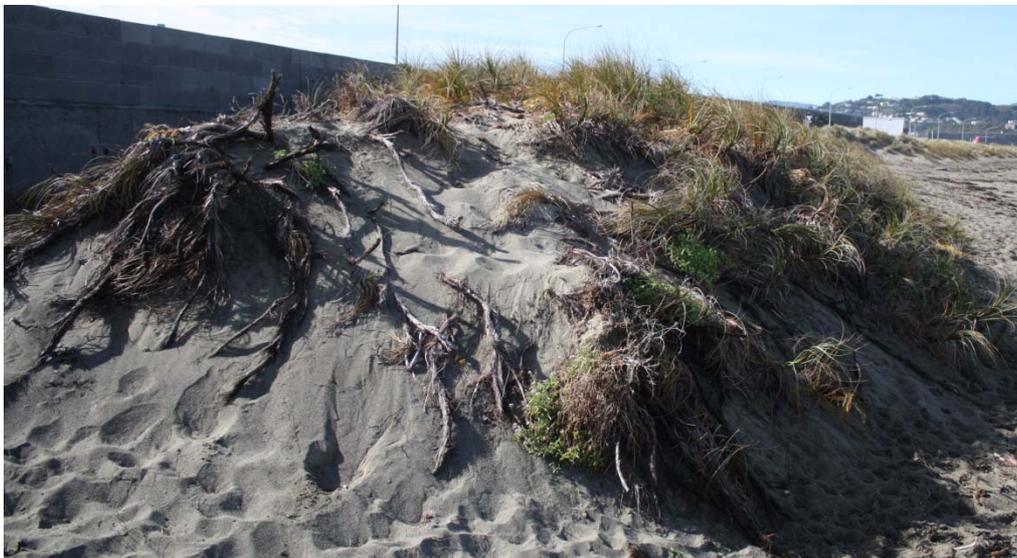
Figure 12: Dieback of pingao is probably caused by trampling by beach users. Encouraging beach users to avoid walking over dune vegetation and planting a diverse mixture of species reduces overall impact on the dune system of dieback of any one species.

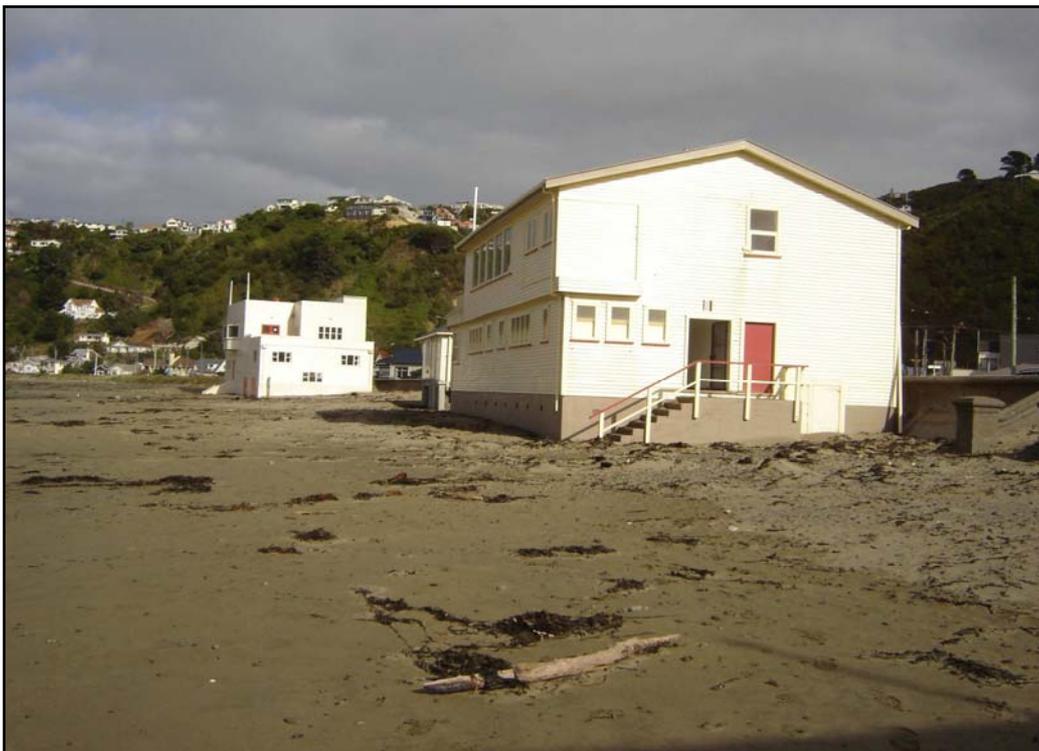
- The location of buildings seaward of the seawall is clearly within the active beach and foredune zone.
- When measured during the field work component of this project, the high water mark was within four to five metres of the seawall. There is no vegetated foredune throughout this area and drifts of windblown sand is evident on the footpath; sand is found along gutters on both sides of the road.

Figure 13: AREA 5 showing buildings located seaward of the seawall that are clearly within the active foredune zone. The relatively flat beach is highly vulnerable to storm waves reaching the buildings and seawall.

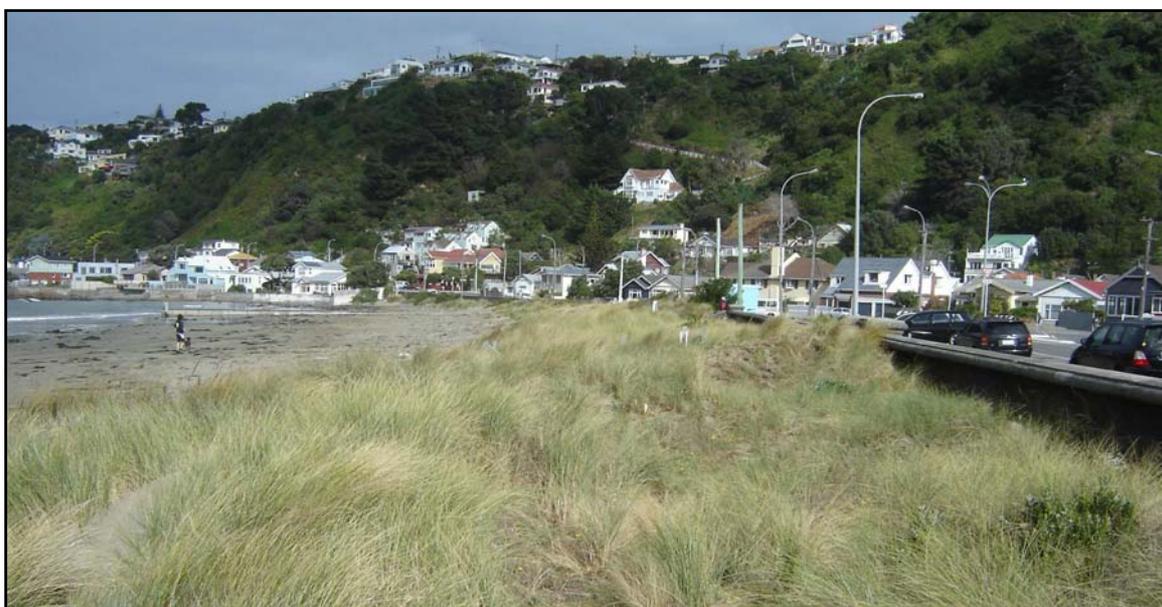
- 320 metres from the western side of AREA E to the beachfront properties.
- Comprises a marram grass-dominated foredune from near the western-most building to the vehicle access.
- South of the vehicle access there is a low flat grassed area that could be the result of fill dumping. This is fringed by small areas of marram grass on the seaward side.
- Due to the seaward alignment of the road, the beach southwest of the stormwater drain lacks a foredune or vegetation cover of any significance.

Figure 14: AREA F – Marram grass dominated relatively flat dune area west of the buildings in the foreground. There is virtually no foredune and limited vegetation in the background at the south western end of the bay.

- A mown grass area used for recreation located at the vehicle access could be retained between the seawall and the foredune.
- The foredune zone should be planted with native sand binders and fenced to reduce damage from beach users and loss of windblown sand onto the grassed area. Erect signs to inform beach users of the importance of keeping off plantings.
- An alternative to retaining the mown grass area would be to remove grass and any fill from the site and reinstate the backdune with the usual suite of native backdune plants.

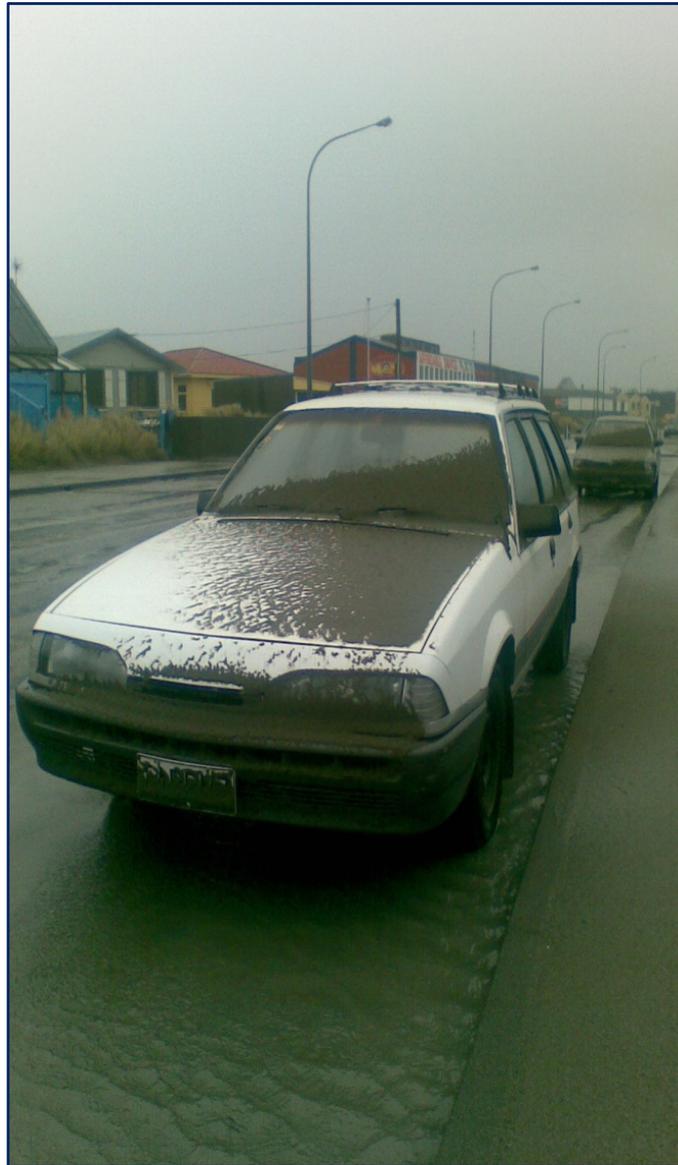
- There are significant quantities of sand blown from the beach and dune system onto the road, footpaths and seaside properties along the entire length of Lyllall Bay. This is particularly evident where there is no vegetated foredunes (see Appendix 1).

Wind blown sand is permanently lost from the beach and is a significant management issue for local residents. (photograph Lyall Bay Coast Care)

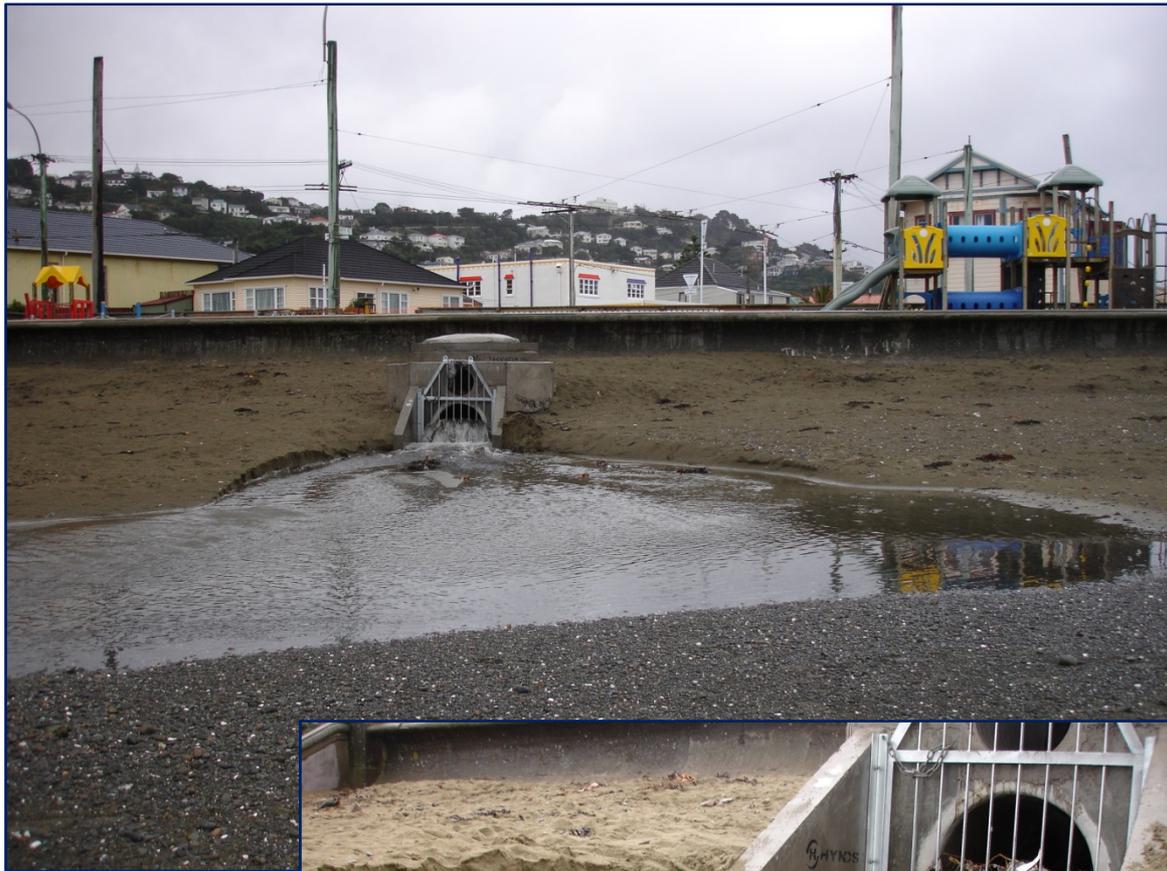
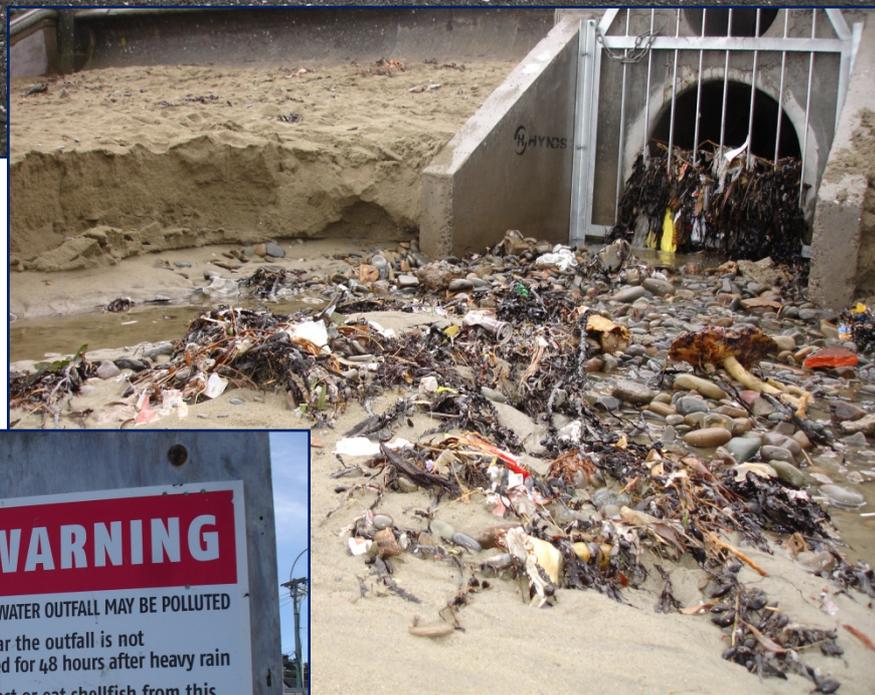
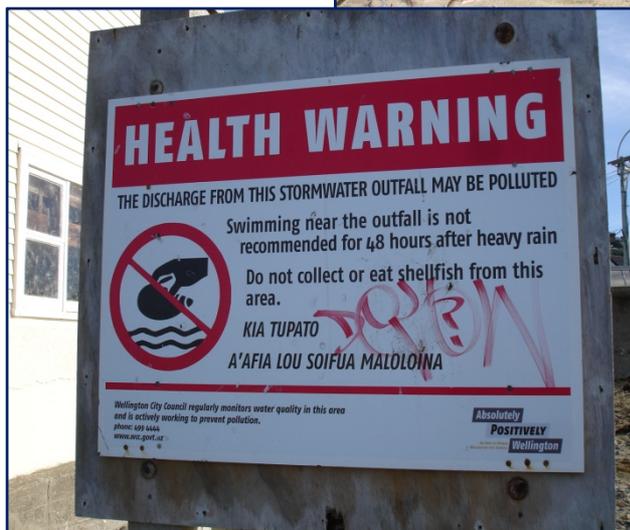
- Scouring of the beach and foredune is occurring where several stormwater drains exit onto the beach.
- Rubbish is reaching the beach from the stormwater system that is draining surrounding streets.

Stormwater outlets and disposal of rubbish onto the beach at Lyall Bay including erosion of the foredune (photograph Lyall Bay Coast Care).

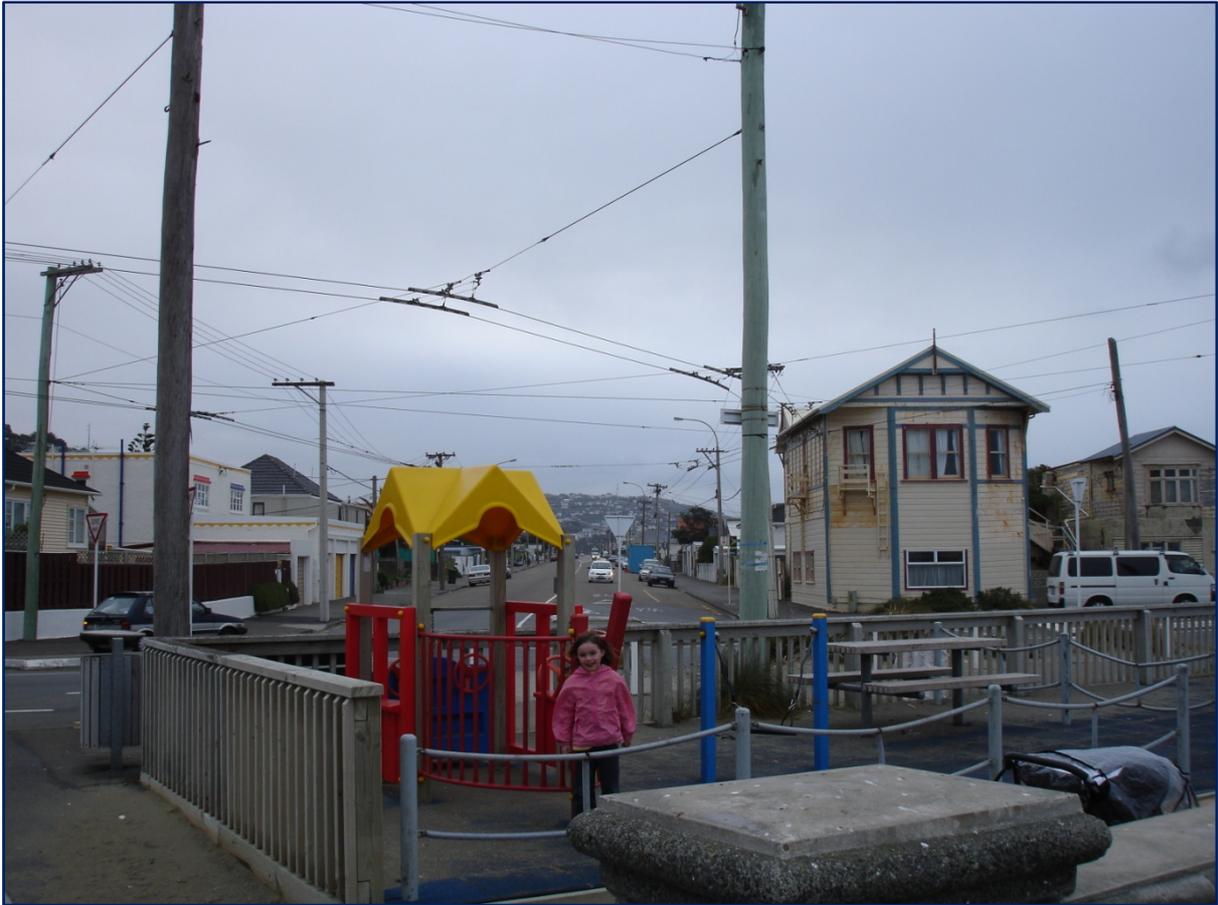
- The seawall extends significantly seaward to accommodate the playground and a path up to nine metres wide westward to the buildings clearly occupies the active foredune. This zone further eastward comprises the narrow vegetated sand binding zone.

The playground is located on the active foredune zone where the seawall has been extended seaward making it difficult to establish a vegetated foredune (photograph Lyall Bay Coast Care).
