The state of our environment

Annual summary 2009/10

greater WELLINGTON
REGIONAL COUNCIL

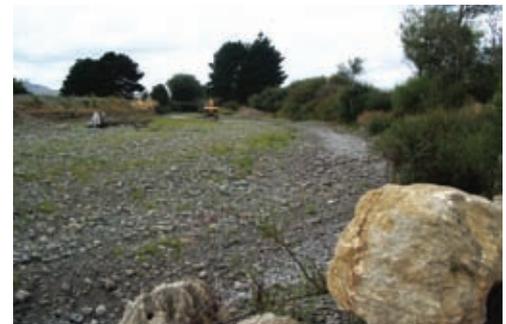
The Mangatarere Stream at Anderson's Line in late summer. The stream in this reach loses flow to groundwater during parts of the year and is often dry in summer. Downstream of this point the stream receives flow from groundwater, highlighting that streams and groundwater need to be managed together when assessing the effects of water takes.

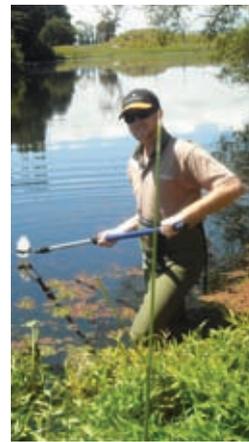
Collecting a water sample from one of the waterways entering Lake Wairarapa. This is one of 15 waterways and four groundwater bores that we sampled in December 2009 to get an idea of the water quality of streams, drains and shallow groundwater entering Lake Wairarapa. The results indicated that elevated levels of nutrients are entering the lake from drainage and stream networks located on its northern and eastern margins where intensive farming occurs.

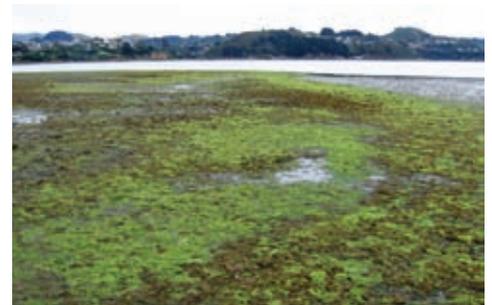
Prolific growths of macroalgae – mainly sea lettuce (*Ulva*) and *Enteromorpha* – at the southern end of the Onepoto Arm of Porirua Harbour in January 2010. Thick growths like this reduce oxygen reaching the underlying sediment and the rotting leaves can produce large quantities of hydrogen sulphide, a foul-smelling and noxious gas.

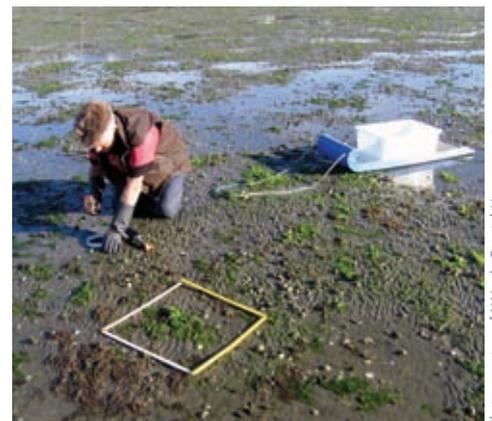
Collecting a sediment core from one of the monitoring sites in Porirua Harbour. At each site, sediment samples are collected for laboratory testing and the algae and animals living in and on the sediment are identified and counted.

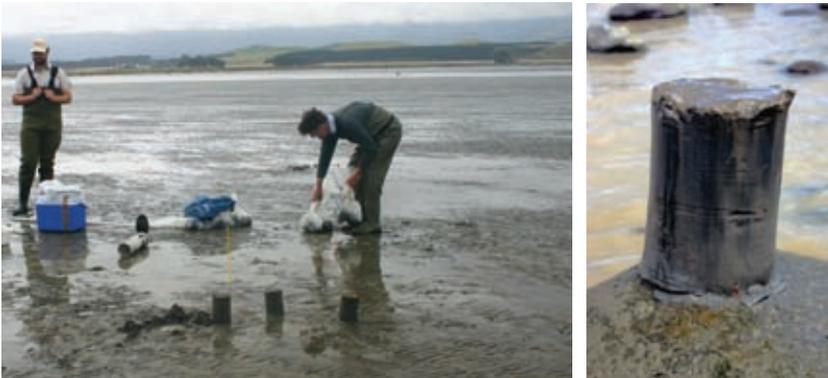
Collecting sediment samples from the intertidal sampling site (left) and one of the sediment cores collected from a subtidal location in Lake Onoke (right). The sediments were black near the surface, indicating oxygen levels are low. Low oxygen conditions are not ideal for most sediment dwelling animals.

Chemical analyses revealed low levels of organic carbon and metals in the sediments at the intertidal site, but nitrogen and phosphorus levels were slightly and moderately elevated respectively, and DDT was detected at low levels in two samples. Slightly higher levels of nutrients and some metals were found in sediments at the subtidal site as compared with the intertidal site, but still well below national sediment quality guidelines.

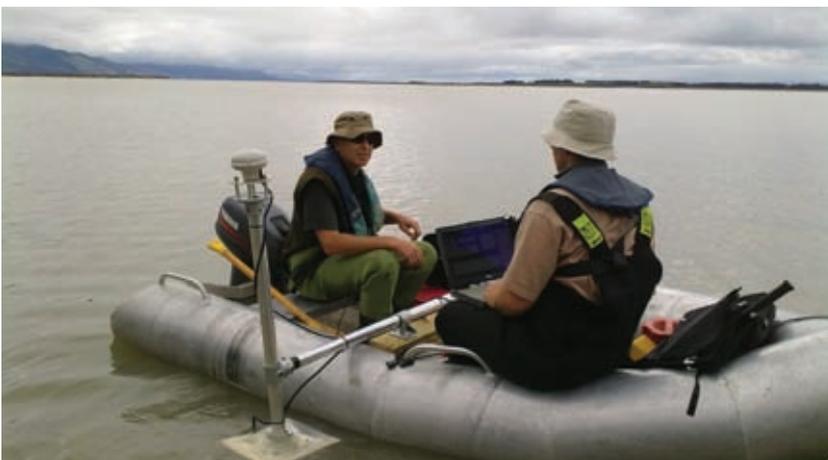
Staff using an echosounder (sonar) during a bathymetric survey in Lake Wairarapa in February. Lake Onoke was also surveyed. A bathymetric survey enables us to measure and map the amount of sediment that has built up over time on the lake bed.

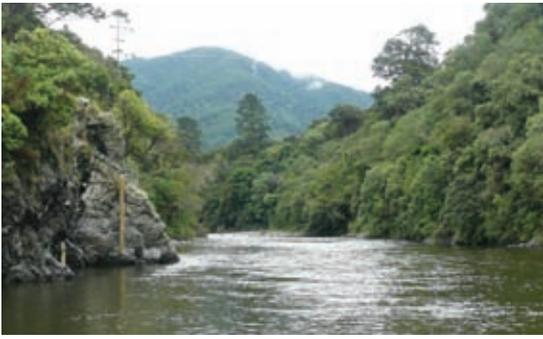
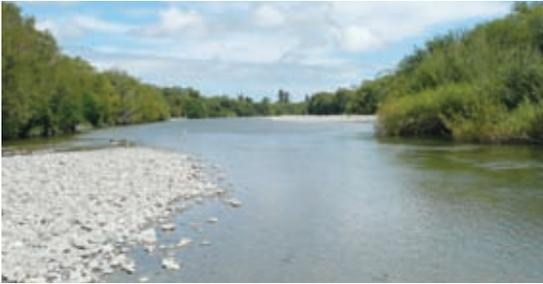
The Tauherenikau River; deep and swift at the Greater Wellington monitoring site in the Tararua Range foothills (top) and shallow and more placid near the river mouth (bottom). Like many other rivers in the Wairarapa and on the Kapiti Coast, the Tauherenikau River naturally loses flow through the river bed to groundwater once it emerges from the ranges and crosses the alluvial gravel plain. This loss can exacerbate low flows in the summer and must be accounted for when setting appropriate minimum flows.

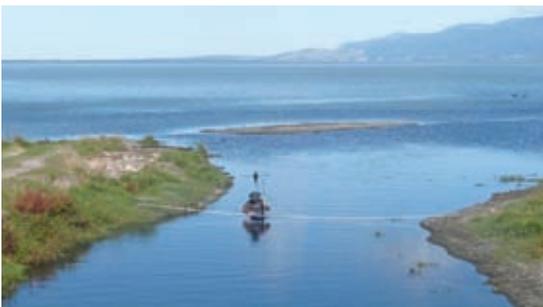
A Greater Wellington staff member measuring the flow in one of the tributary streams on the northern shore of Lake Wairarapa in April 2010. Understanding the cumulative input of flow from tributaries during summer dry spells will help inform lake management policies, especially the setting of sustainable abstraction limits.

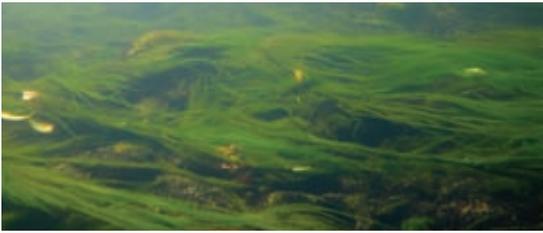
Sites that exceed periphyton guidelines, such as the Kopuaranga River near Masterton pictured here, typically have elevated levels of dissolved nutrients which fuel periphyton growth. Other factors such as limited shading and long periods of stable stream flow can also promote periphyton growth.

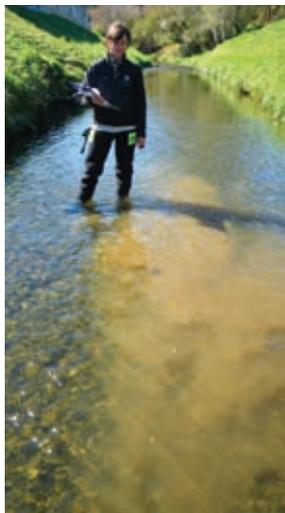
Measuring sedimentation in the Porirua Stream by disturbing the streambed and assessing the resulting change in water clarity.

Excessive sediment is known to have many impacts on aquatic ecosystems, including smothering the fauna and flora and degrading the overall stream habitat. Many of the region's waterways receive heavy sediment loads from stormwater discharges, large scale earthworks and/or intensive agriculture. Sediment that ends up in rivers and streams ultimately makes its way downstream into sensitive water

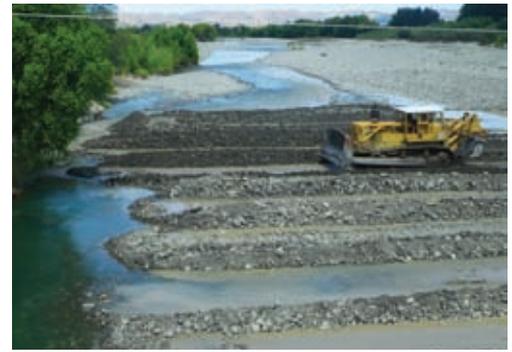
A bulldozer realigning a section of the Waingawa River channel to reduce erosion that is occurring along the left bank.

During 2009, we investigated the effects of extensive channel realignment on the aquatic ecosystem in a reach of the Waingawa River near Masterton. Channel realignment was shown to immediately reduce the number and quality of deep water habitats (e.g. pools) within this river reach. Re-establishment of pools did begin to occur but took several months. Some aquatic fauna, such as large longfin eels, prefer to live in deep pools and may have suffered from the loss of these types of habitats. Further work is required to see how the localised loss of habitat may impact on the wider river ecosystem and to investigate ways to lessen the potential impact from flood protection activities.

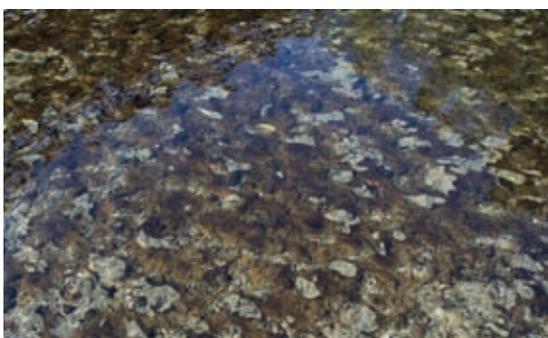
Blue-green algal mats on the bed of the Waipoua River at Paerau Road, 4 km northwest of Masterton. These types of mats can produce toxins that may harm people and animals, especially dogs.

Although swimming spots in rivers were mostly safe from pathogens, the Waipoua River in Masterton was affected by widespread growth of toxic blue-green algae (cyanobacteria) from mid January onwards. Health warning signs were put up along the river, but unfortunately a dog died after coming into contact with the toxic algal mats. For more information on toxic blue-green algae go to www.gw.govt.nz/toxic-algae.

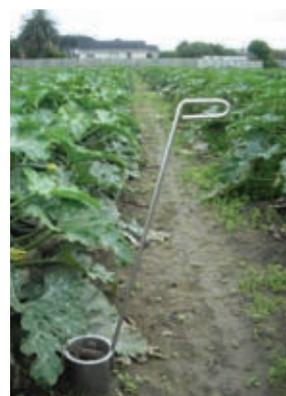
This market garden in Otaki is one of our soil quality monitoring sites. The soil at this site (as with many of the market garden sites) had poor structure, low soil carbon, and a high level of plant available phosphorus.

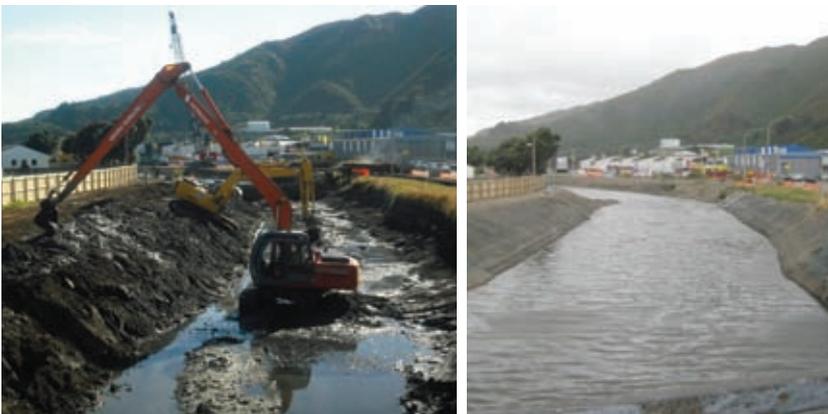
Diggers removing contaminated sediment from a section of the Waiwhetu Stream upstream of the Hutt Park bridge (left) and the same section of stream flowing naturally again and ready to be planted with native vegetation (right).

The project used an innovative technique involving damming 200 metre sections of the stream with sheet-piling, dewatering the resulting "cell" and excavating the contaminated material. Upstream and downstream dams were required in the lower reaches where the stream is tidal.

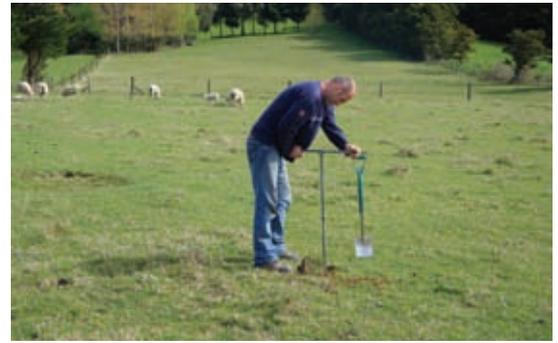
One of seven drystock sites in the Mangatarere catchment where soil samples were collected. Each site was surveyed first by excavating small soil cores with an auger to determine the soil type.

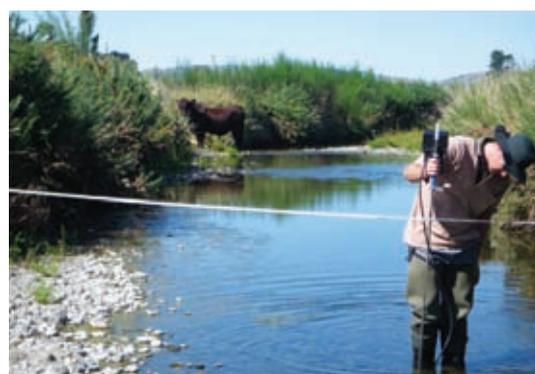
Measuring flow in the Kaipaitangata Stream, a tributary of the Mangatarere stream. Note the cattle beast in the background with access to the stream.

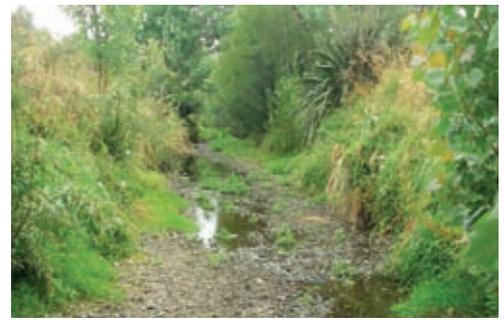
The lower reaches of the Enaki Stream reduced to a few pools in February 2009
