# Recreational water quality in the Wellington region

State and trends

GW/EMI-T-12/142  
ISBN: 978-1-927217-10-8 (print)  
ISBN: 978-1-927217-11-5 (online)

May 2012

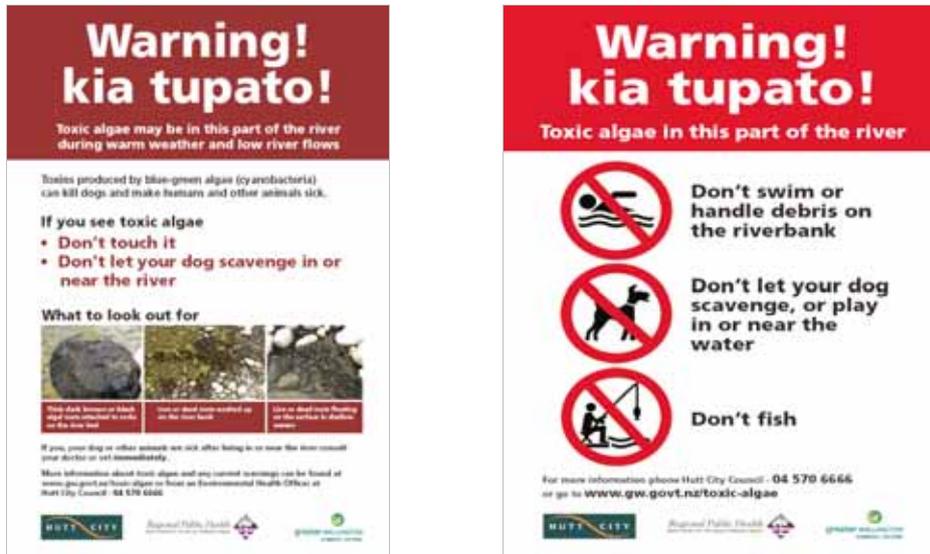
Figure 3.2: Alert (left) and action (right) level warning signs used to inform the public of the health risk from cyanobacterial mats in rivers in the Wellington region

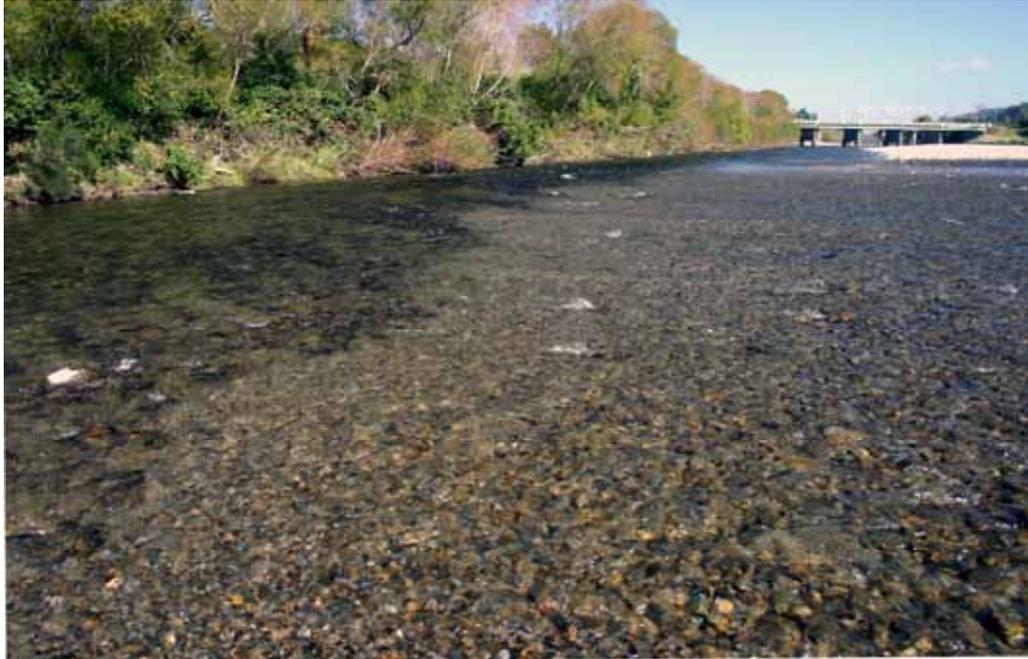
Figure 3.10: Cyanobacterial mats along the left bank of the Hutt River at Silverstream in autumn 2009

At least five dogs died after coming into contact with cyanobacteria mats in the Hutt River in November and December 2005. During this period and for much of the 2005/06 summer bathing season there was thick cyanobacteria growth in Hutt River in the Boulcott/Avalon area. This extensive cyanobacteria growth coincided with an unusually low number of 'flushing flows' and sustained low flow conditions during spring 2005 (Milne & Watts 2007).

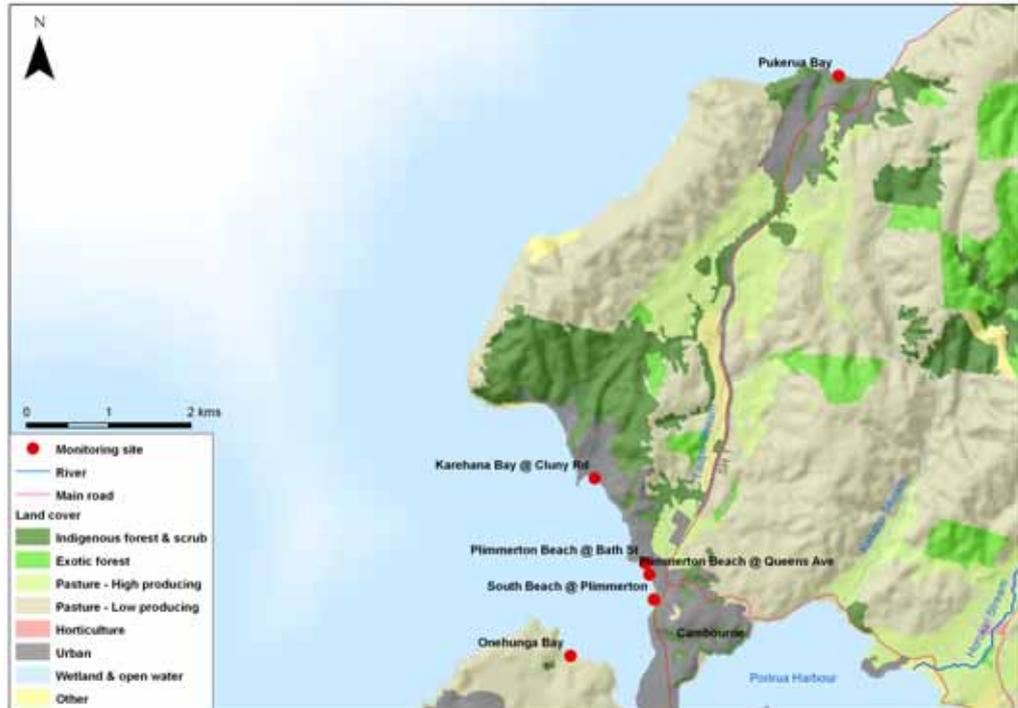
Figure 4.11: Location and surrounding land cover of recreational water quality monitoring sites at Pukerua Bay and outer Porirua Harbour

During bathing seasons between 2005/06 and 2009/10 recreational water quality monitoring was undertaken at two sites along Plimmerton Beach and at one site each at South Beach and Pukerua, Karehana, and Onehunga bays (Figure 4.11).

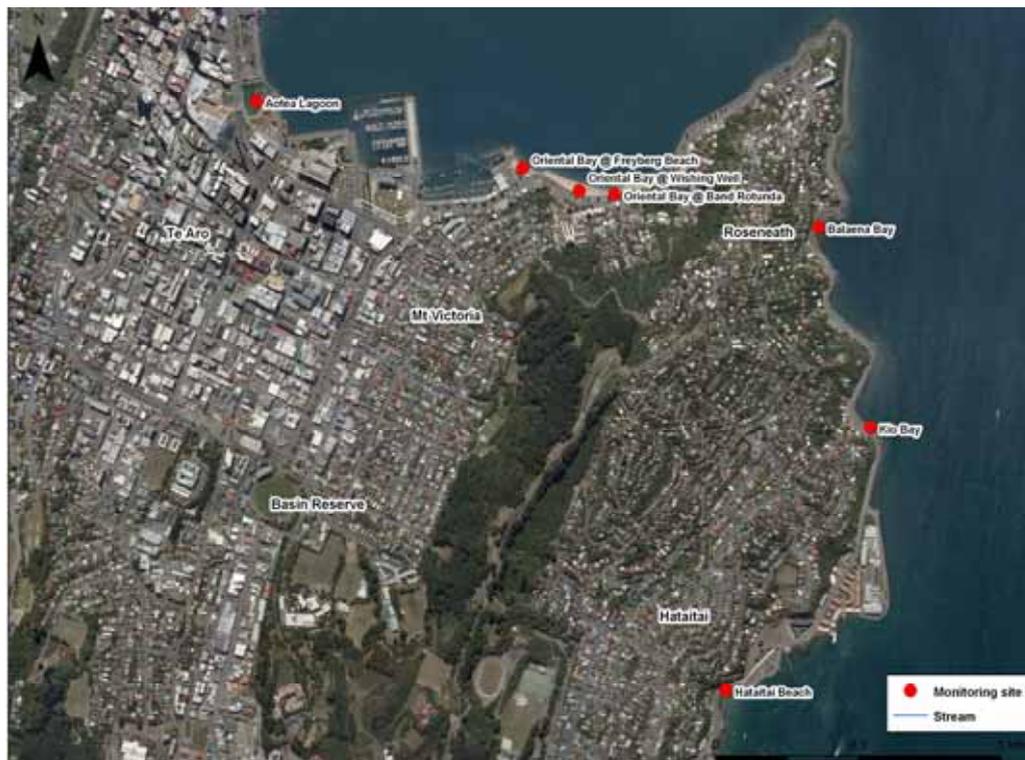
Figure 4.21: Location and surrounding land cover of recreational water quality monitoring sites in the inner Wellington Harbour

Recreational water quality was monitored at seven sites in the western part of Wellington Harbour over the 2005/06 to 2009/10 bathing seasons: three in Oriental Bay, one each in Balaena and Kio bays, one on Hataitai Beach and one in Aotea Lagoon (Figure 4.21).

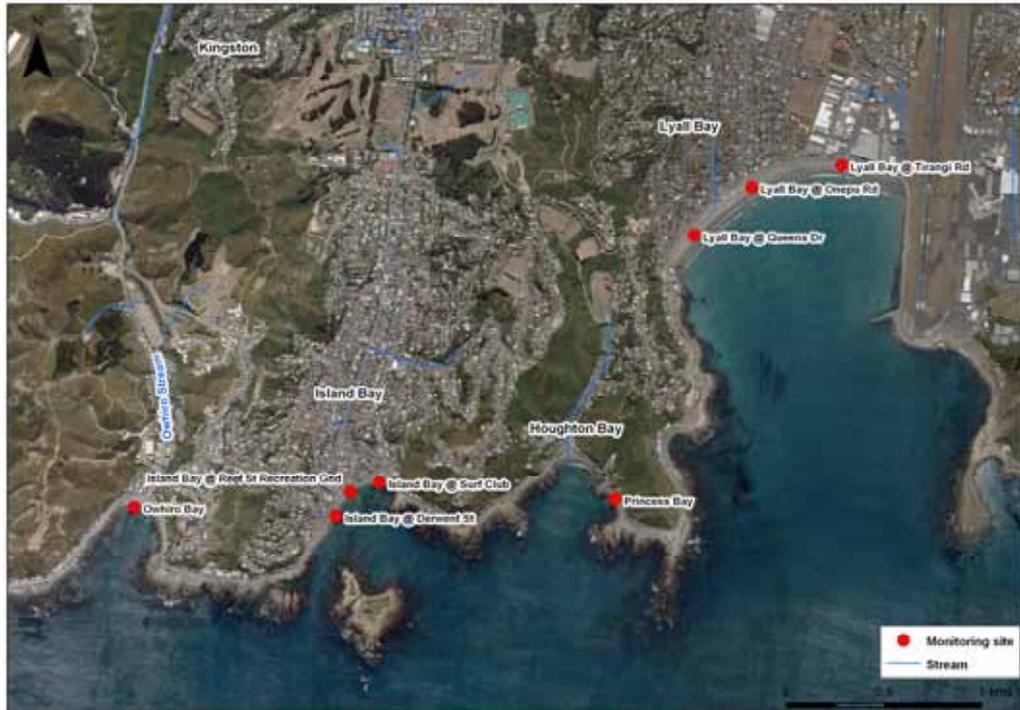
Figure 4.27: Location and surrounding land cover of recreational water quality monitoring sites on Wellington city's south coast

Recreational water quality is monitored at eight sites along the south coast: three each within Lyall Bay and Island Bay, and one each in Princess Bay and Owhiro Bay (Figure 4.27).

Land cover along Wellington city's south coast includes urban areas of the suburbs of Lyall Bay, Houghton Bay, Island Bay and Owhiro Bay as well as scrub land bordering Princess Bay and parts of Houghton Bay (Figure 4.27).

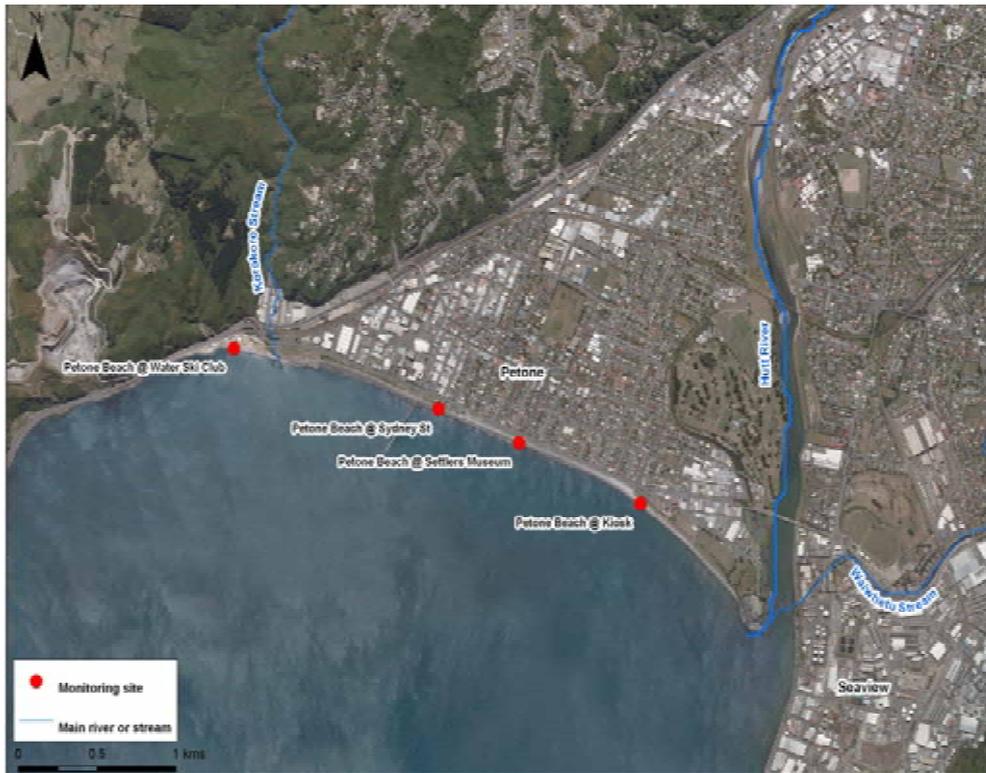
Figure 4.31: Location and surrounding land cover of recreational water quality monitoring sites along Petone Beach

Petone Beach is a long, sandy beach flanked to the west by Korokoro Stream and to the east by the mouth of the Hutt River. During 2005/06 and 2009/10, recreational water quality was monitored at four sites along Petone Beach (Figure 4.31).

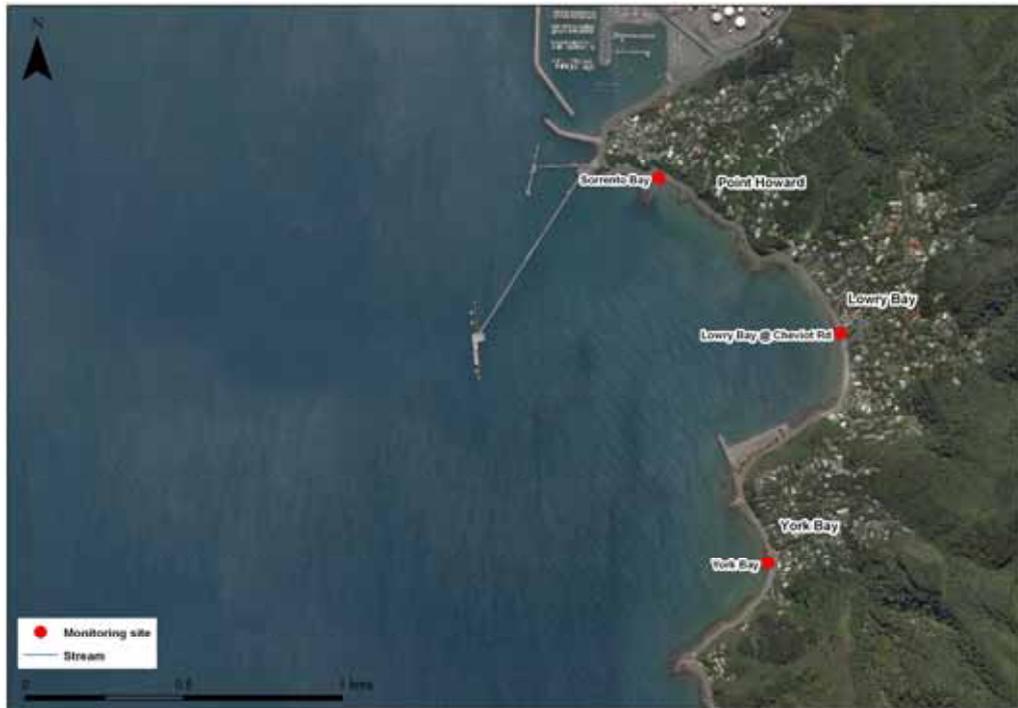
Figure 4.34: Location and surrounding land cover of recreational water quality monitoring sites at Sorrento, Lowry and York bays

Sorrento, Lowry and York bays comprise short, sandy or gravelly beaches separated by rocky outcrops. Each of these bays is fed by small but steep catchments. Recreational water quality is monitored at one site in each bay (Figure 4.34), with water quality at Sorrento Bay also monitored for shellfish gathering purposes.

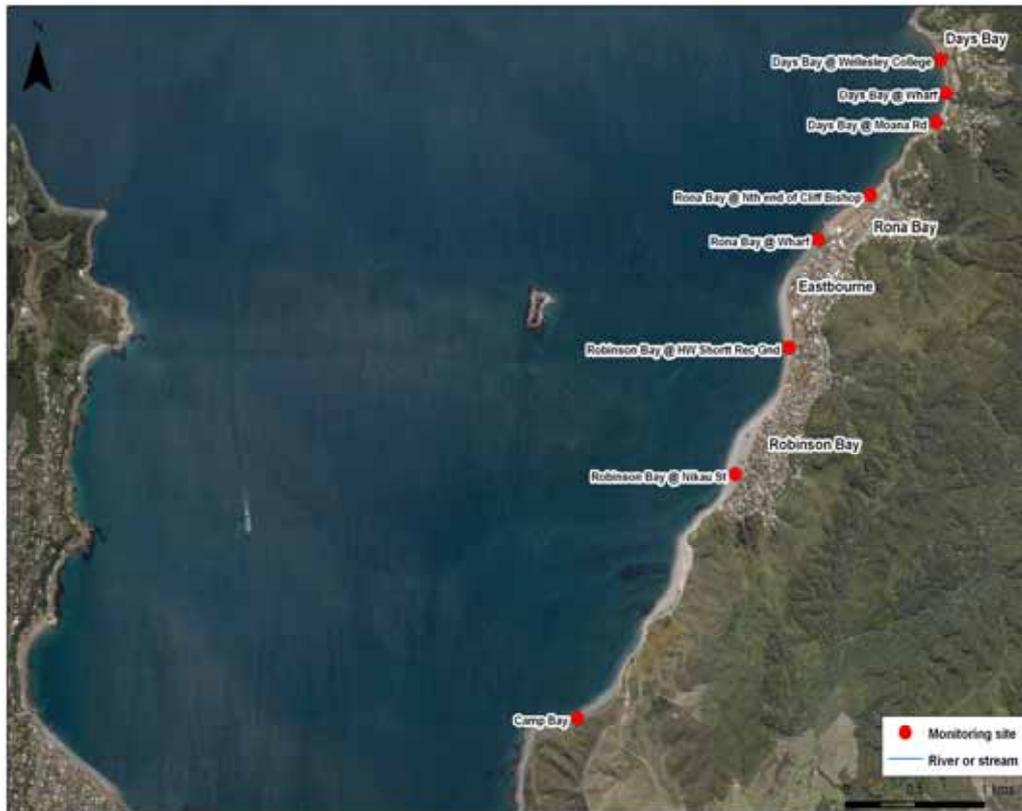
Figure 4.37: Location and surrounding land cover of recreational water quality monitoring sites along the Eastbourne coast between Days Bay and Camp Bay

Days Bay and Camp Bay are characterised by a sandy beach separated by rocky outcrops. Rona Bay and Robinson Bay form a long stretch of sandy beach which runs from the northern end of Rona Bay to Point Arthur. Each of these bays is fed by small but steep catchments. Recreational water quality is monitored at three sites in Days Bay, at two sites each in Rona and Robinson bays, and at one site in Camp Bay (Figure 4.37).
