Porirua Harbour

Broad Scale Habitat Mapping 2012/13

Greater
Wellington
Regional
Council

November
2013

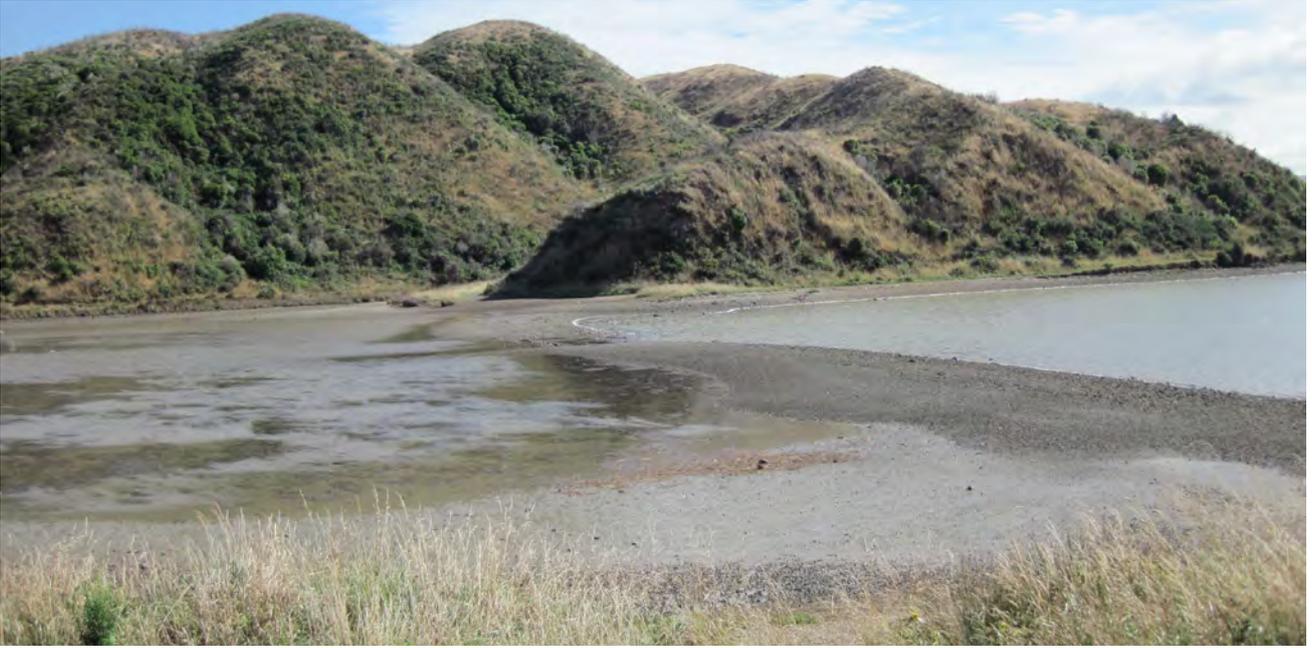
Te Onepoto Bay showing the constructed causeway restricting tidal flows.

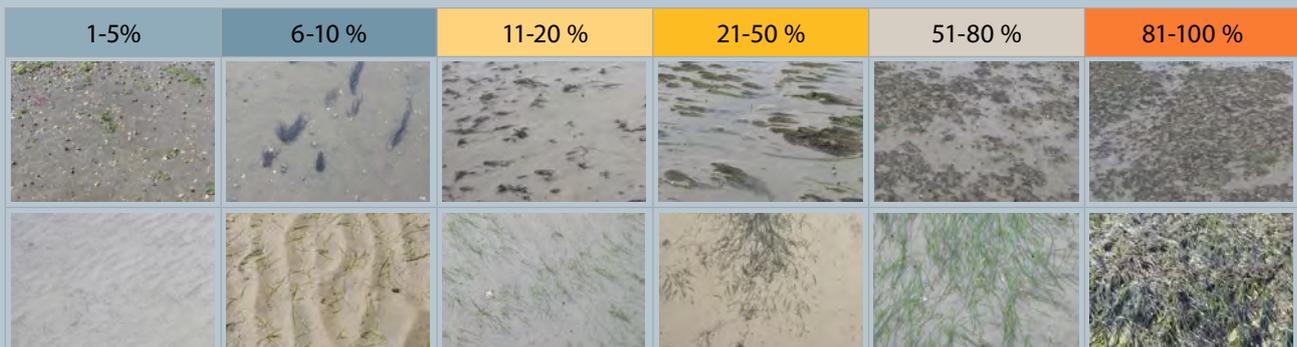
Figure 3. Visual rating scale for percentage cover estimates of macroalgae (top) and seagrass (bottom).

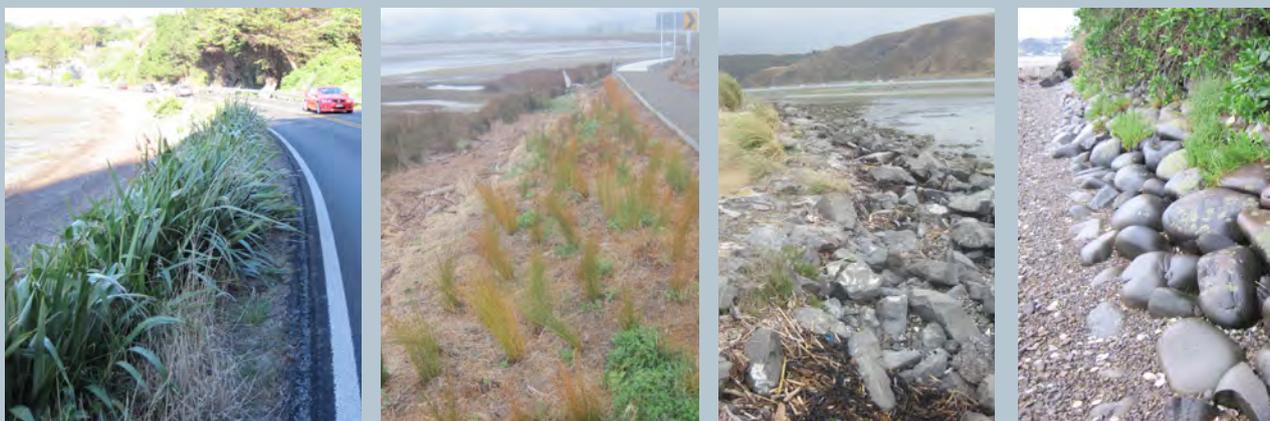
Examples of artificial barriers along the estuary margin.

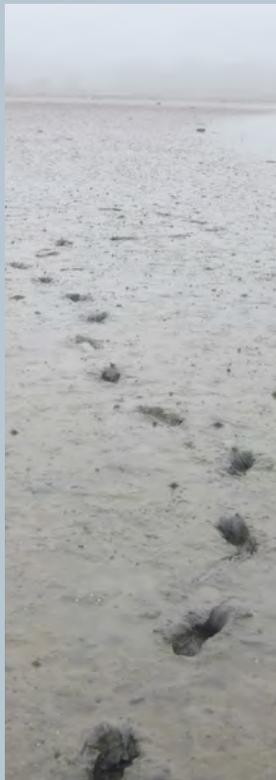
Soft muds on previously sandy tidal flats near the Horokiri Stream mouth.
