Baring Head/Ōrua-pouanui

Lighthouse Compound Heritage Plan
Prepared for Greater Wellington Regional Council

7 May 2014

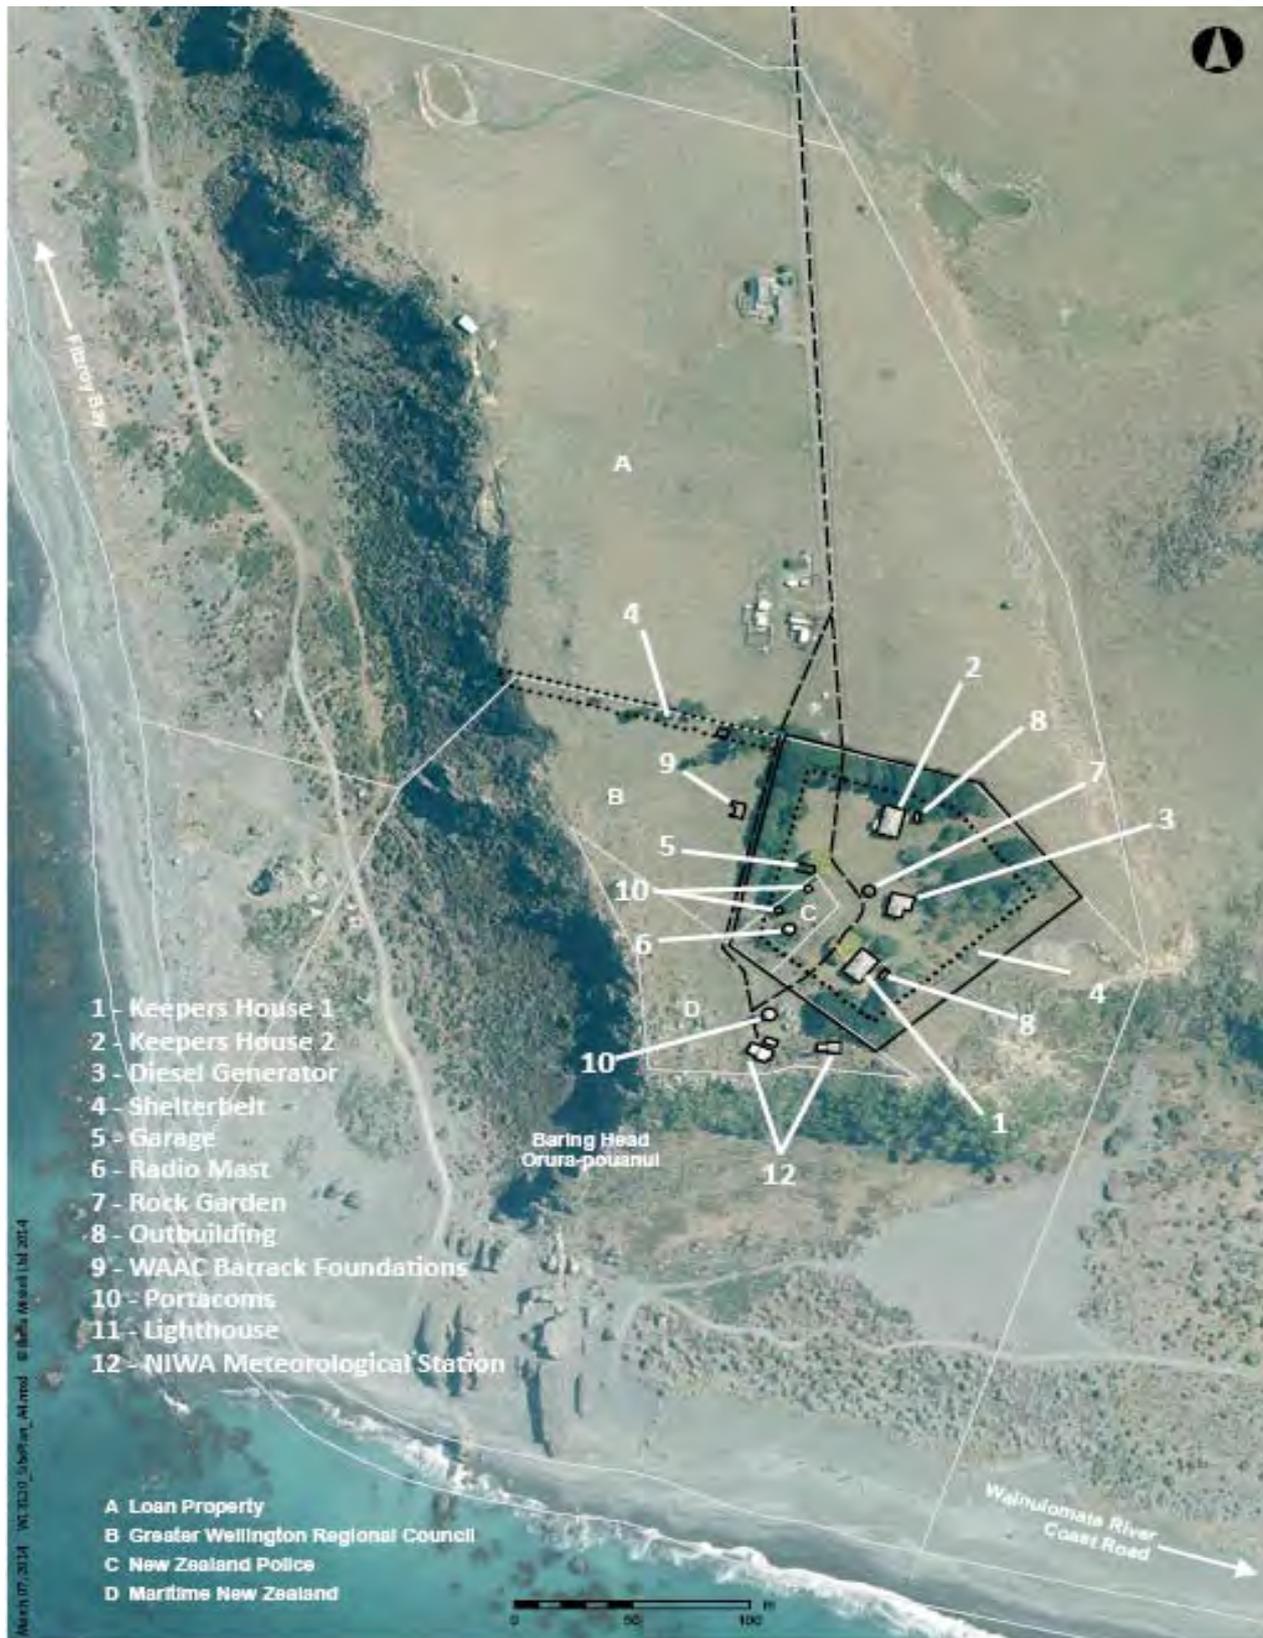
Figure 2. Site Context Plan

The key elements of the compound described above are illustrated in Figure 2.

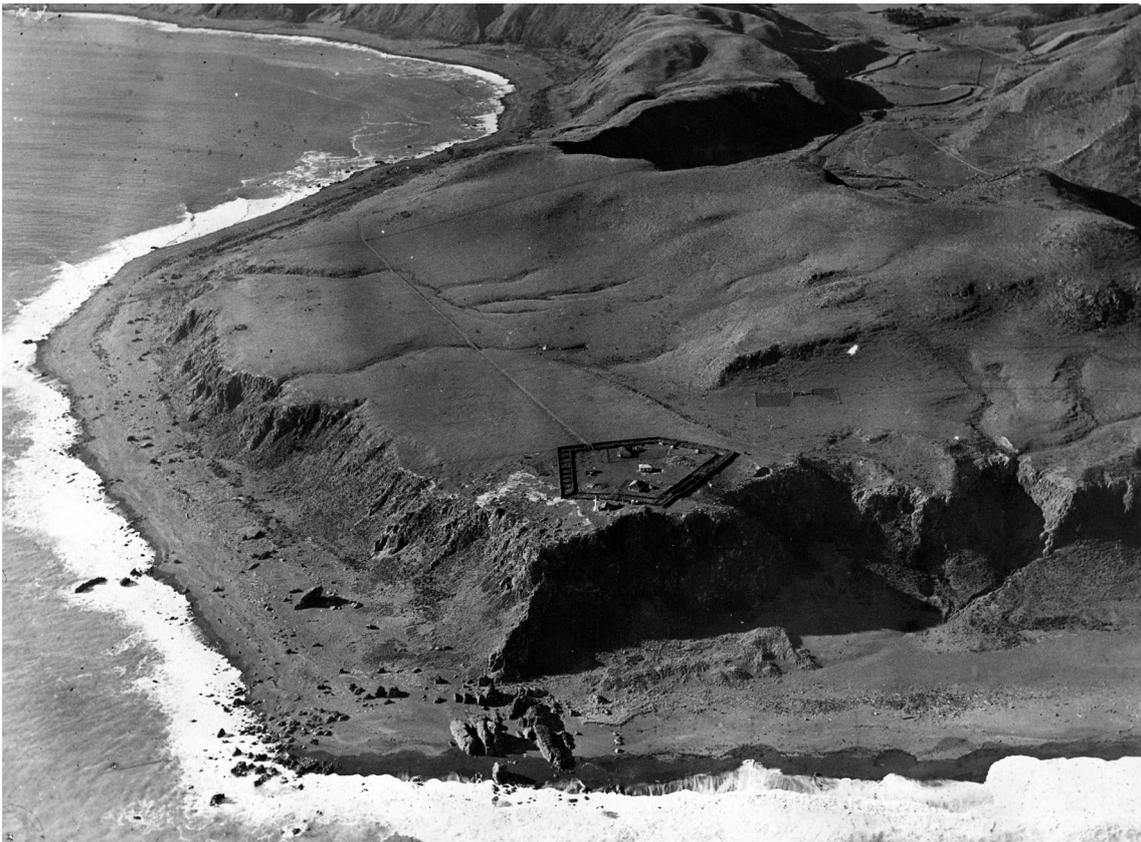
Aerial photograph of the Baring Head headland including the lighthouse and associated compound, escarpment and uplifted marine terrace. Date unknown (courtesy of Maritime New Zealand)

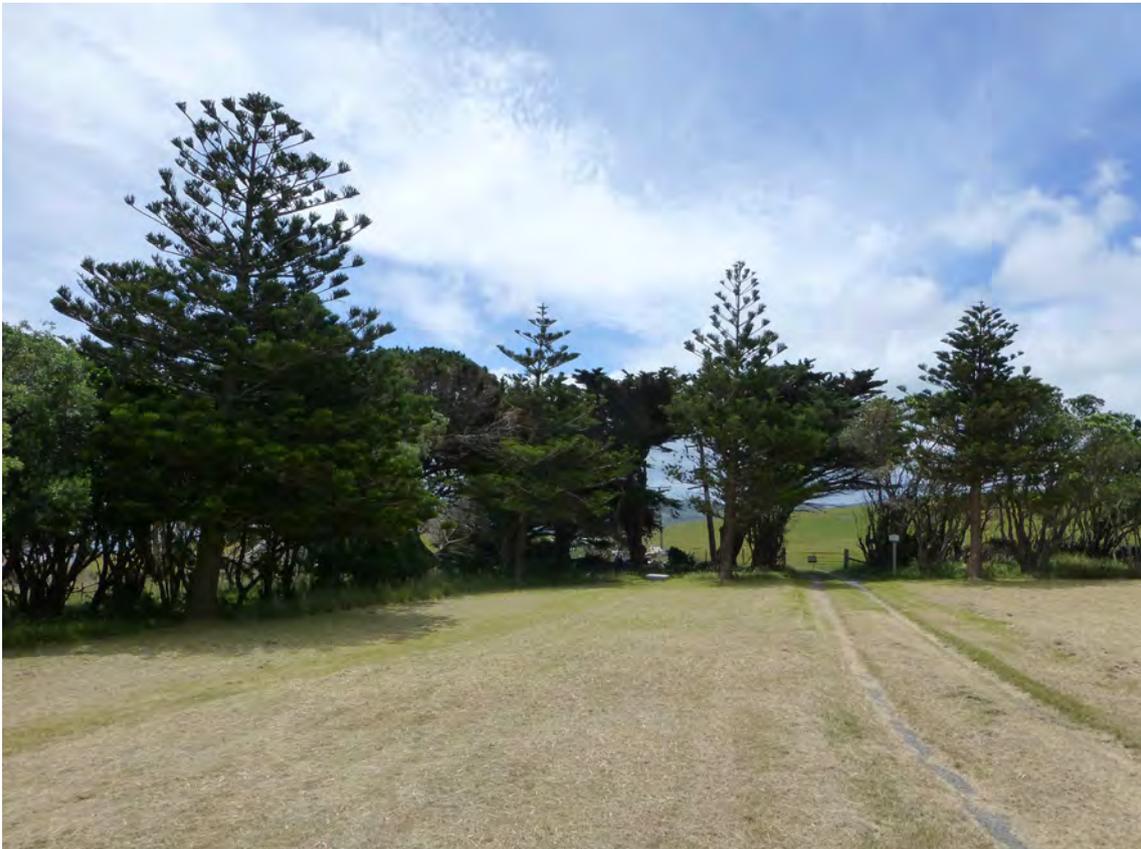
Shelterbelt looking north towards the compound entrance

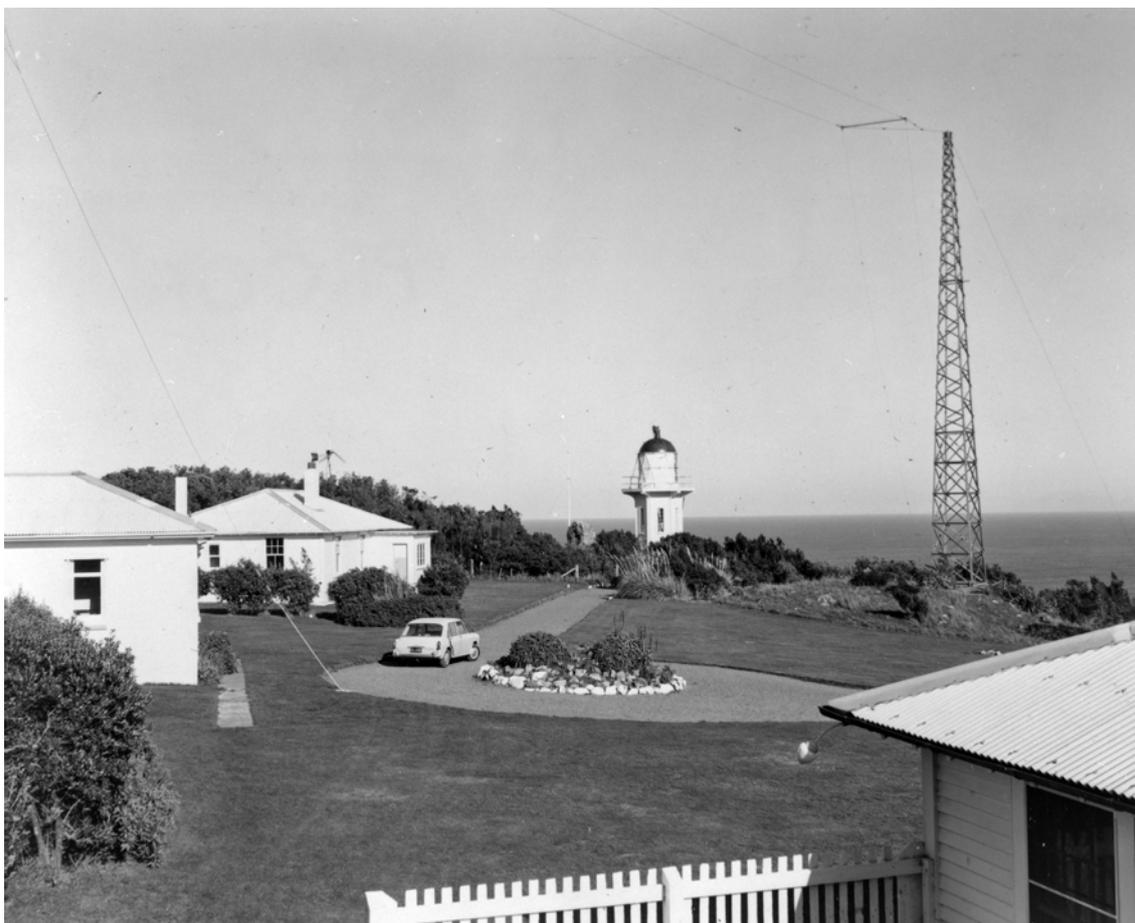
Interior of the compound including Keepers' House 1&2, the diesel generator house, the remaining radio beacon mast, the rock garden and the internal driveway. Date unknown (courtesy of Maritime New Zealand)

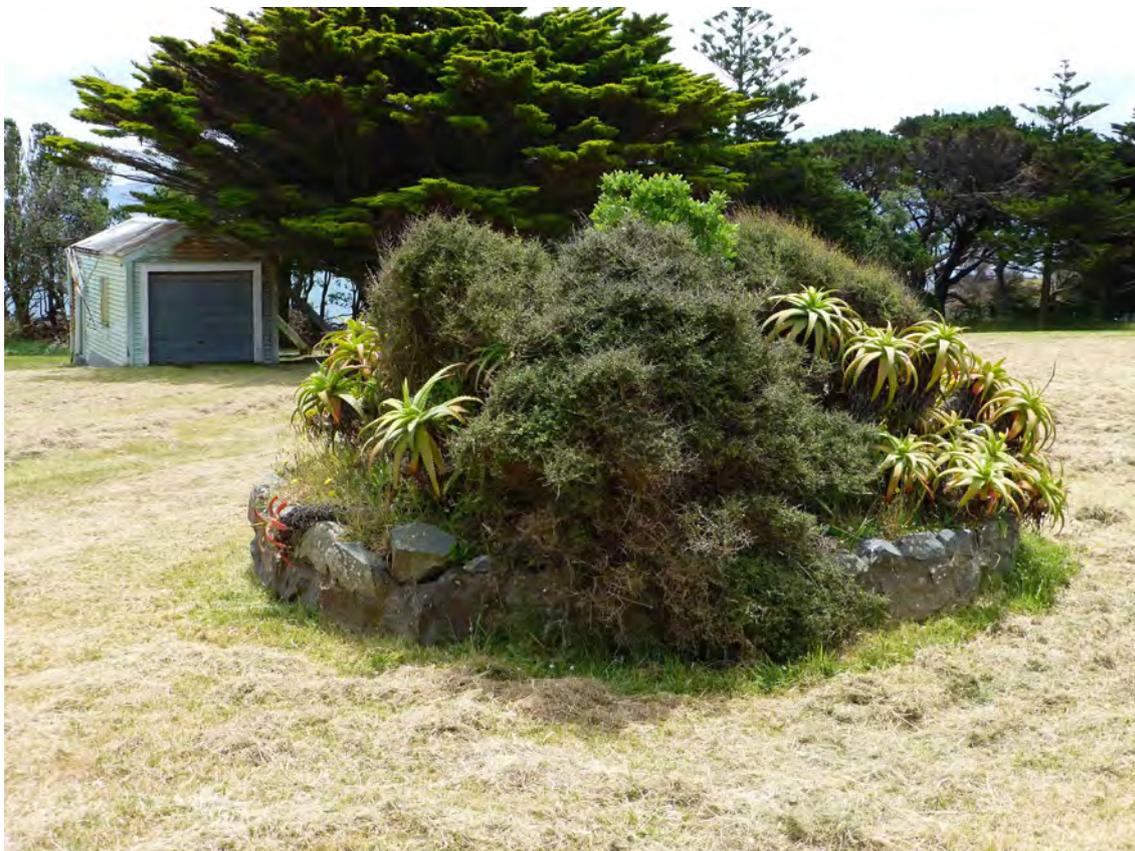
Ornamental rock garden with original garage in the background

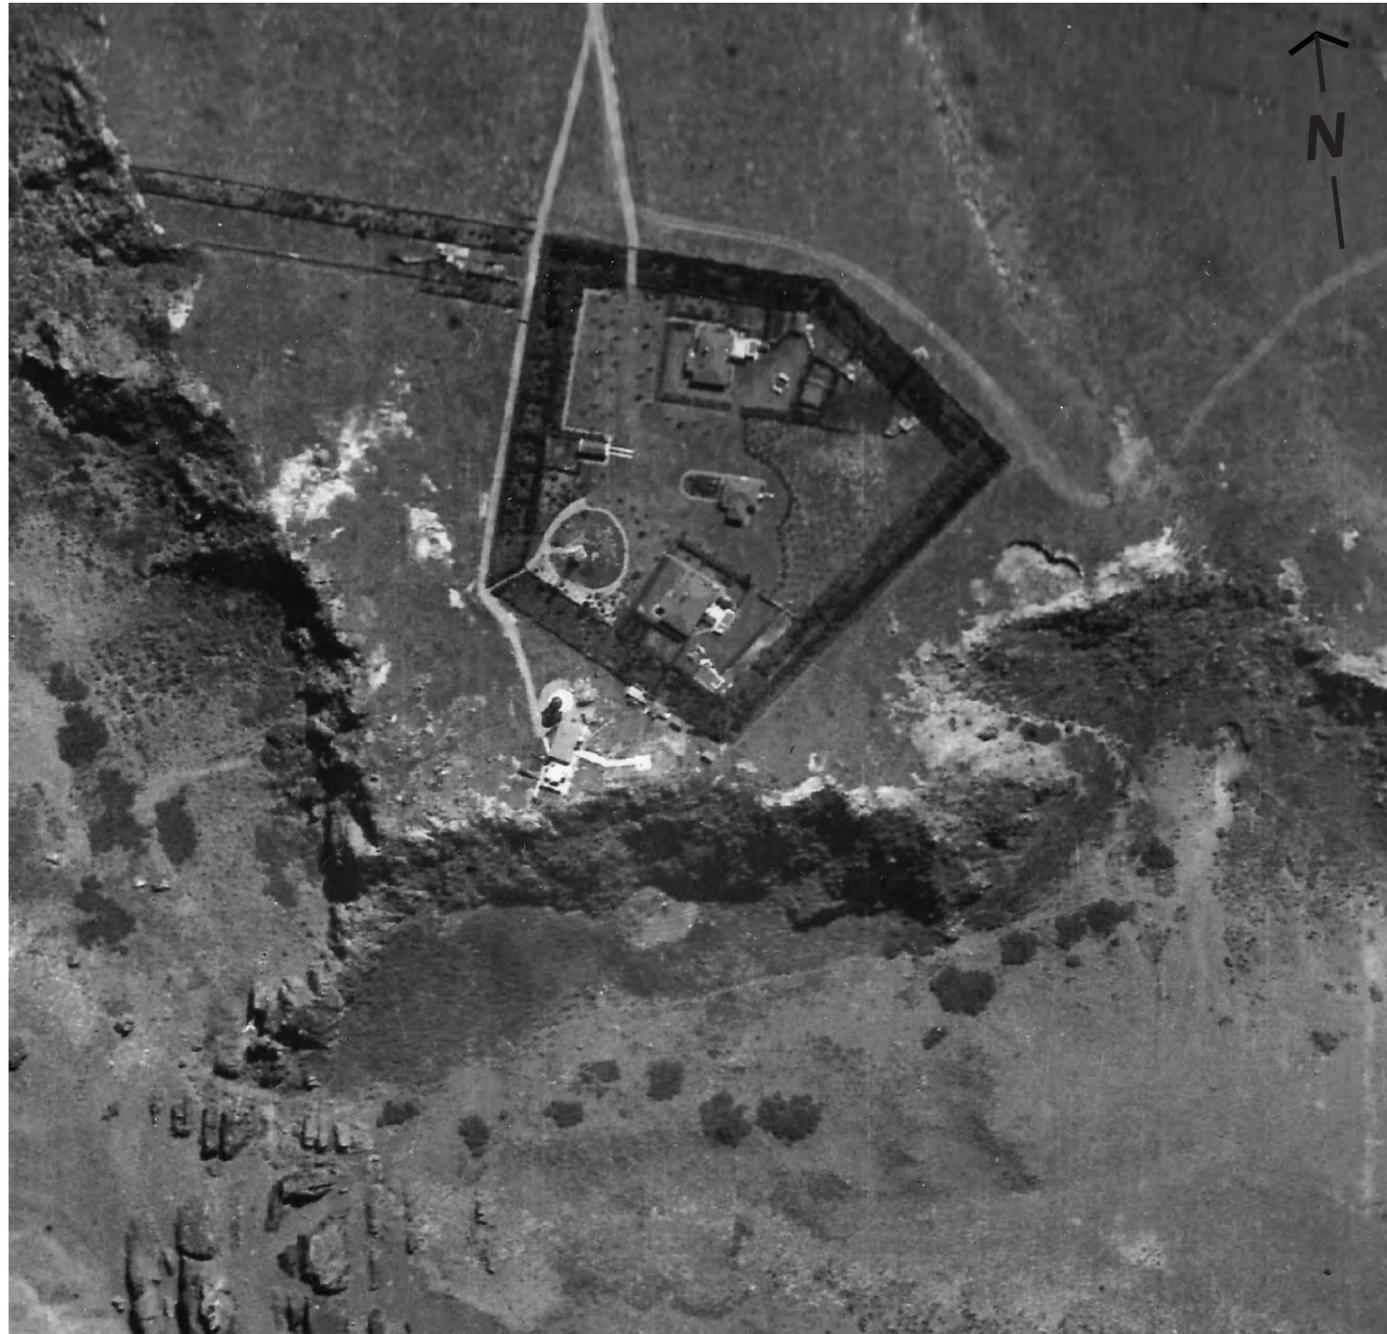
The compound six years after the lighthouse was opened clearly shows the extent of the shelterbelt planting within the compound and the internal fencing around the two keepers' houses. Date of imagery: 1941

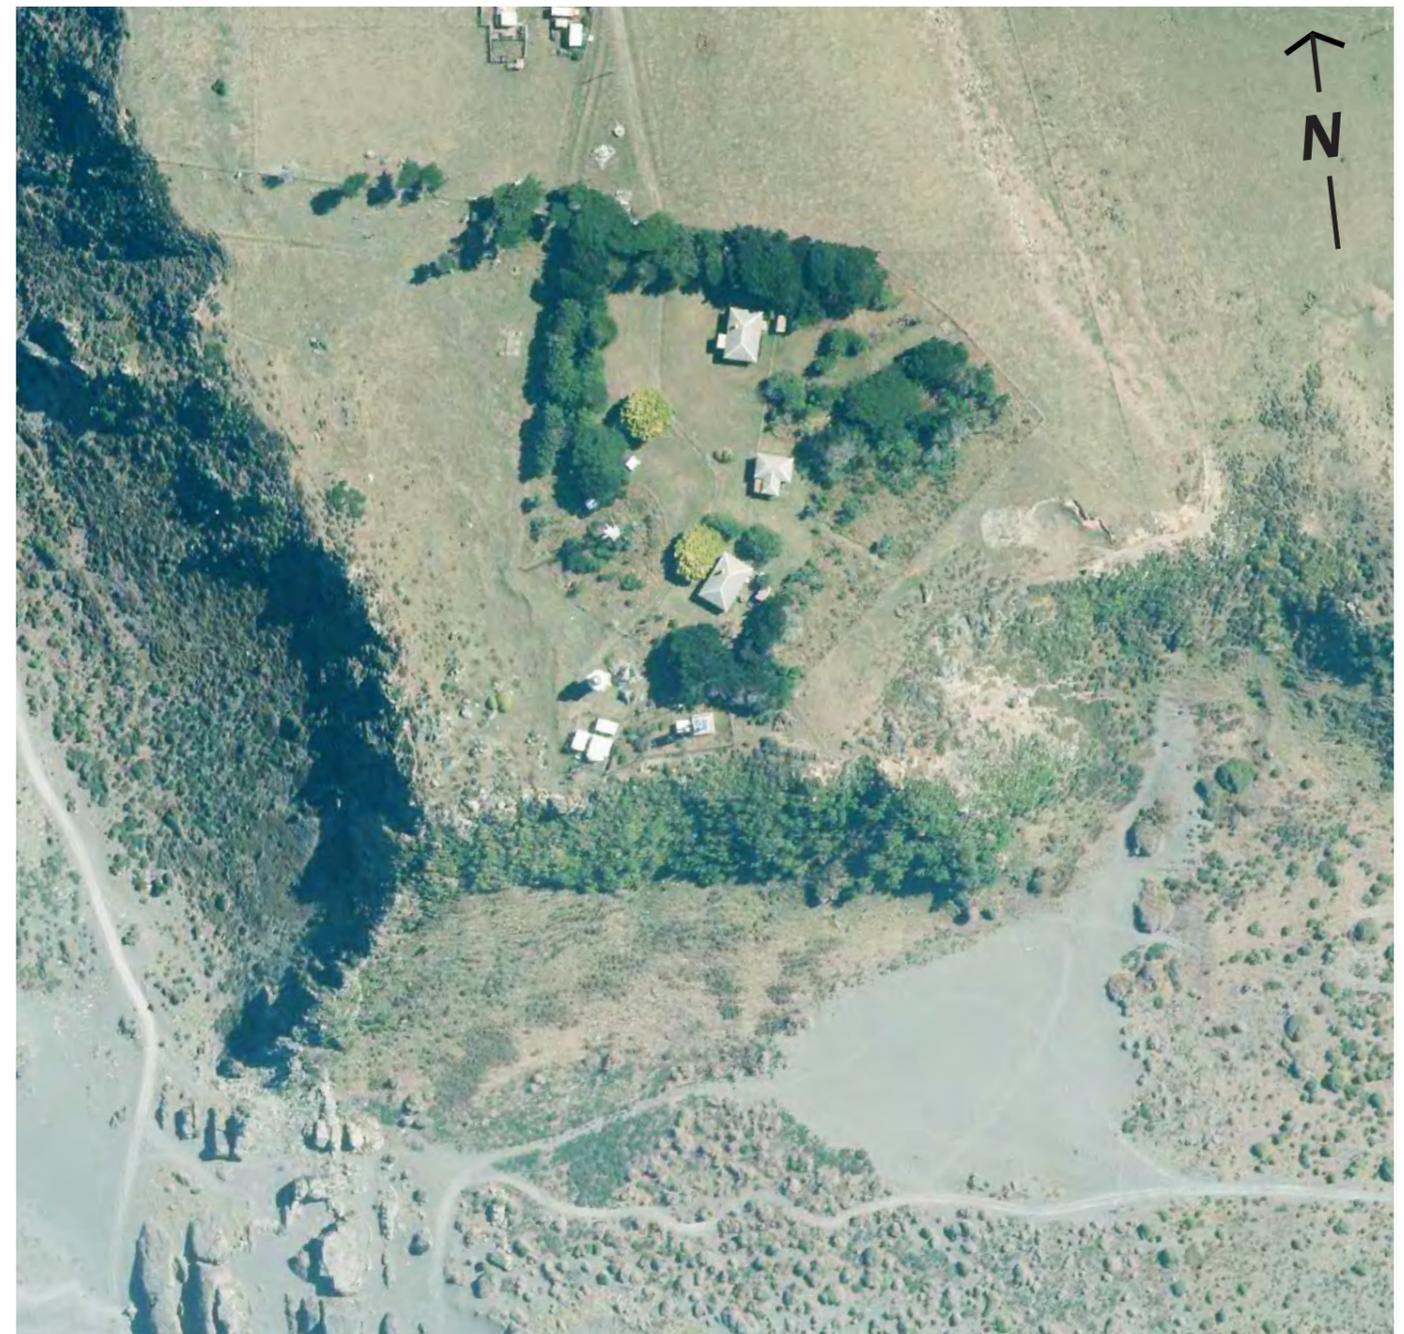
Seventy years later the shelterbelt remains intact around part of the compound, but there are gaps particularly along the south-eastern boundary. The shelterbelt between the western boundary of the compound and the escarpment is reduced to a few straggly trees. The internal fencing around the keepers' houses no longer exists. Date of imagery: 2013

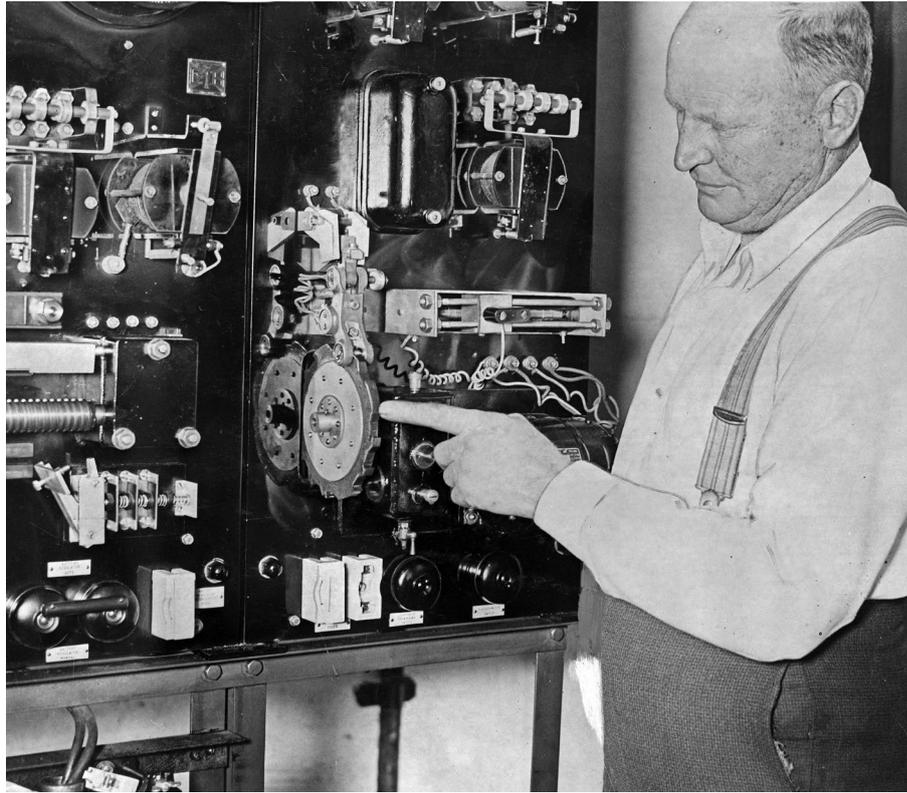
Bob Wilson pointing to a piece of electrical equipment used to regulate the periods of the occulting light installed at the Baring Head Lighthouse. Photographed in 1936 by an unidentified photographer at the Evening Post (courtesy of the National Library of New Zealand)

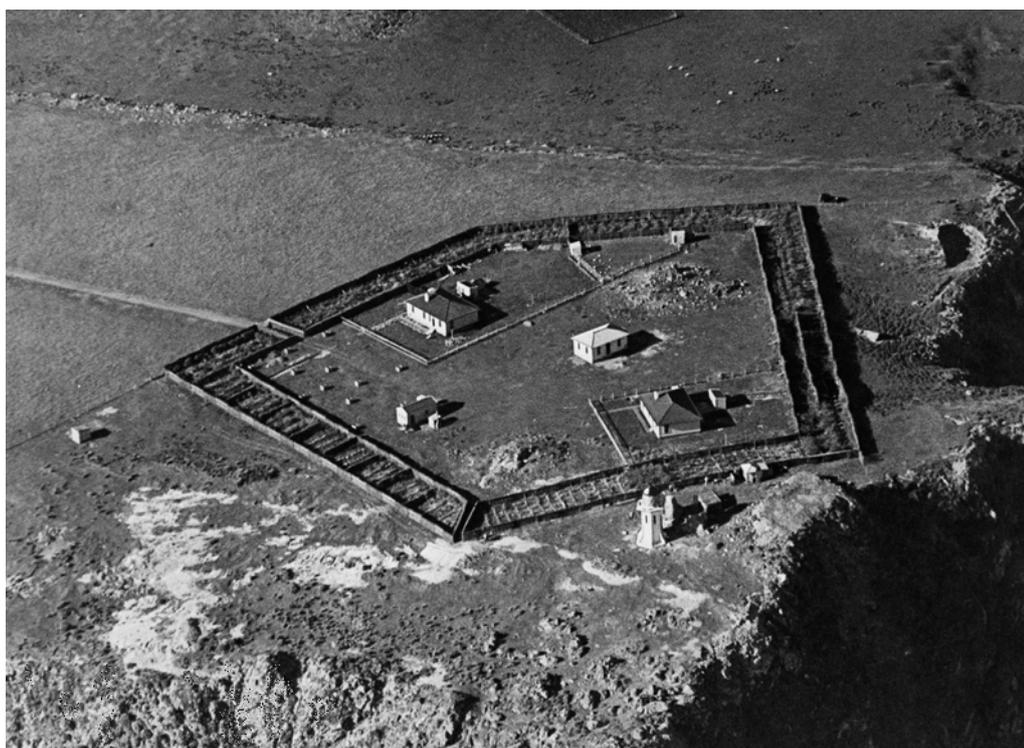
Aerial oblique photograph of the Baring Head Lighthouse and compound in 1935. Photographed by an unidentified photographer from the Evening Post (Baring Head – origin – general, M1 769 8/62/1, Archives New Zealand)

The landscape on which the compound is located is highly and widely recognisable – from parts of Wellington, and when entering and leaving Wellington by sea or by air. The coastal escarpment sharply defines the edge of the lower marine terrace, and this is further emphasised by the dark macrocarpa shelterbelt that encloses the compound. The absence of woody vegetation on the terraces and the open pastoral landscape also enhances appreciation of the distinctiveness of this landform and the compounds' position as a sentinel at the entrance to Wellington Harbour.

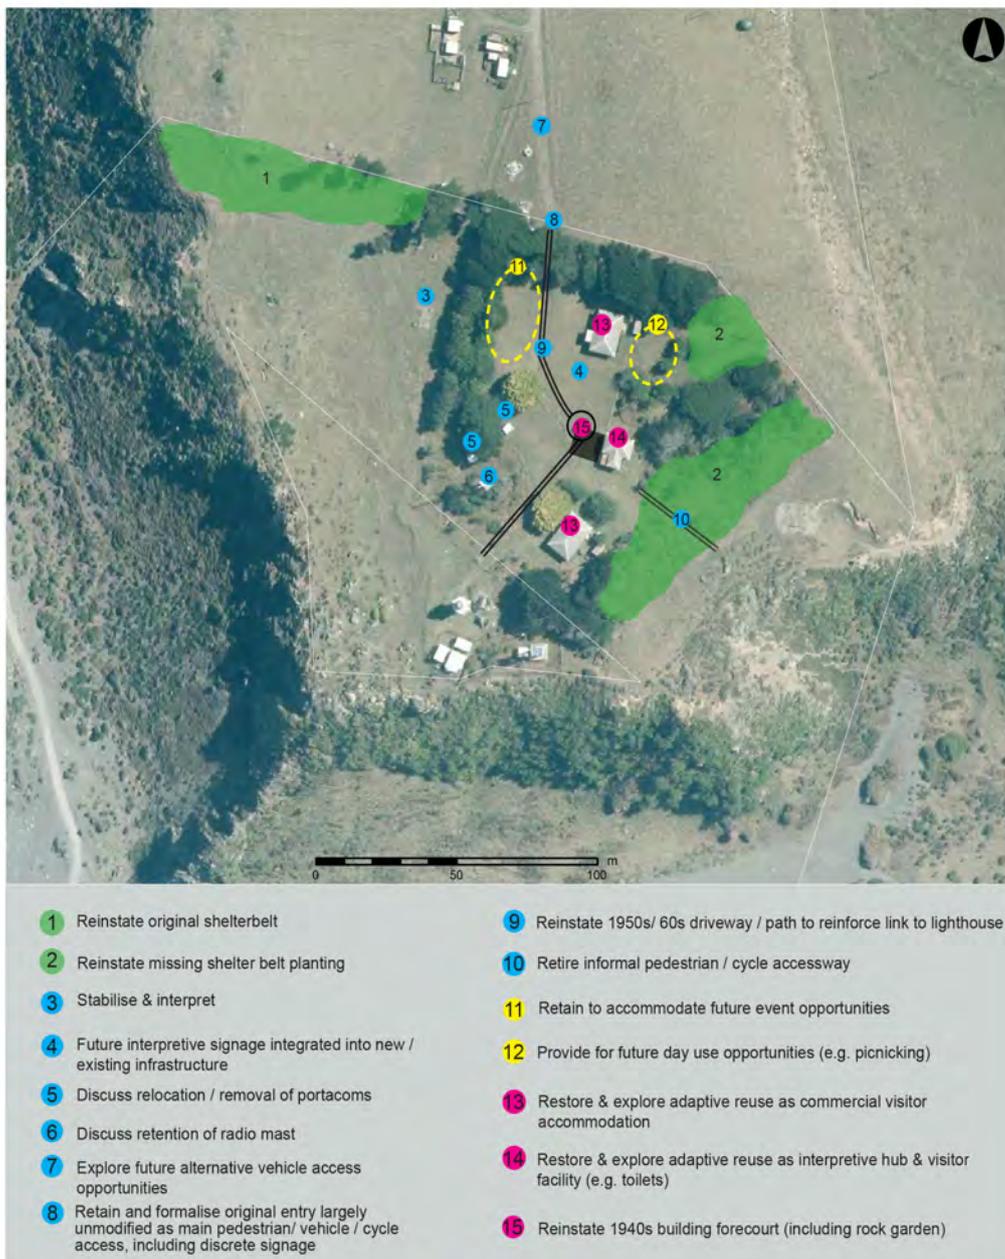
Figure 4. Indicative Compound Development Concept

Based on the guidelines and actions outlined in section 5.3, Figure 4 below presents an indicative concept of how the compound might be developed in future consistent with its identified heritage values. The conceptual ideas illustrated in the diagram are intended to help inform the preparation of a more detailed implementation framework for the compound. They are also intended to provide a basis for further discussions within GWRC, and between GWRC and parties with an interest in the compound (e.g. Friends of Baring Head), on its future use and development.
