# Effects of Flood Protection Activities on Aquatic and Riparian Ecology in the Hutt River

Prepared for Greater Wellington Regional Council (Flood Protection)

December 2016

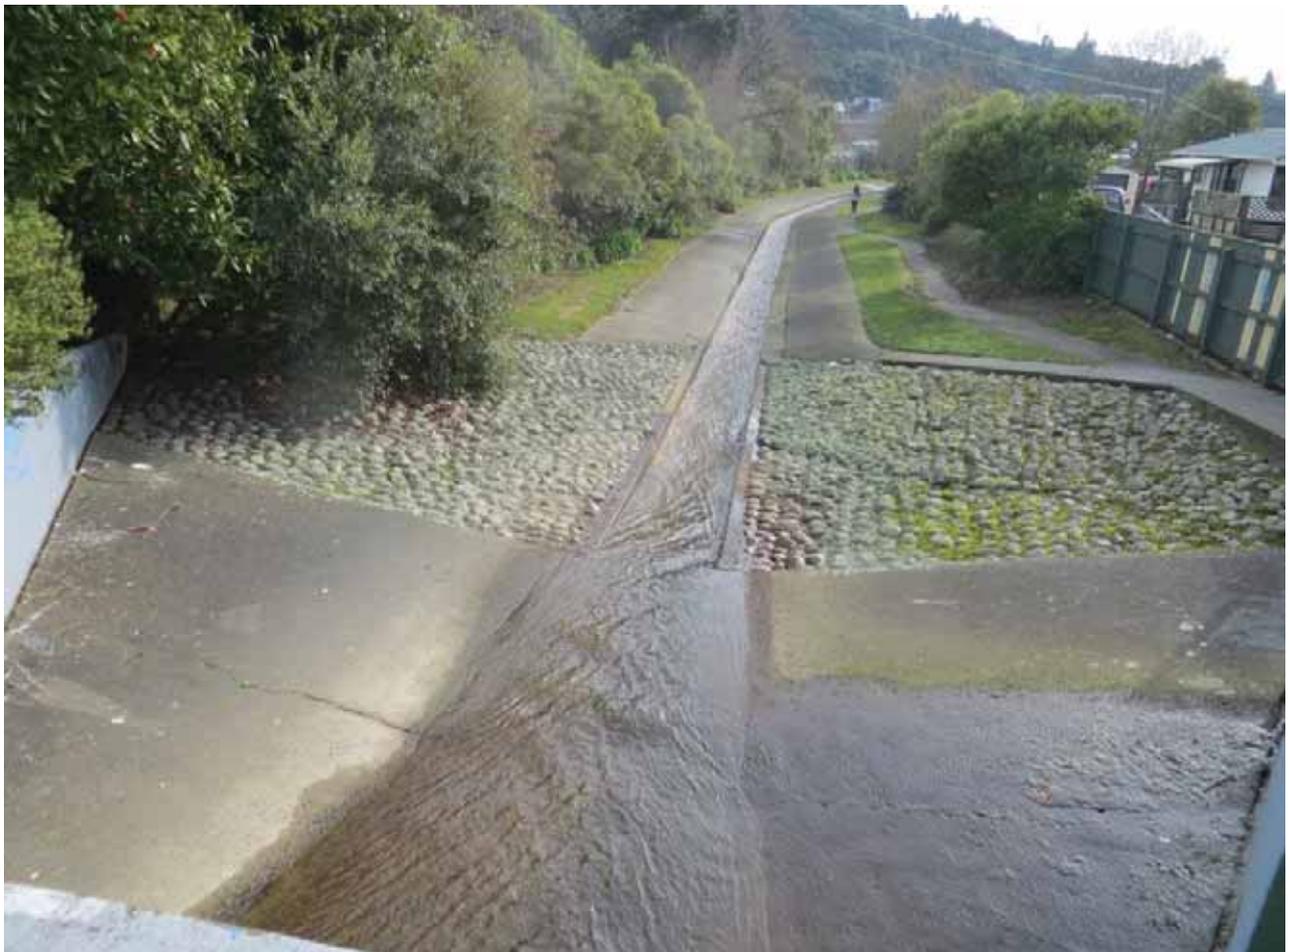
**Figure 3-4:** View of Stokes Valley Stream downstream of Bowers Street, 700m upstream of the application area

The results of a habitat assessment conducted in the reach downstream of Stokes Valley Road during July 2015, summarised in Table 3-3 and 3-4, show that the stream is in a degraded condition due to extensive urbanisation of its catchment causing loss of forest cover, modifications to its channel and removal to riparian vegetation, loss of shade and cover over the streambed, loss of connectivity to the flood plain, loss of hydraulic complexity and loss of woody inputs to the stream. These factors contribute to a low abundance and diversity of habitat for invertebrates and fish.

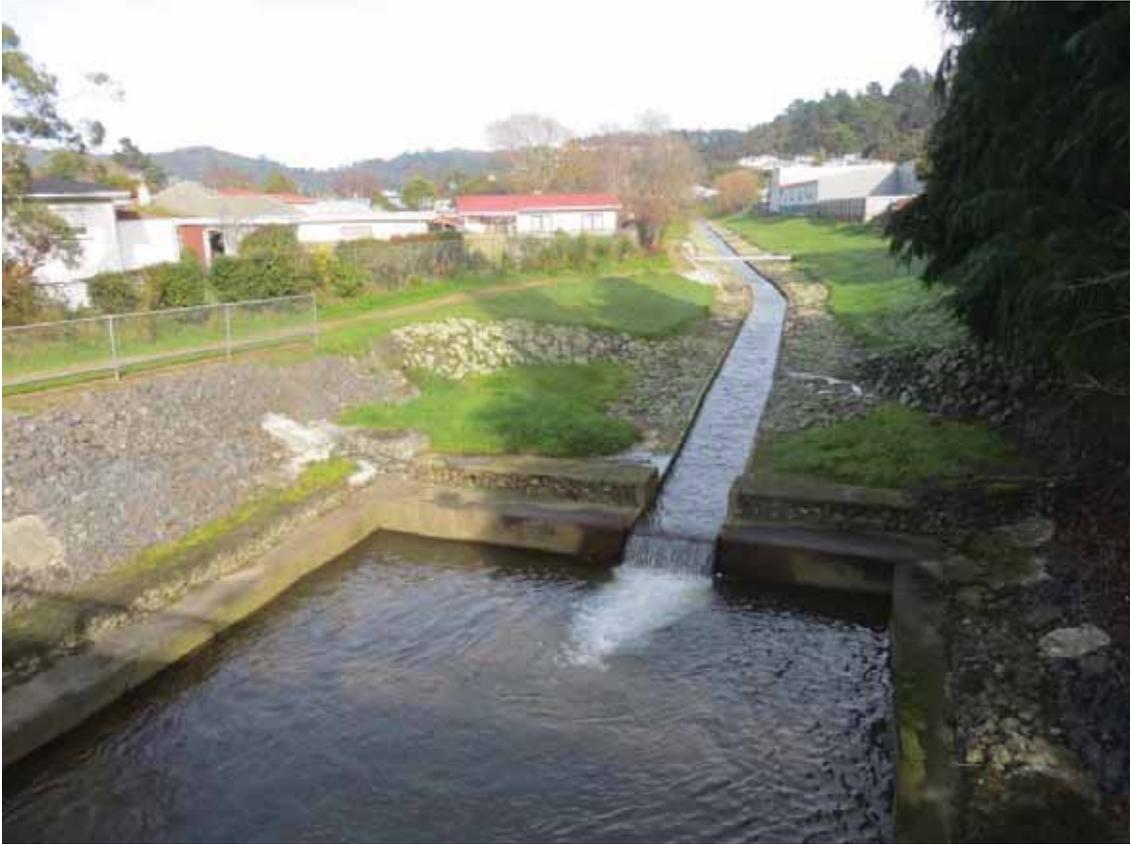
**Figure 3-5:** View of concrete lined channel and stilling basin at Stokes Valley Road, within the application area

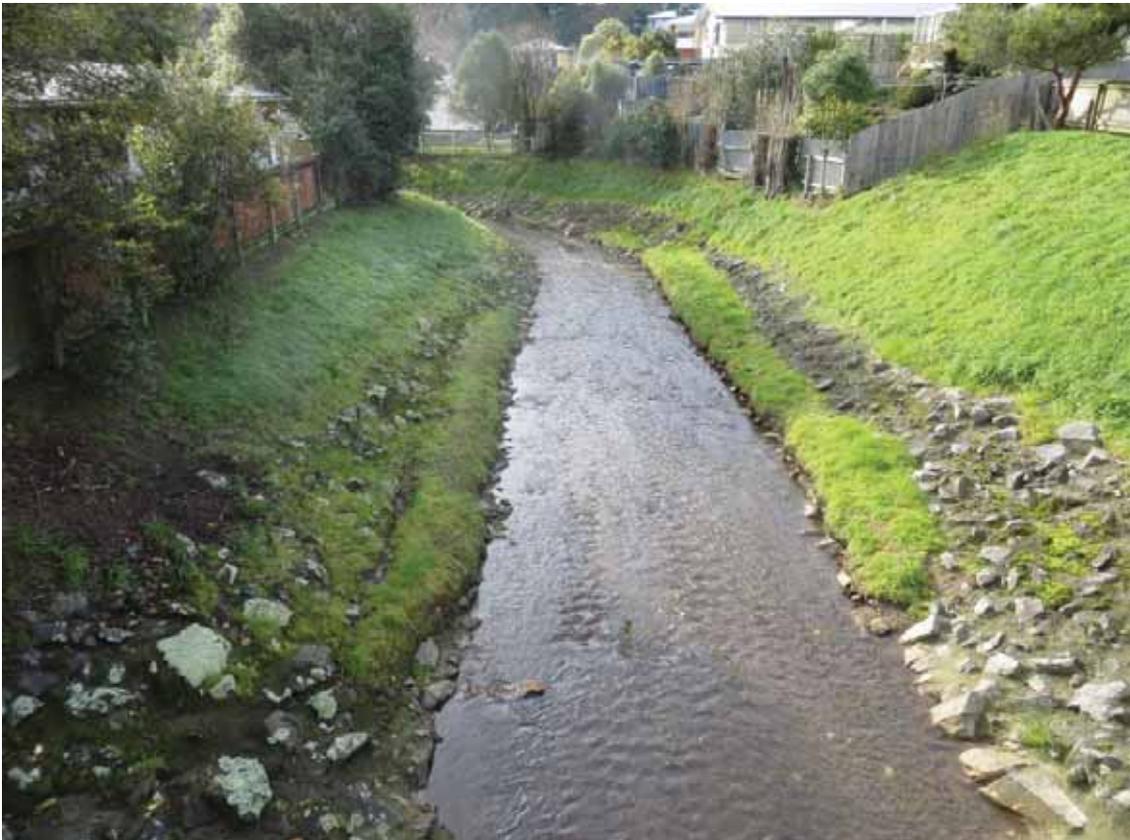
**Figure 3-6:** View of modified straightened stream channel downstream of Stokes Valley Road, within the application area

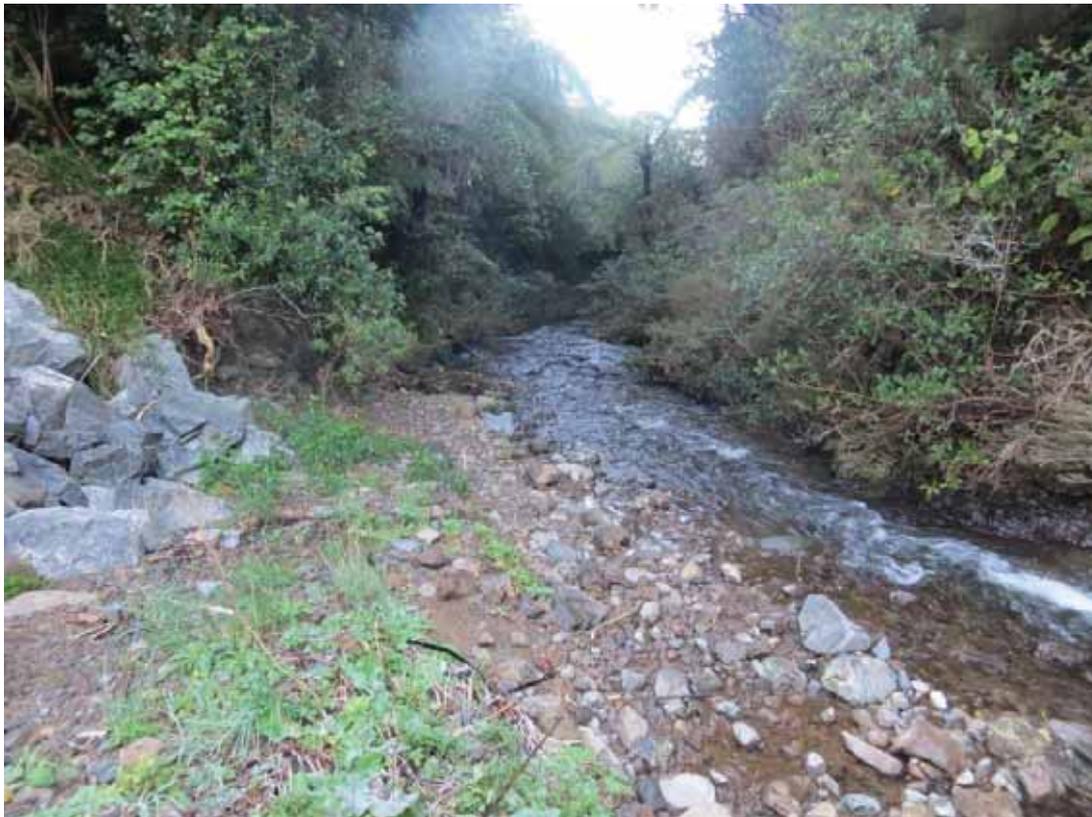
**Figure 3-10:** View of Speedy's Stream downstream of the debris arrester

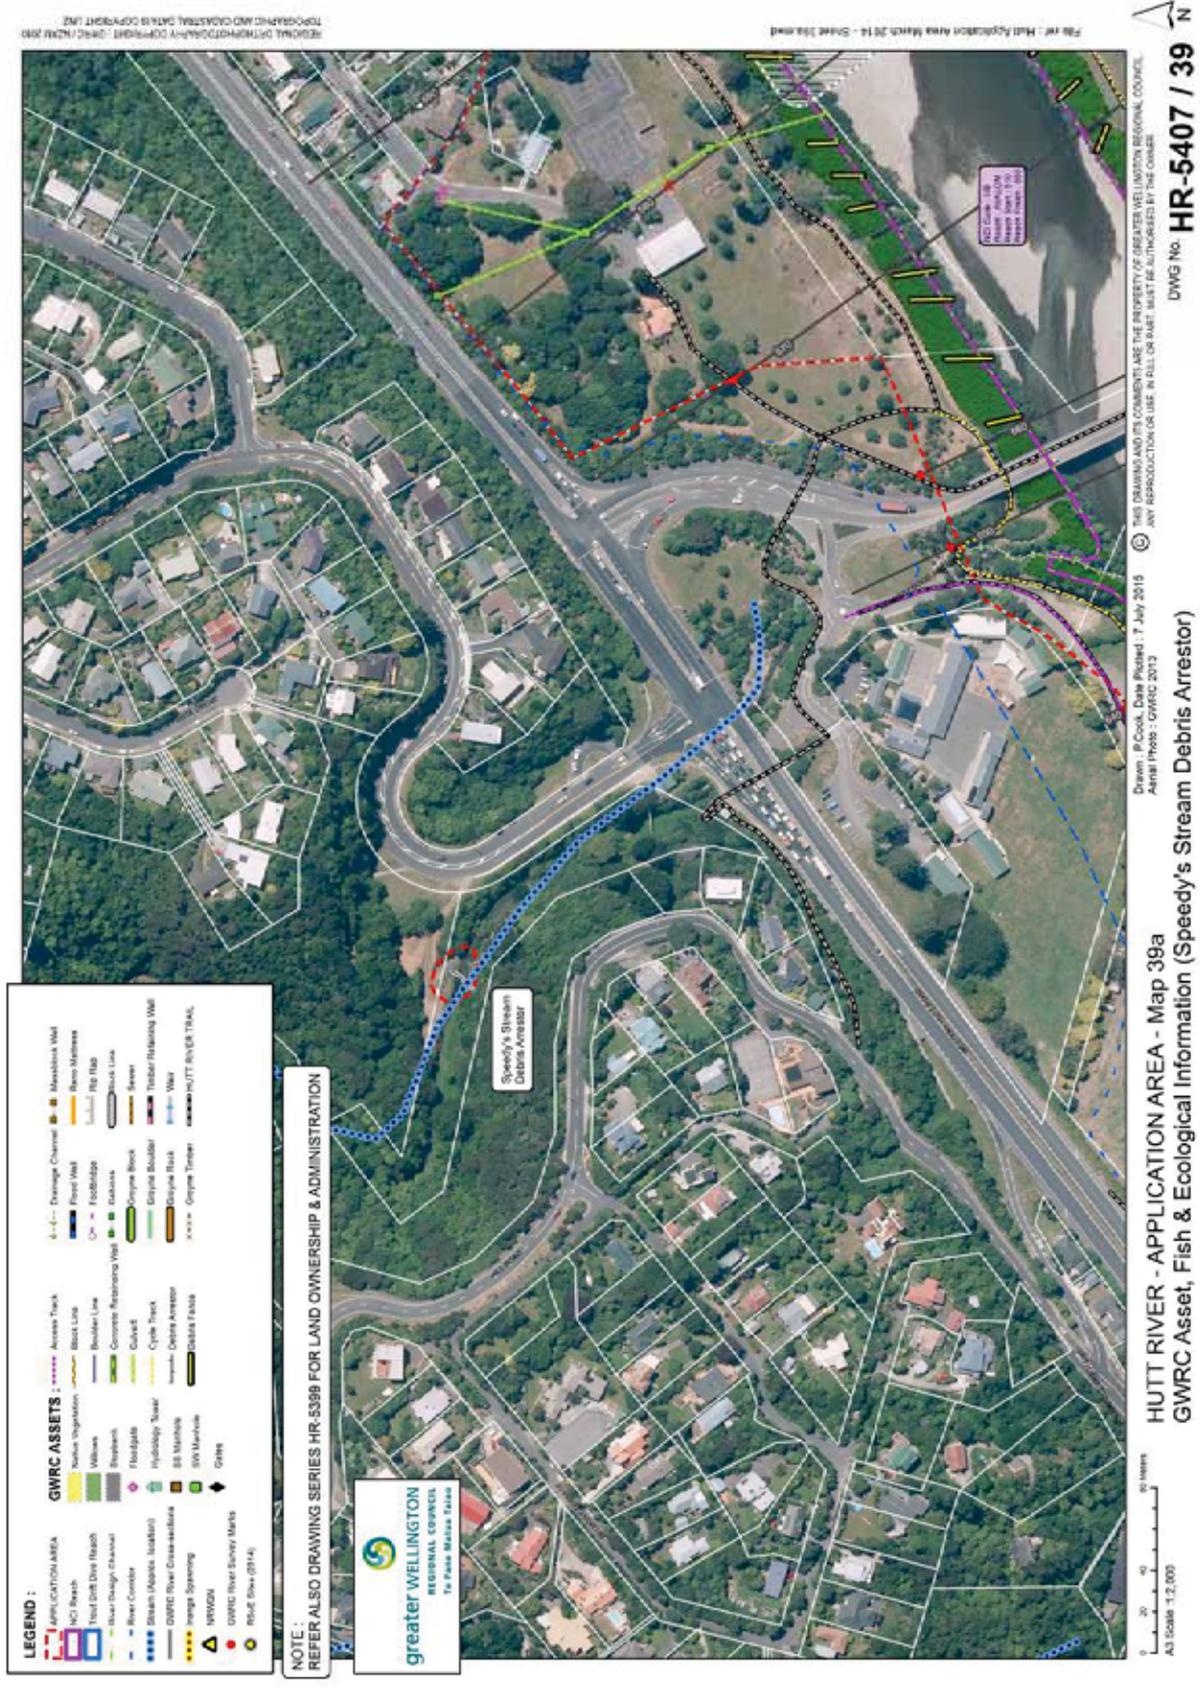
Figure 3-13: Map of application area within Speedy's Stream, showing location of debris arrester

GWRC maintains the bed and banks around the Speedy's Stream Debris Arrester (Figure 3-12 and 3-13).

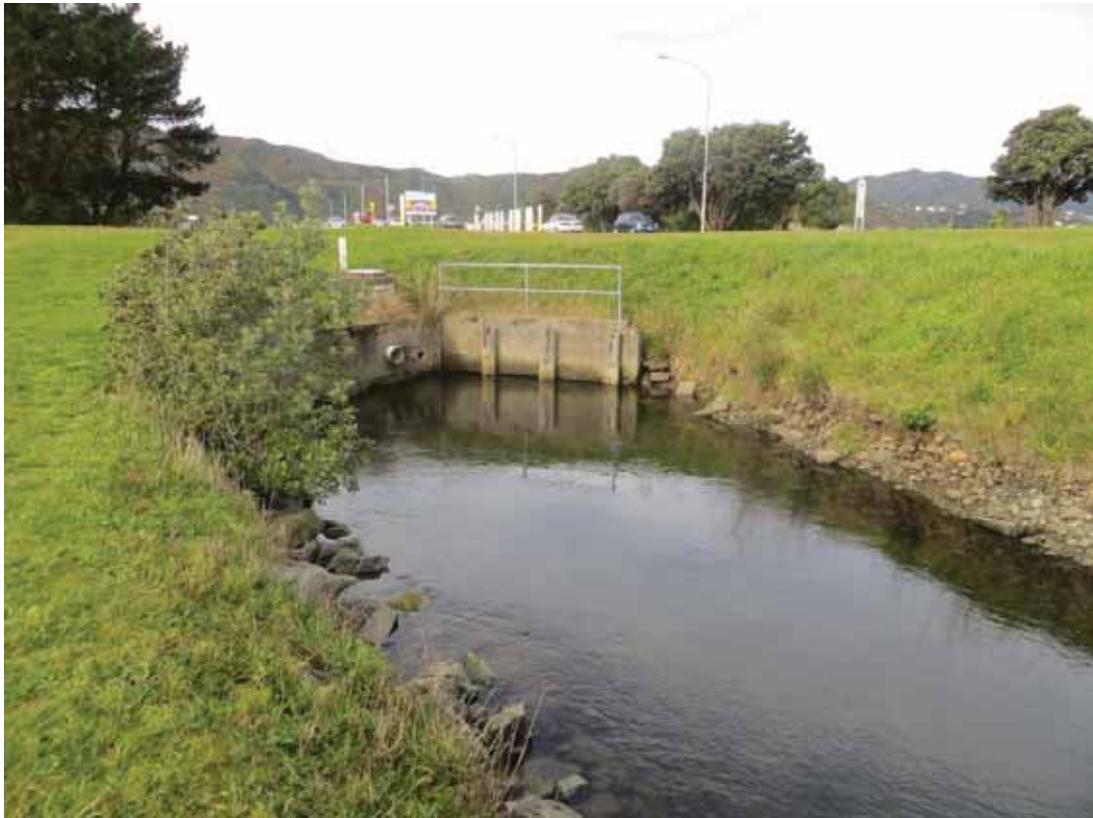
**Figure 3-14:** Waione Street culvert which connects the Te Mome Stream to the Hutt River

The main flood protection activities undertaken are occasional dredging to remove silt and tidal debris, including removal of debris from around the flood gate to ensure their efficient operation.

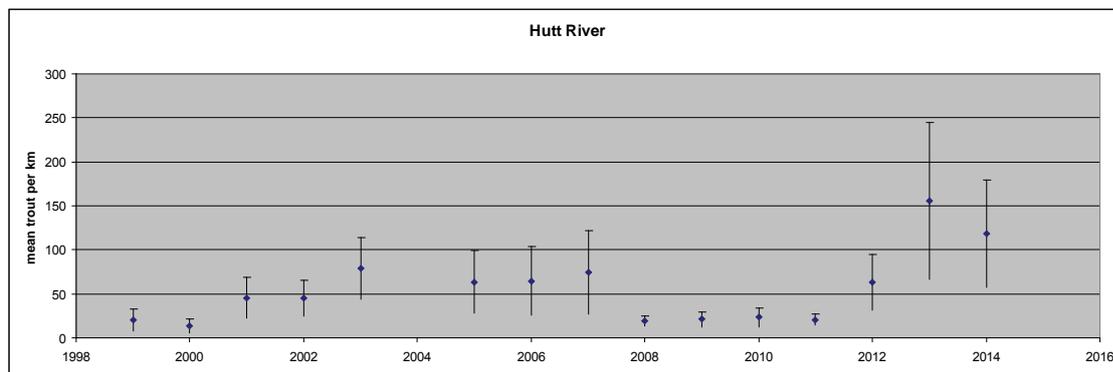
**Figure 3-27:** Mean large and medium trout per km, Hutt River (from Pilkington 2014)

The author goes on to note that the severity of spring floods is believed to reduce trout recruitment (i.e., Hayes, 1995). In an earlier report Pilkington (2012) notes that correlating flood data against the number of medium trout counted 1.5 years later shows a reasonably strong negative correlation, and that the negative correlation increased with severity of the flood. However, it was also noted in that report that where cross blading (i.e. bed re-contouring) had been undertaken recently at the Melling site, there was virtually no invertebrate life visible and no trout of any size class observed. These observations suggest that while bed re-countering and gravel extraction is likely to influence trout abundance at impacted sites in the short term, broader scale climatic factors are likely to be important in the longer term.

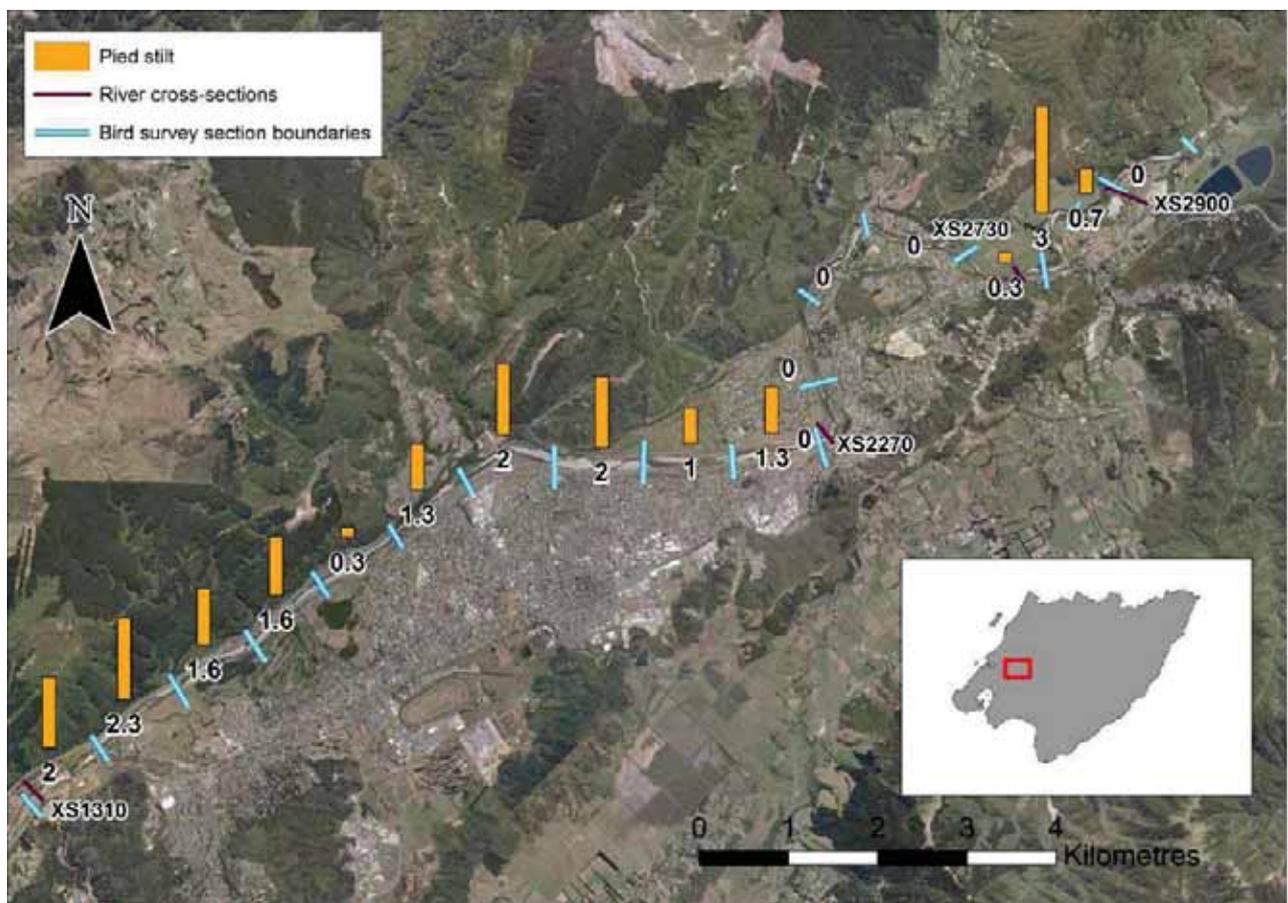
**Figure 3-29:** Map of the Hutt River showing the spatial pattern in the relative abundance of pied stilts (from McArthur *et al*, 2015). Coloured bars and adjacent values represent the mean number of birds counted along each 1 km survey section during three annual surveys between 2012 and 2015.

On average 20 pied stilts were recorded along the 31.5 km of river surveyed each year, or 0.6 birds per km of river. As illustrated in Figure 3-29, these birds were concentrated in two discrete reaches of the river, between XS1310 and XS2270 (within the application area, from the Silverstream Weir to the eastern end of Awa Kairangi Park) and between XS2730 and XS2900 (upstream of the application area, alongside the Te Marua Golf Course).

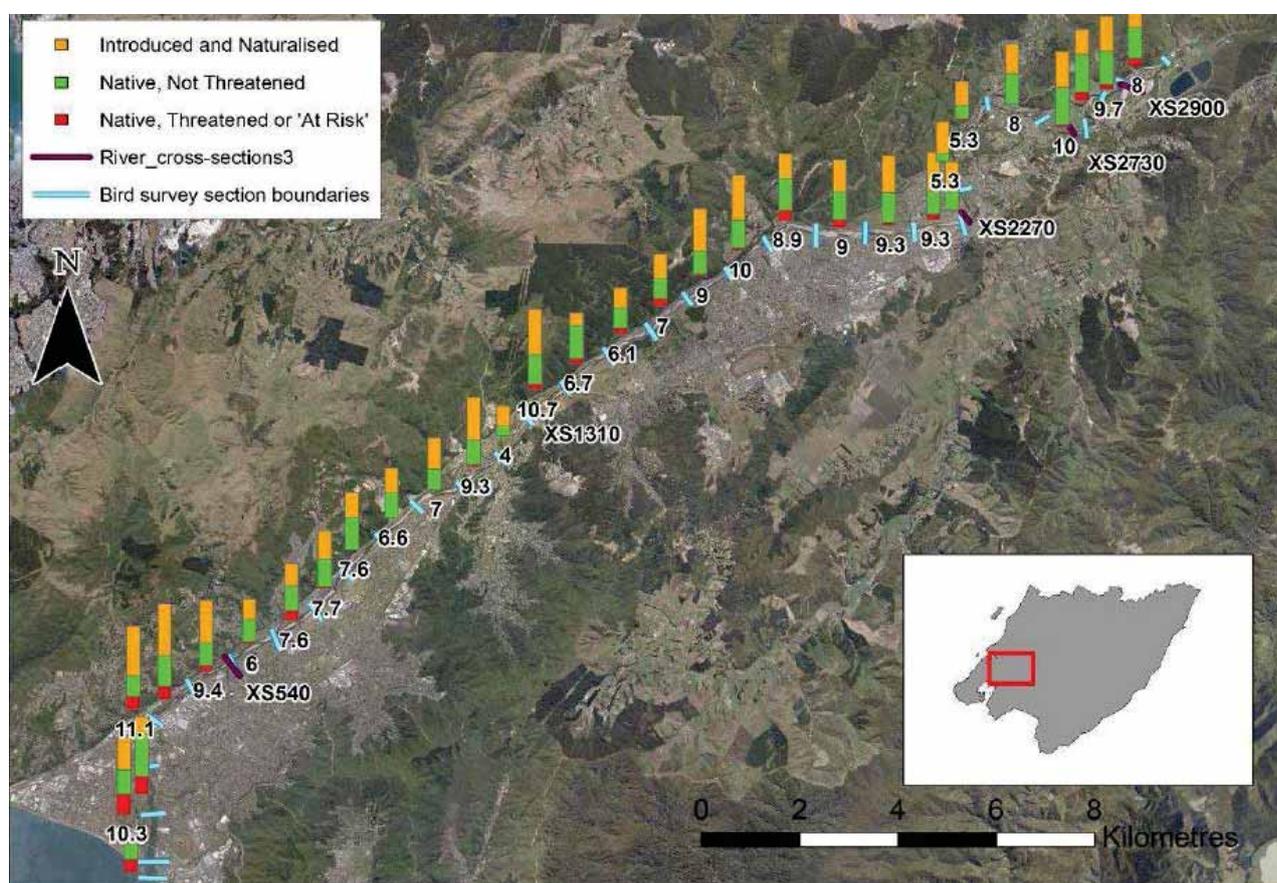
**Figure 3-30:** Map of the Hutt River showing the spatial patterns in bird species diversity (from McArthur et al, 2015). Coloured bars and adjacent values represent the mean number of species detected along each 1 km survey section during the three annual surveys between 2012 and 2015.

Both the total number of species and the ratio of native to introduced species encountered within each 1km survey section varied little along the 31.5 km of the Hutt River that was surveyed (Figure 3-30). A slightly higher proportion of Threatened or 'At Risk' species were recorded between XS1310 and XS2270 (within the application area, from the Silverstream Weir to the eastern end of Awa Kairangi Park) and between XS2730 and XS2900 (upstream of the application area, alongside the Te Marua Golf Course), due to the presence of both pied stilts and black shags on the riverbed in these reaches. The total number of species recorded, the ratio of native to introduced species and the proportion of threatened and 'at risk' species all increased with increasing distance downstream of XS540. McArthur et al (2015) concluded that this change was due to the presence of greater numbers of predominantly coastal bird species such as red-billed gulls (*Larus novaehollandiae*), royal spoonbills (*Platalea regia*), pied shags and variable oystercatchers in this lower reach of the Hutt River.

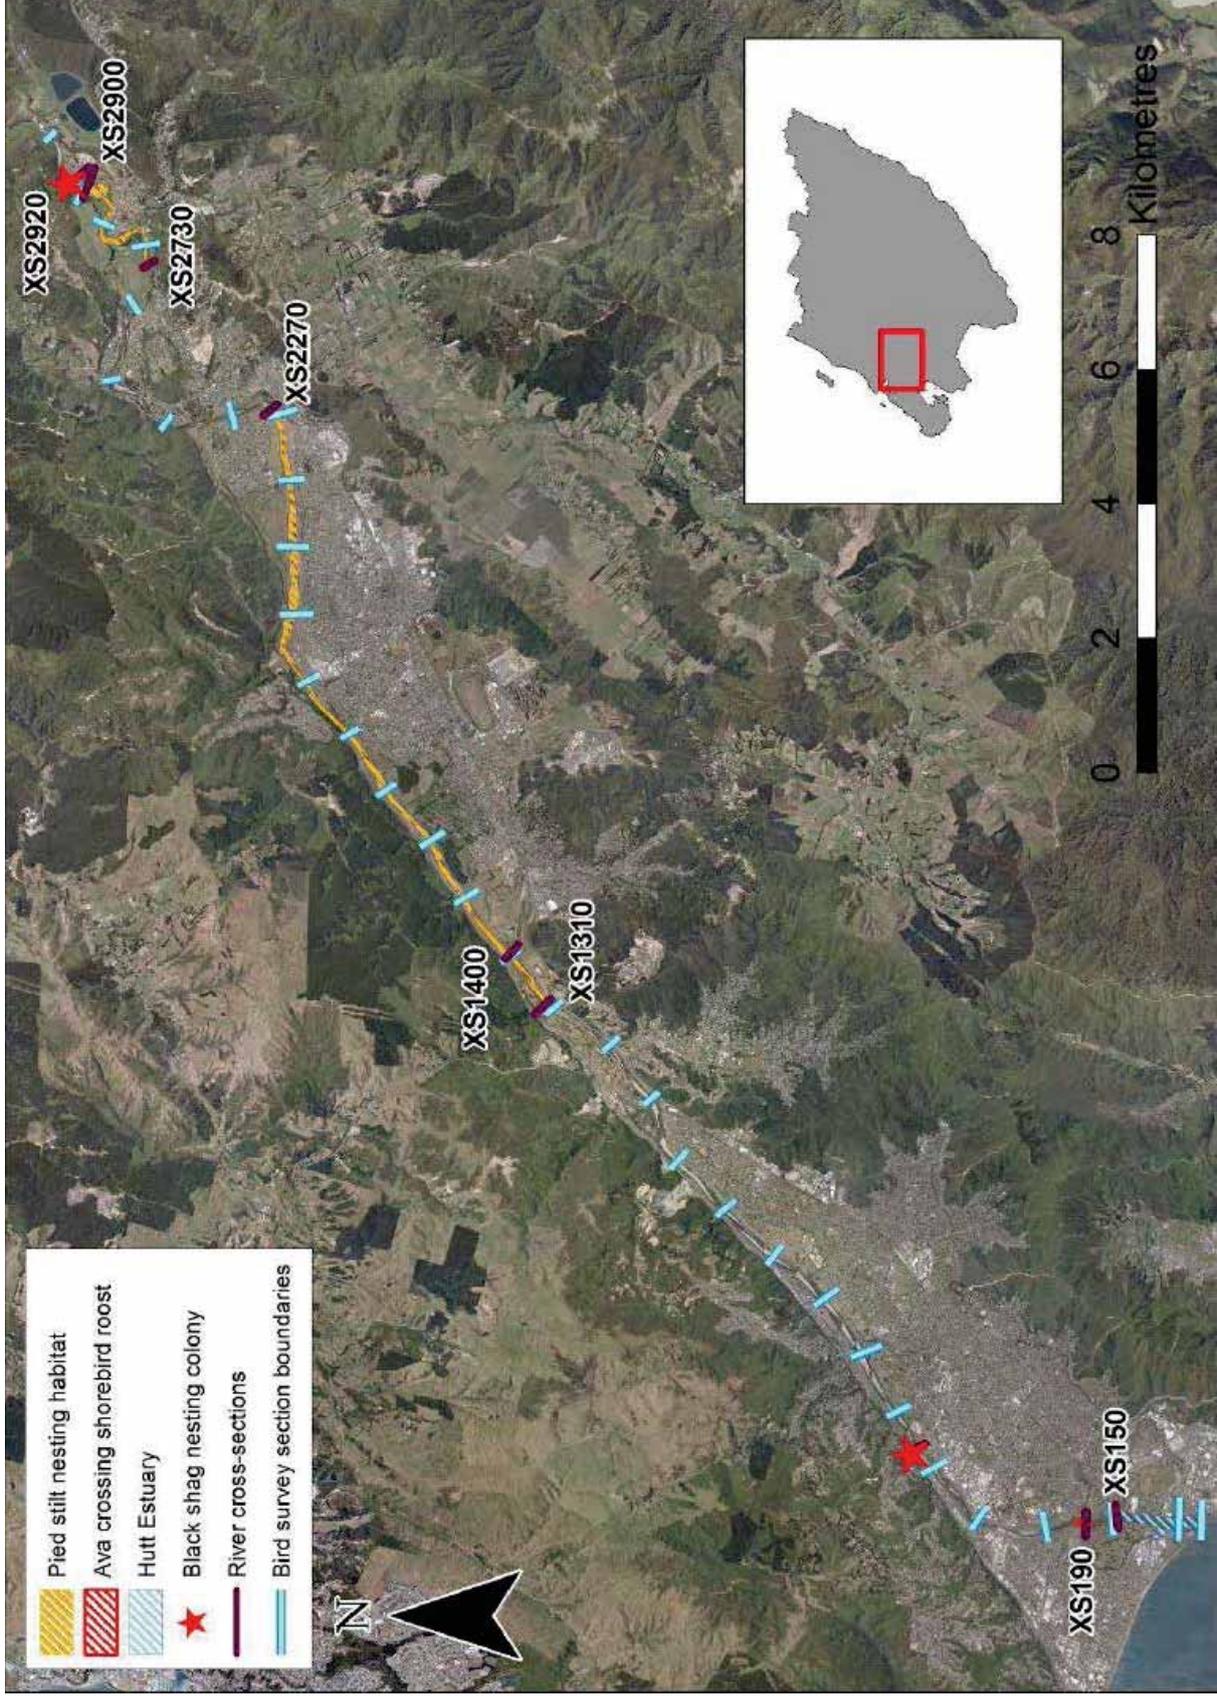
**Figure 3-31:** Map of the Hutt River showing birds sites of value identified in the 2015-15 surveys (from McArthur et al 2015)

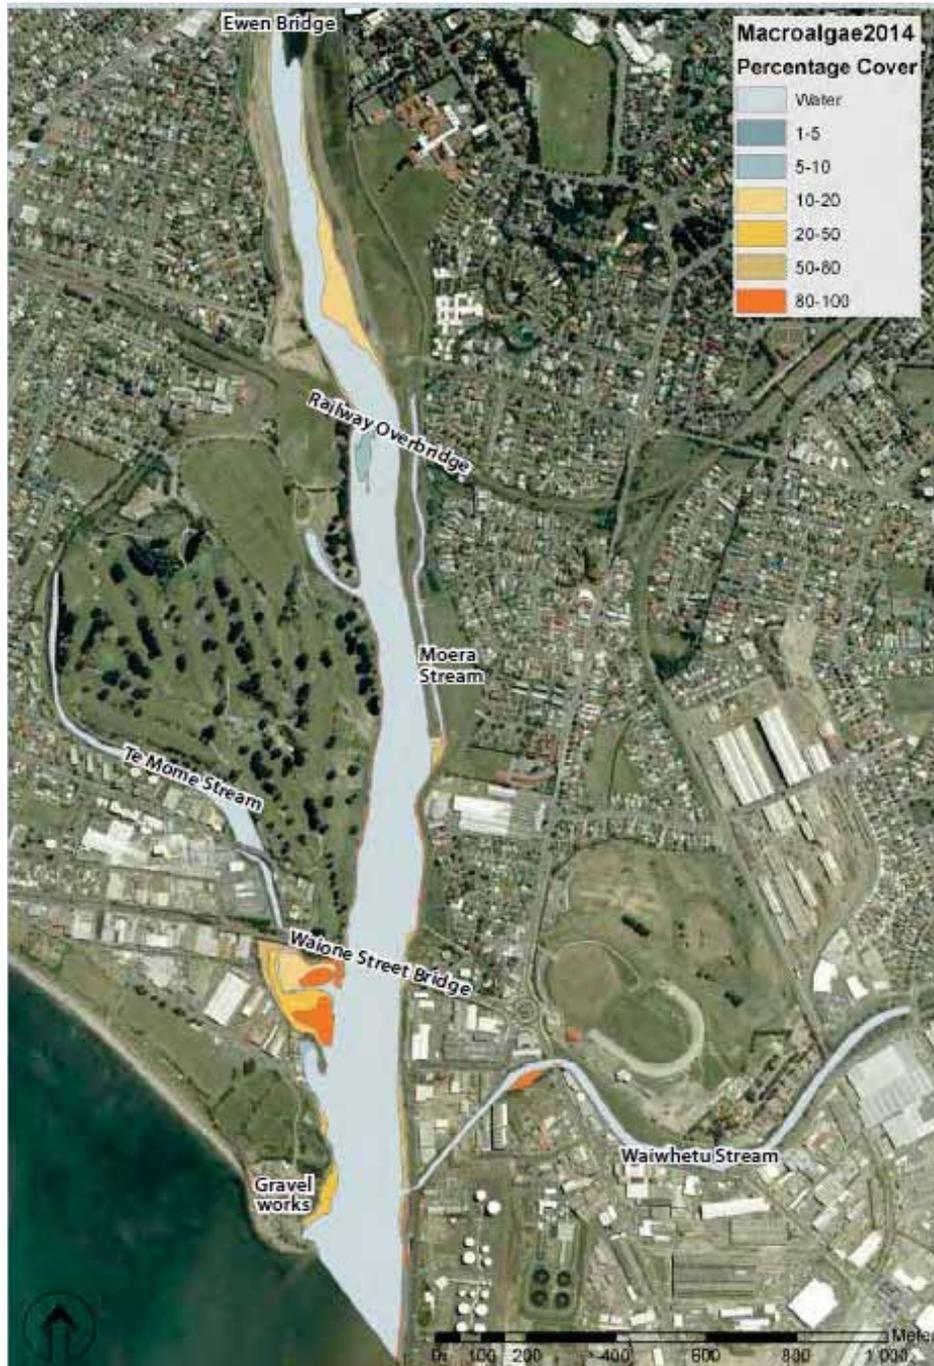
**Figure 3-33:** Map of intertidal macroalgal cover in the Hutt Estuary (from Stevens & Robertson, 2014)

Macroalgal monitoring has been undertaken annually in Hutt Estuary from 2010 to 2014 and is reported by Stevens & Robertson (2014). The authors note that *Ulva intestinalis* grows on almost every part of the intertidal habitat with an extensive cover extending from the railway over bridge to the Hutt River mouth. *Gracilaria* and the green alga *Ulva* (sea lettuce) is largely confined to the lower intertidal reaches. Despite the high cover, nuisance conditions (rotting macroalgae and poorly oxygenated and sulphide rich sediments) are not widespread in intertidal areas. Regular flushing of the estuary appears to currently restrict the presence of nuisance conditions to localised areas on intertidal flats, and in subtidal areas near the Hutt River mouth. The distribution of macroalgae on 22 January 2014 is illustrated in Figure 3-33.

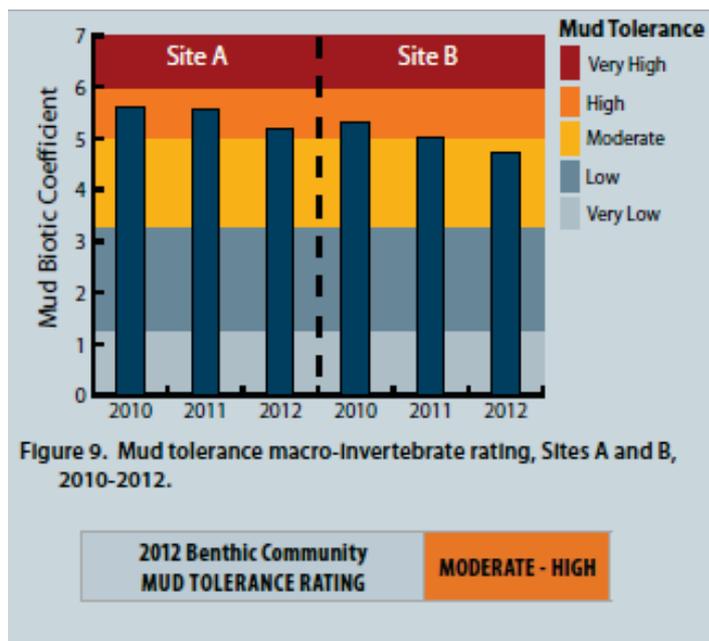
**Figure 3-34:** Mud tolerance macroinvertebrate rating, sites A and B, 2010-2012

The mud tolerance of the Hutt Estuary macroinvertebrate community was in the “moderate-high” category in 2012, a slight improvement from the previous two years (Figure 3-34). The results show that the community was dominated by species that prefer mud rather than those that prefer sand.

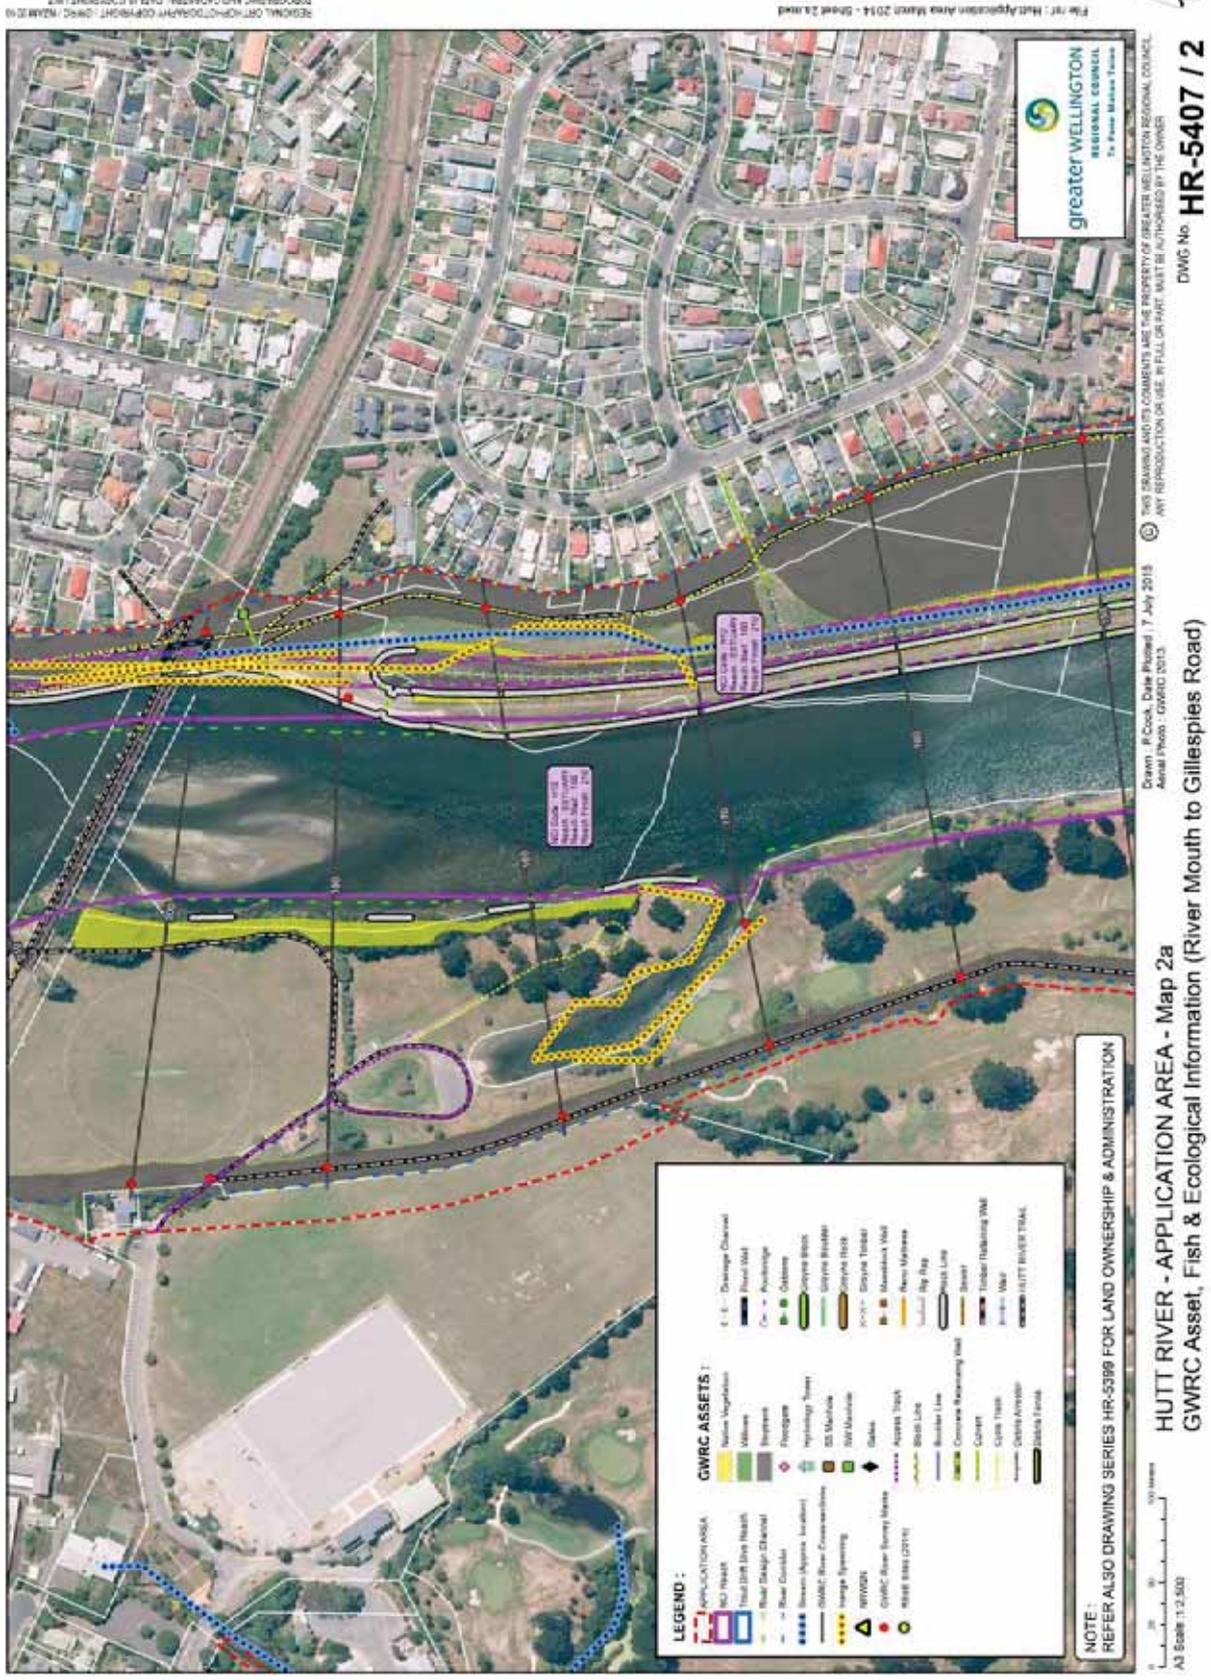
**Figure 3-35:** Potential inanga spawning habitat in the Hutt Estuary is indicated by yellow/red dotted lined (from Taylor and Kelly, 2001)

Despite the general unsuitability of the main-stem for inanga spawning, there are records of inanga spawning in areas in the tidal reach where bank armoring is absent. These include observations near the Sladden Park boat ramp in Petone, at Te Mome Stream and Opahu Stream (Taylor & Kelly, 2001). In recent years GWRC has undertaken works to enhance inanga spawning habitat in the lower Opahu Stream, as part of flood protection upgrade works in the Ava to Ewen reach. Potential inanga spawning habitat identified by Taylor and Kelly (2001) is shown in Figure 3-35.

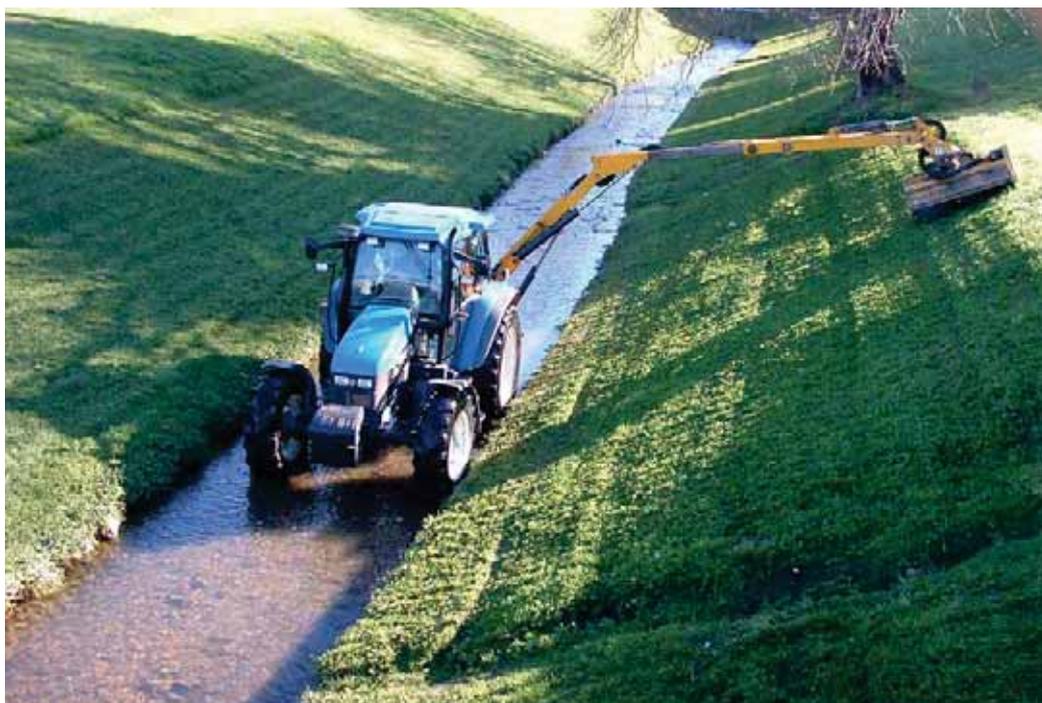
**Figure 5-1:** Mowing stop-banks in Stokes Valley Stream

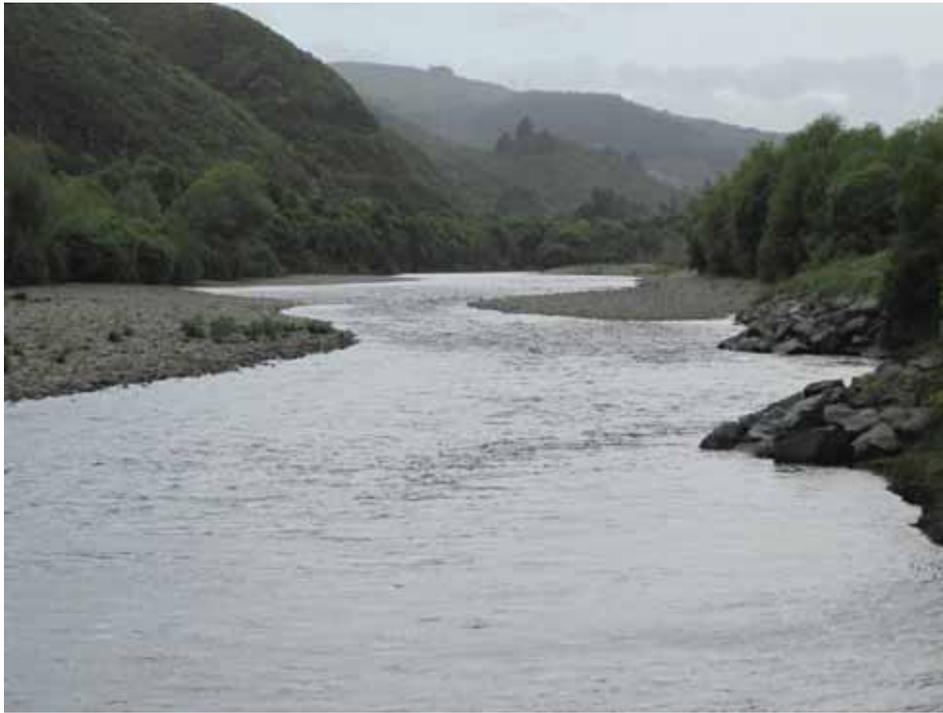
**Figure 5-2: Rock groynes on the Hutt River upstream of Kennedy Good Bridge**

It can be concluded that rock groynes have the potential to enhance some forms of fish habitat and that the overall effect of this structure on native fish and trout populations in the Hutt Rivers is likely to range from neutral to positive.

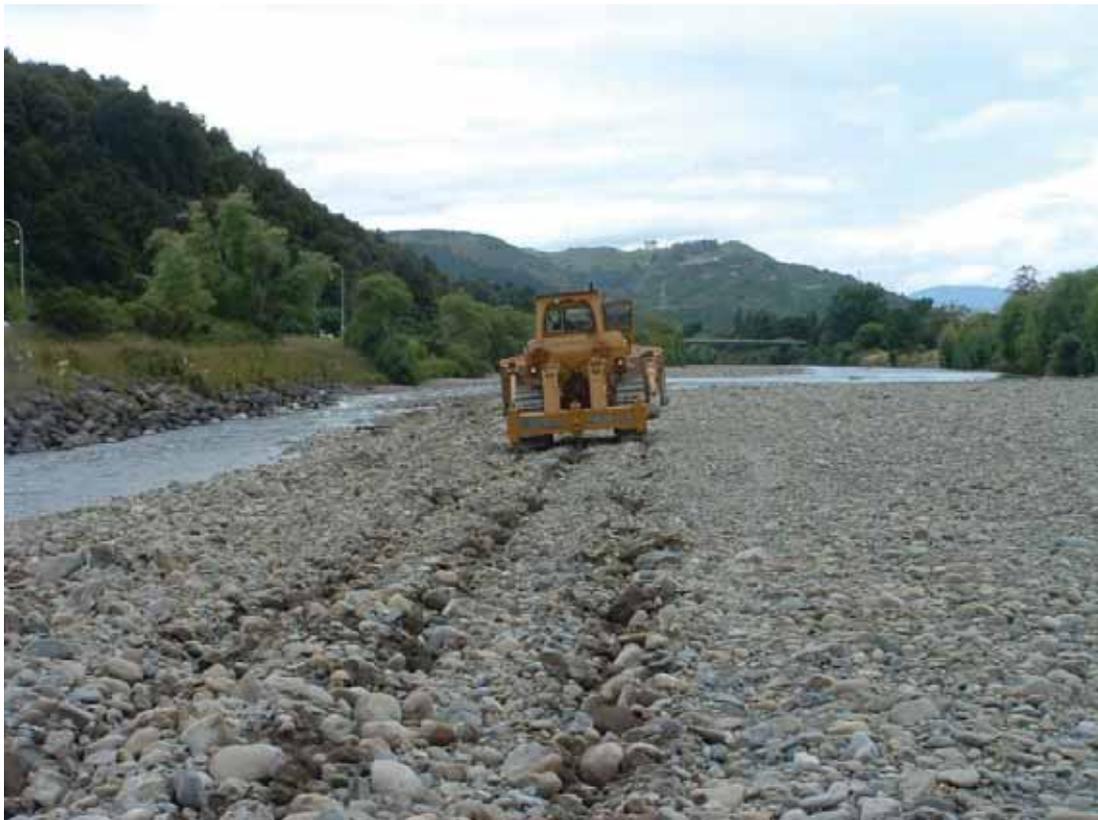
**Figure 5-9:** Beach ripping in the Hutt River

Both activities involve excavation or disturbance of bed material but do not typically result in a discharge of sediment to the flowing channel.

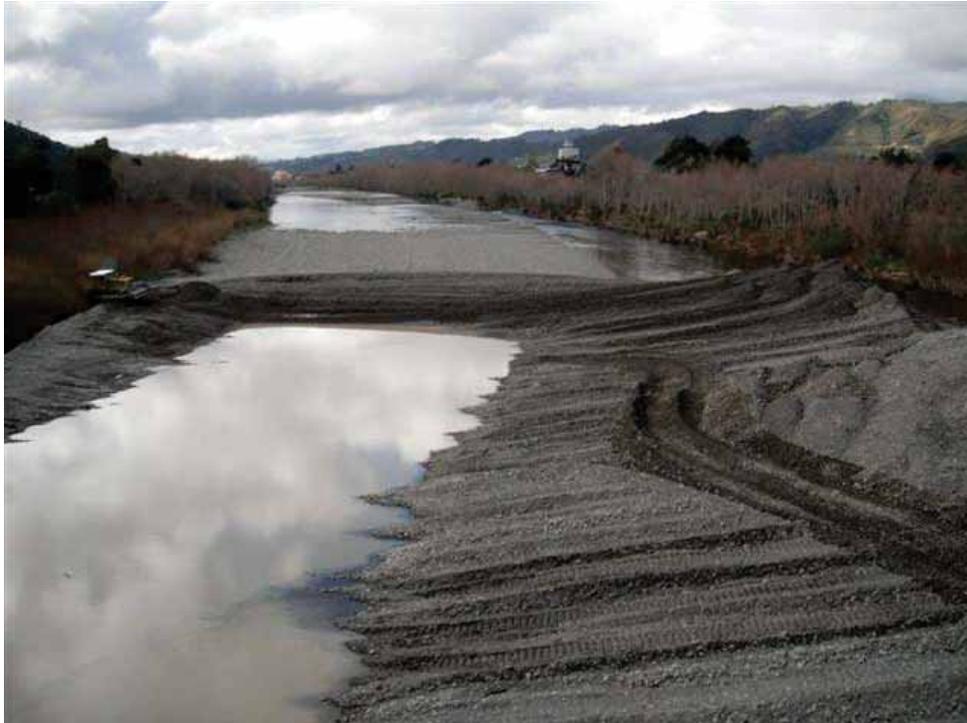
**Figure 5-10:** Gravel extraction; shaping of a new low flow channel with meander pattern

which relies heavily on the natural river processes to rework the river channel to a new form post extraction.

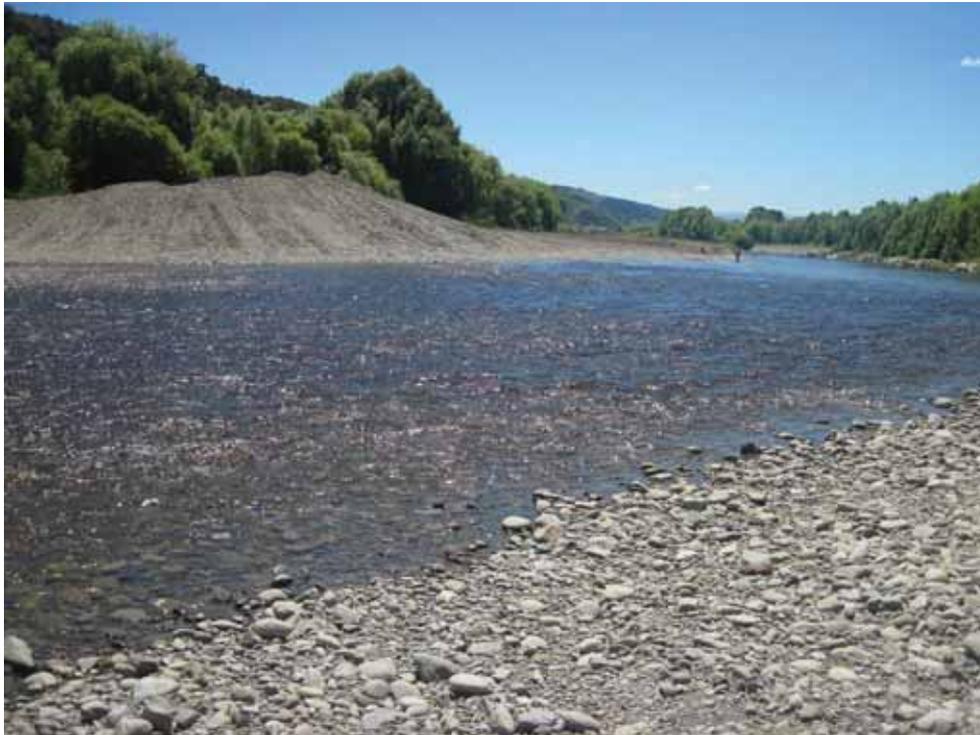
**Figure 5-11:** Riffle on 20<sup>th</sup> December 2012 near Kennedy Good Bridge, one day after completion of gravel extraction and channel shaping works, showing simplified channel structure and reduced substrate particle size (compared with pre-works)

healthy and diverse benthic community in the river upstream of the works area would be available to resource the re-colonisation of disturbed reaches (as already occurs after major floods). It is noted however, that where the area of mechanical disturbance involves multiple riffles the overall productivity of that reach will be reduced, potential reducing food supplies for fish.
