# Effects of Flood Protection Activities on Aquatic and Riparian Ecology in the Hutt River

Prepared for Greater Wellington Regional Council (Flood Protection)

December 2016

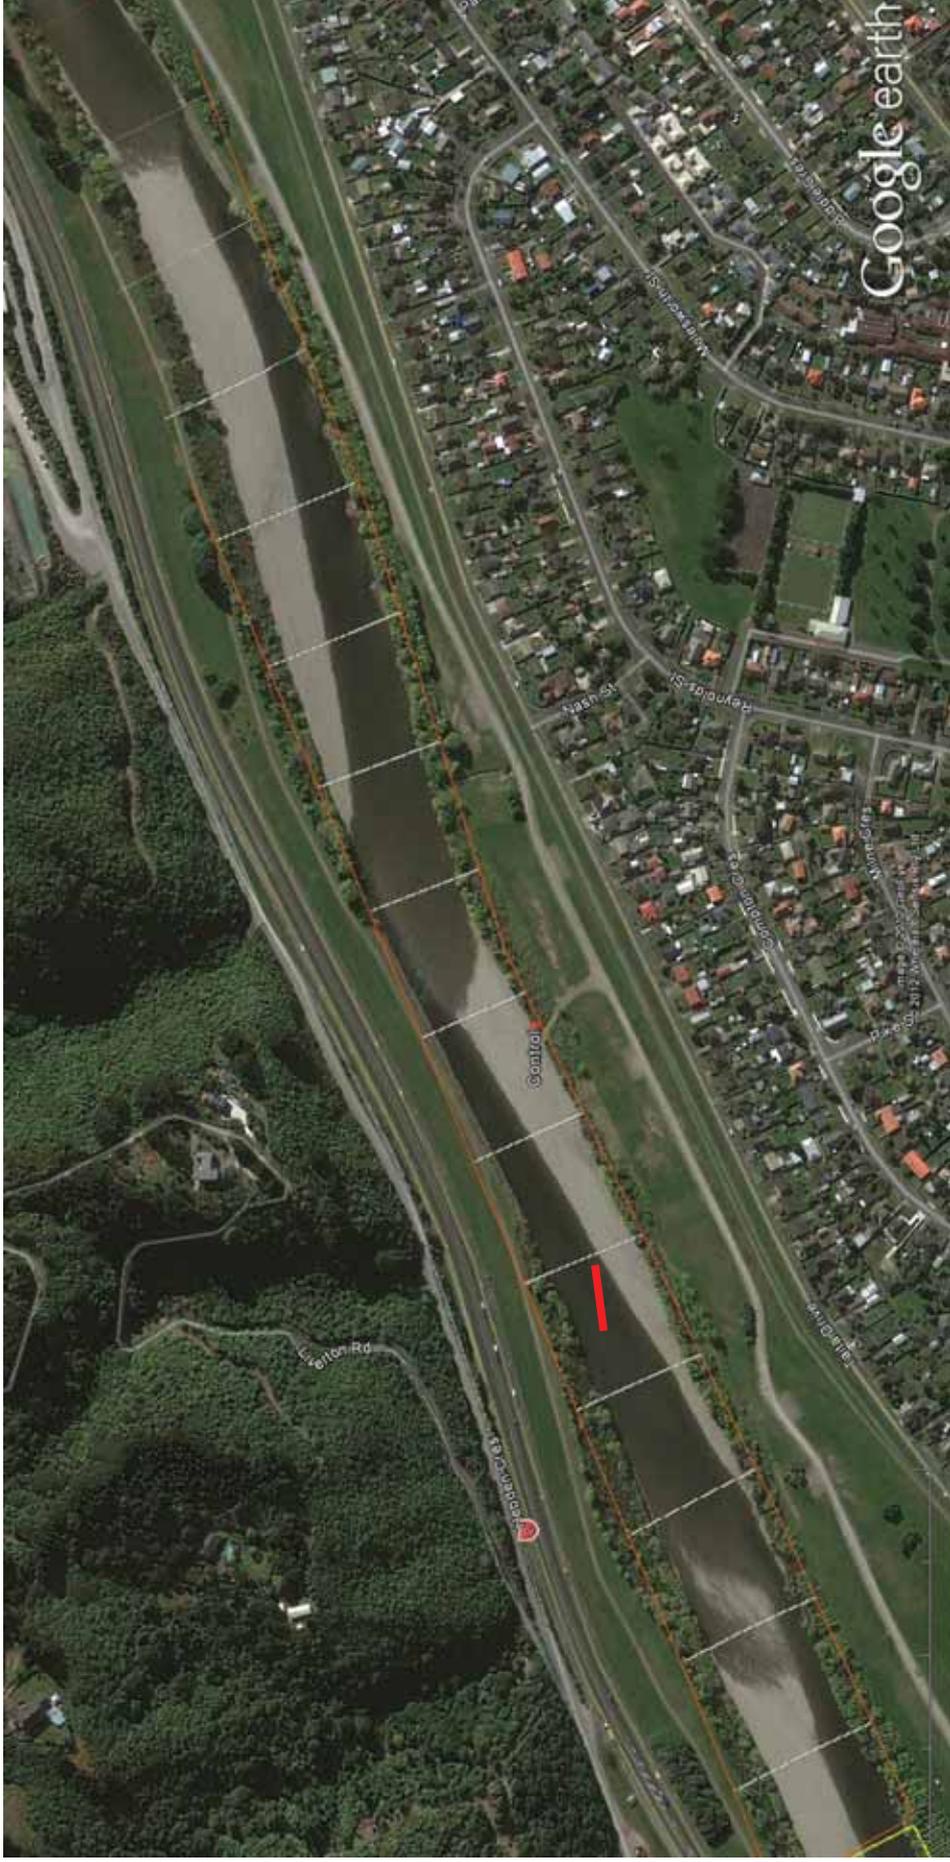
Figure 2-1: Location of the Hutt River 'control reach'. Cross river transects are located at approximately 100m intervals. The red bar denotes a representative sediment assessment site.

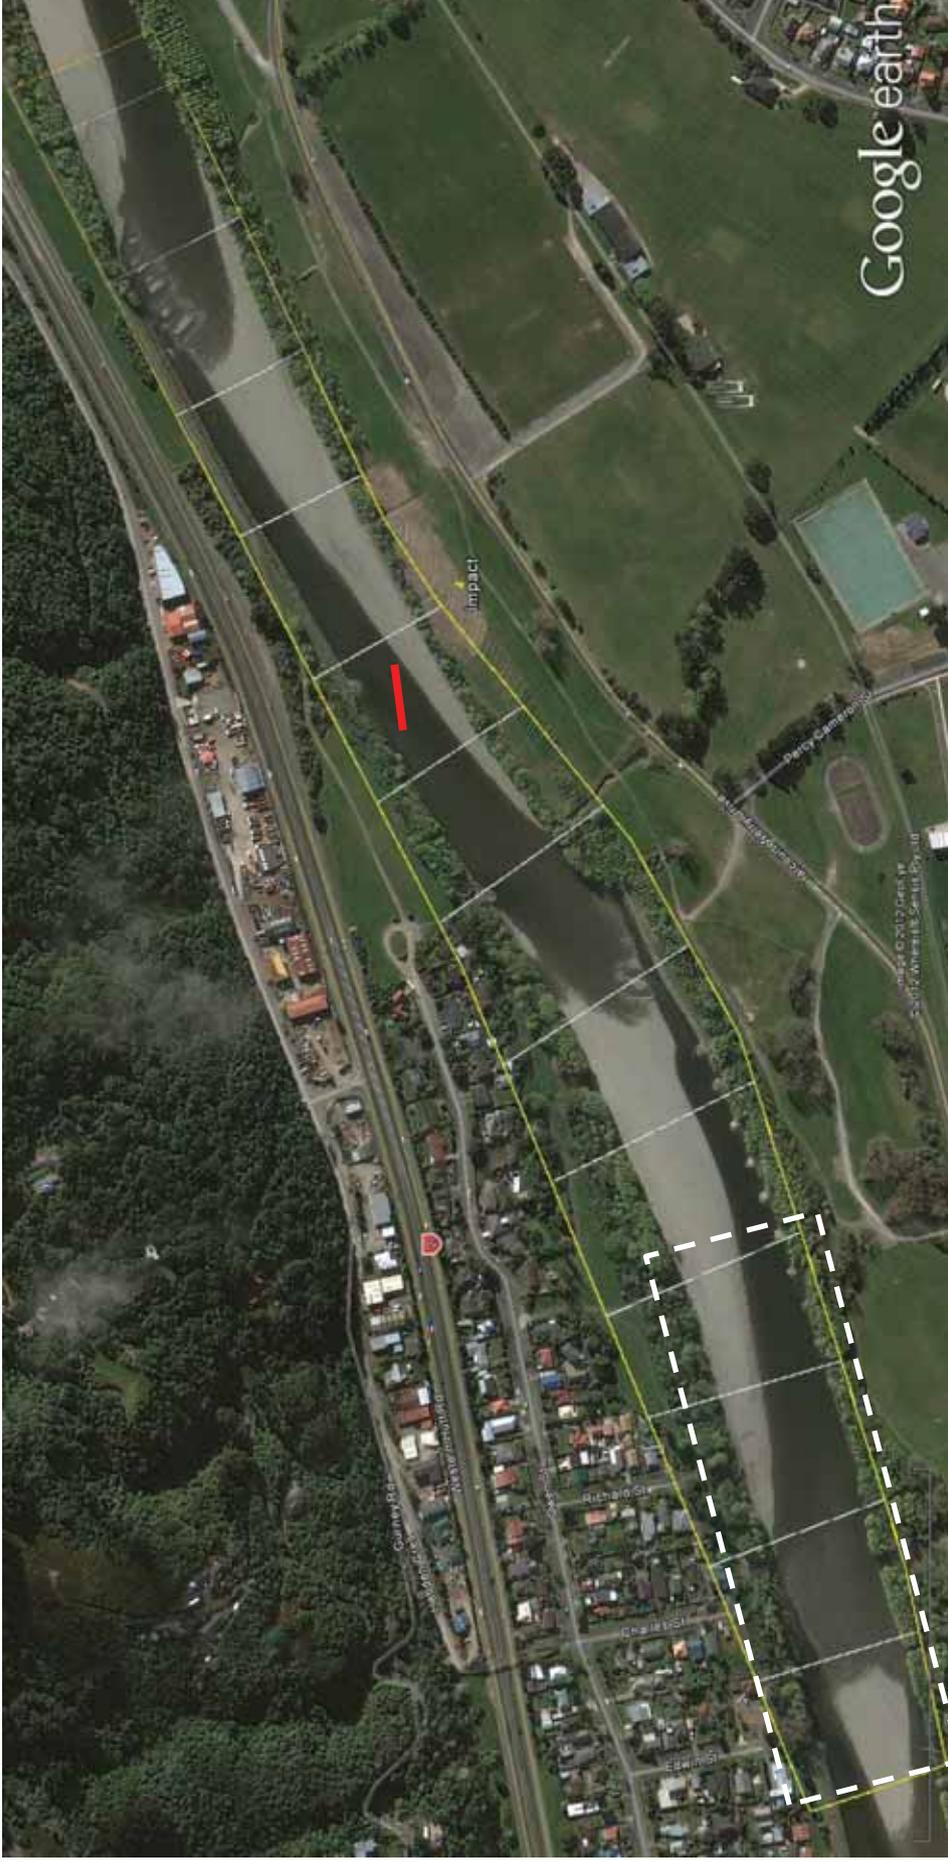
Figure 2-2: Location of the Hutt River 'impact reach' which is immediately downstream of the control site. Cross river transects are located at approximately 100m intervals. The red bar denotes a representative sediment assessment site. The area within the dotted line was affected by gravel extraction activities.

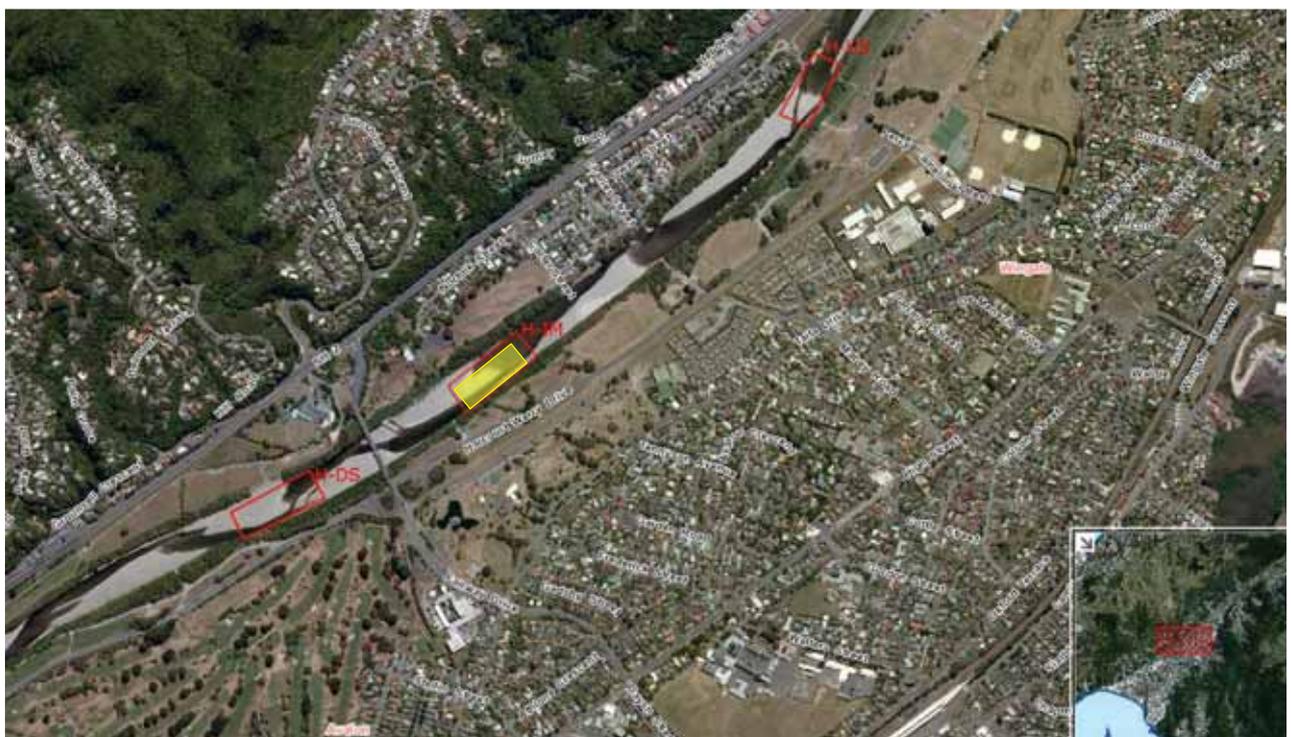
**Figure 2-1:** Locations of Hutt River Aquatic Ecology Monitoring Sites (red) and works site (yellow)

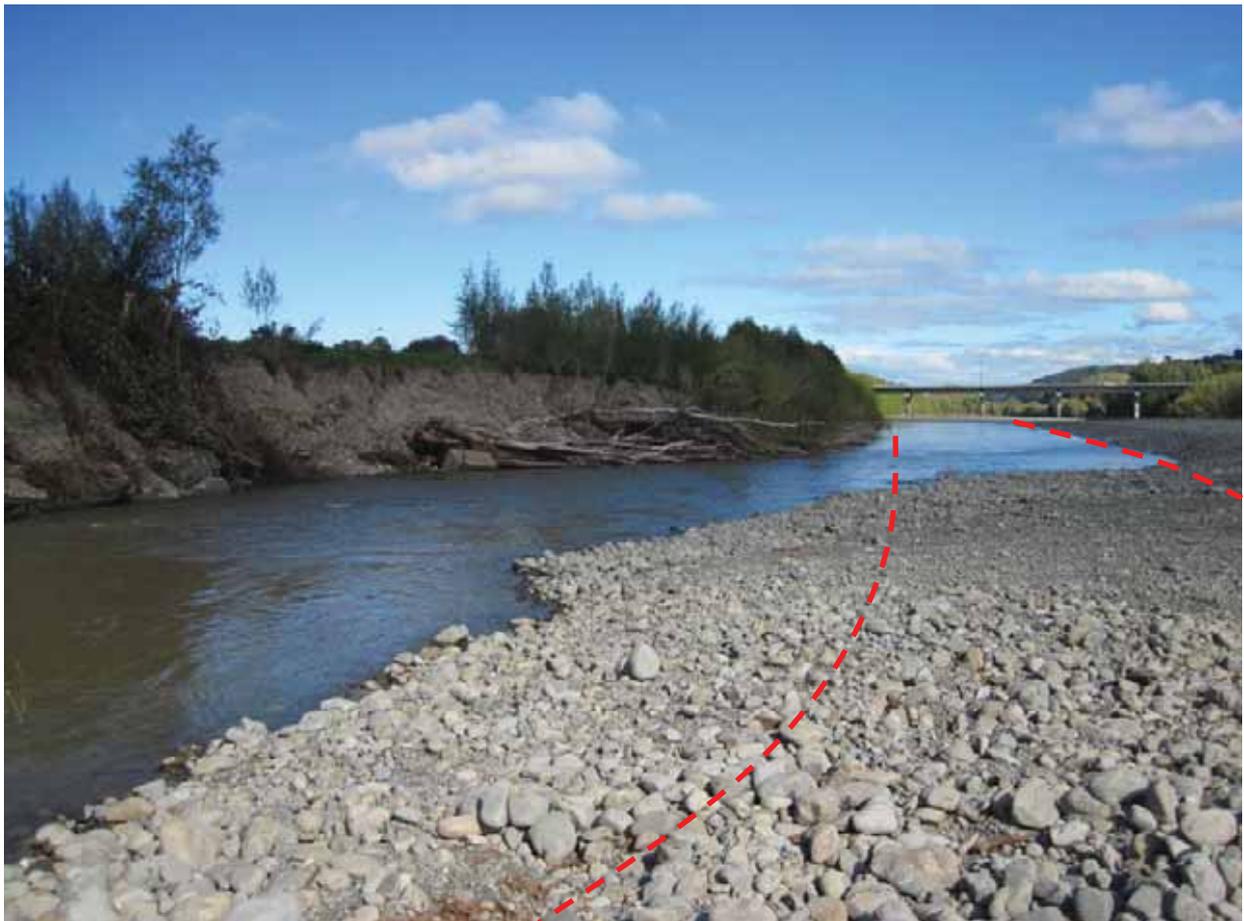
**Figure 3-1:** Erosion site on the true left bank of the Hutt River at Belmont, and proposed new channel alignment (indicative)

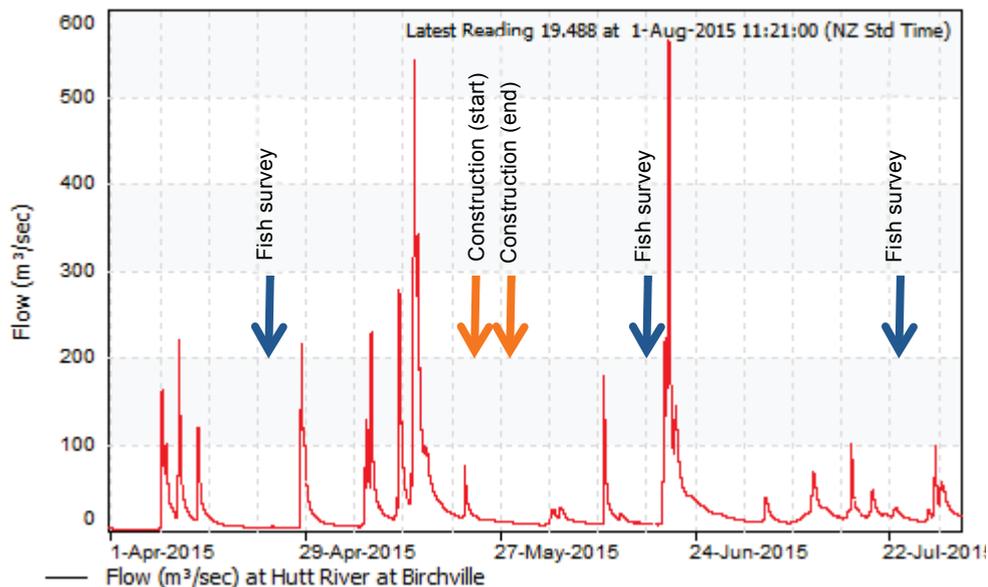
**Figure 3-2:** Hydrograph of Hutt River for the study period show the beginning and end of river works (orange arrows) and the three fish surveys (blue arrows)

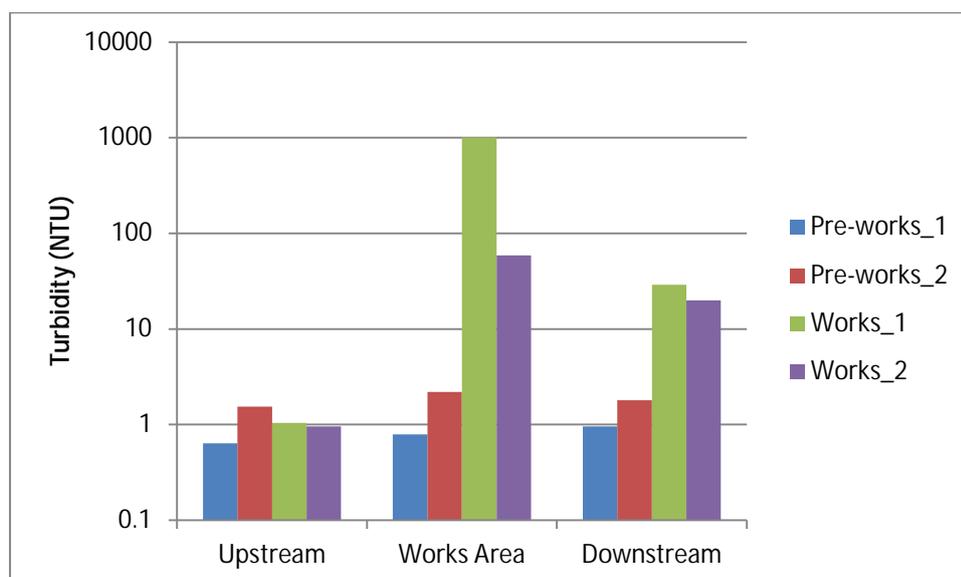
**Figure 3-11:** Turbidity (NTU) at sites sampled in the Hutt River in May 2015 (log scale)

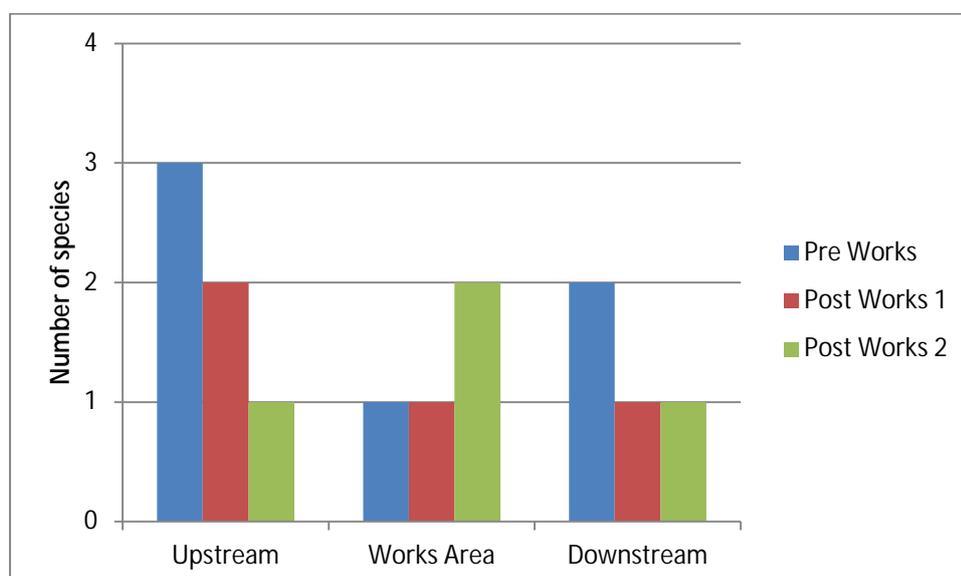
**Figure 3-18:** Number of fish species collected in the Hutt River, 2015

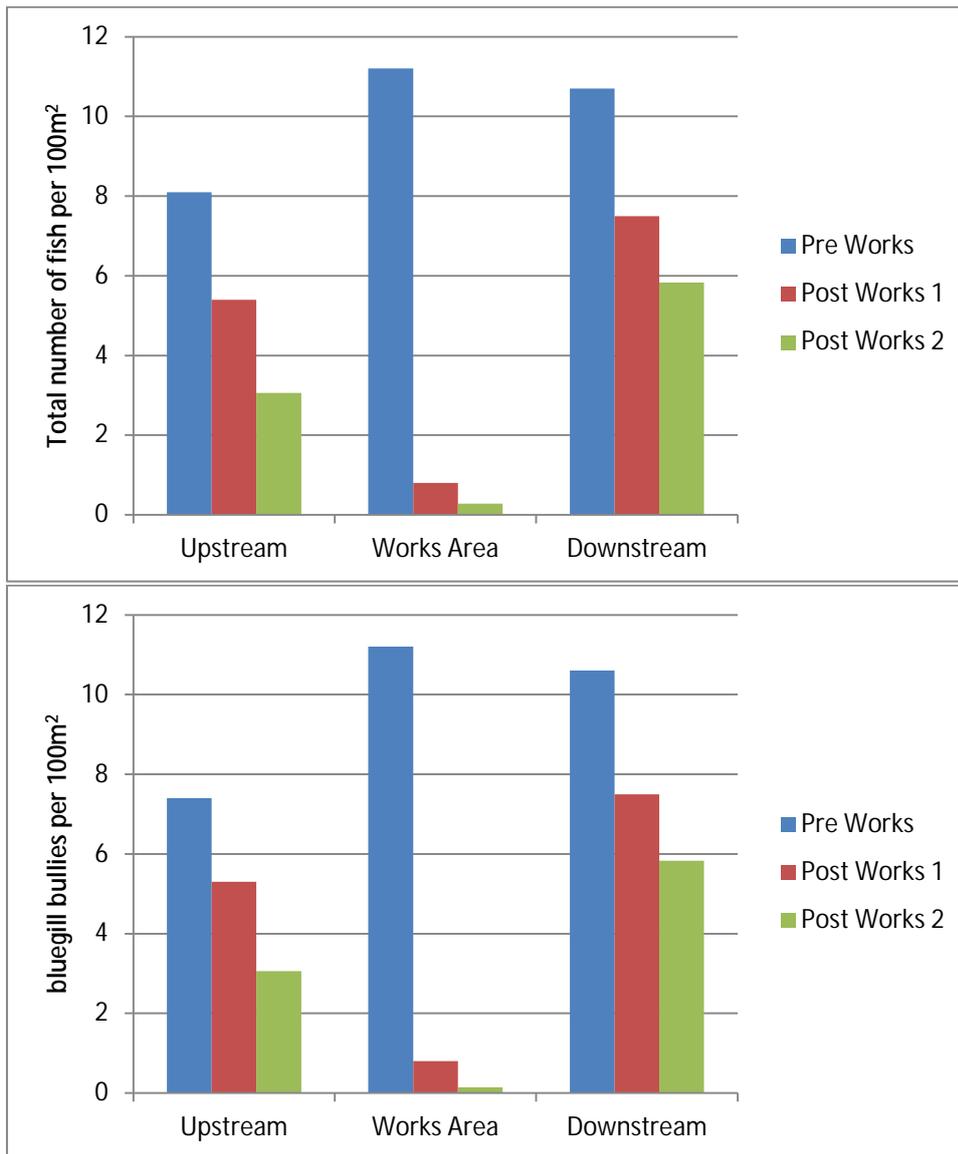
**Figure 3-19:** Total number of fish and number of bluegill bullies collected per 100m<sup>2</sup> in the Hutt River

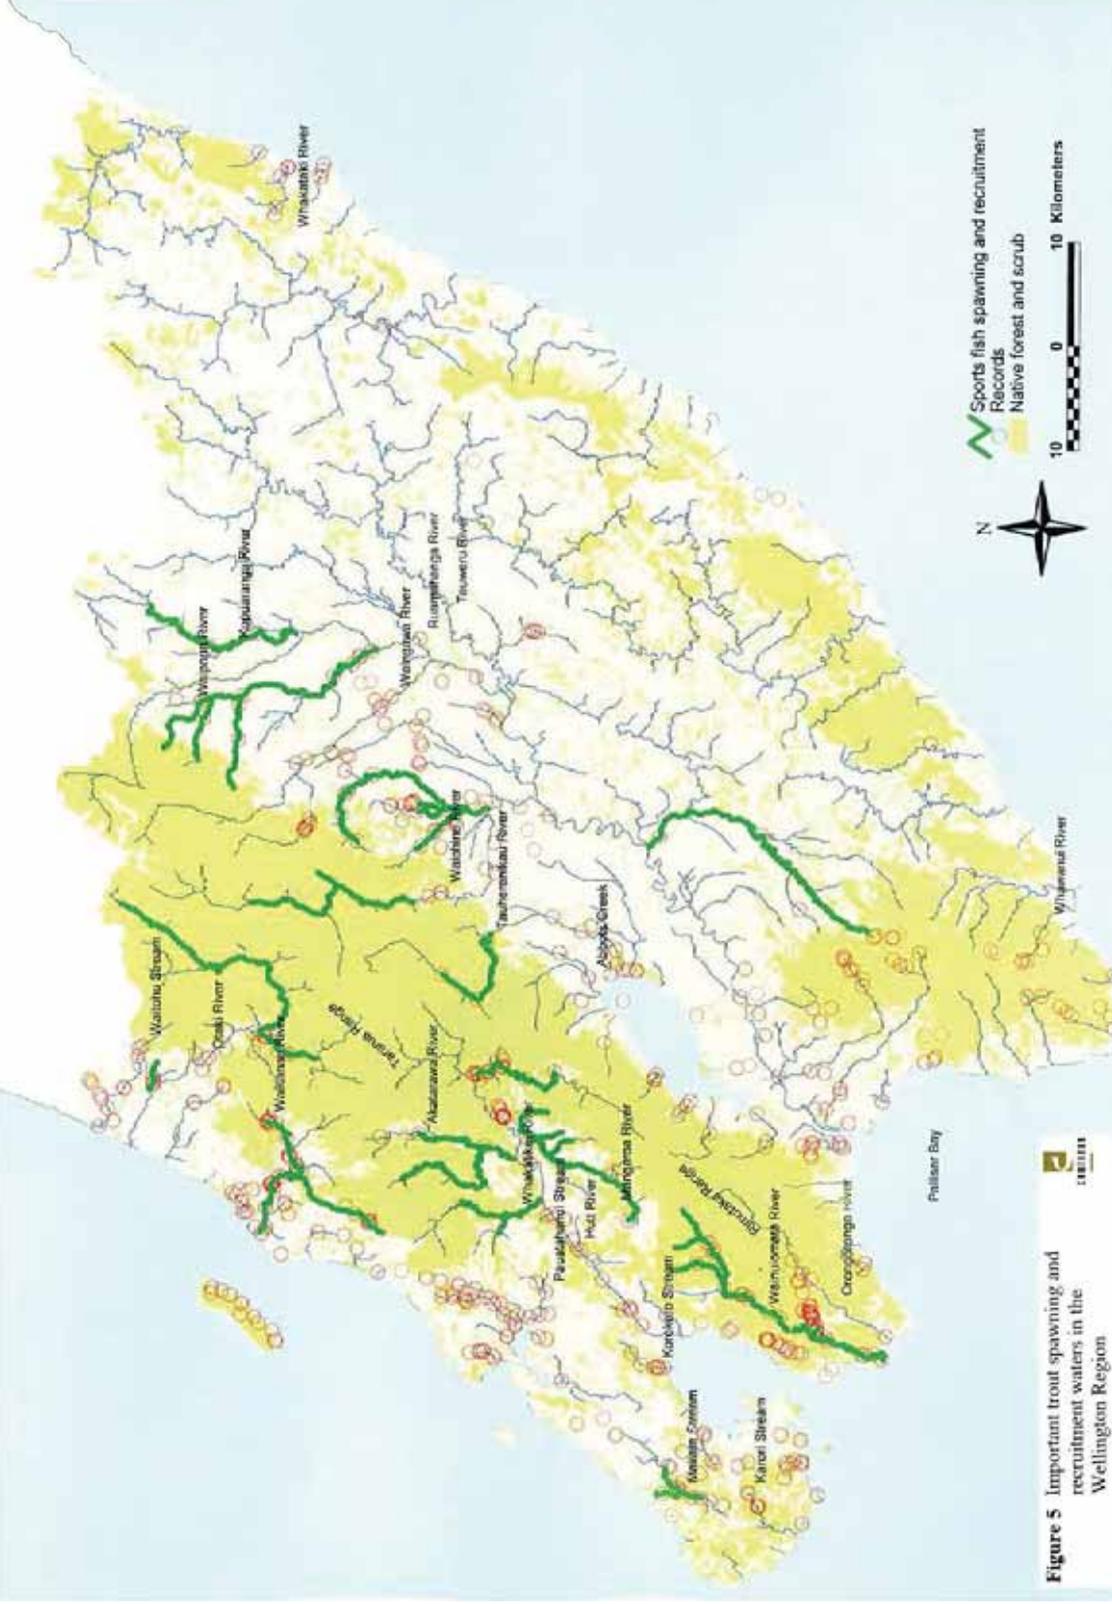
**Figure 5** Important trout spawning and recruitment waters in the Wellington Region
