***Condition and Remedial Action
Report***

**Baring Head Lighthouse Compound
February 2014**

IAN BOWMAN
Architect and Conservator
BOYDEN EVANS
Landscape Architect

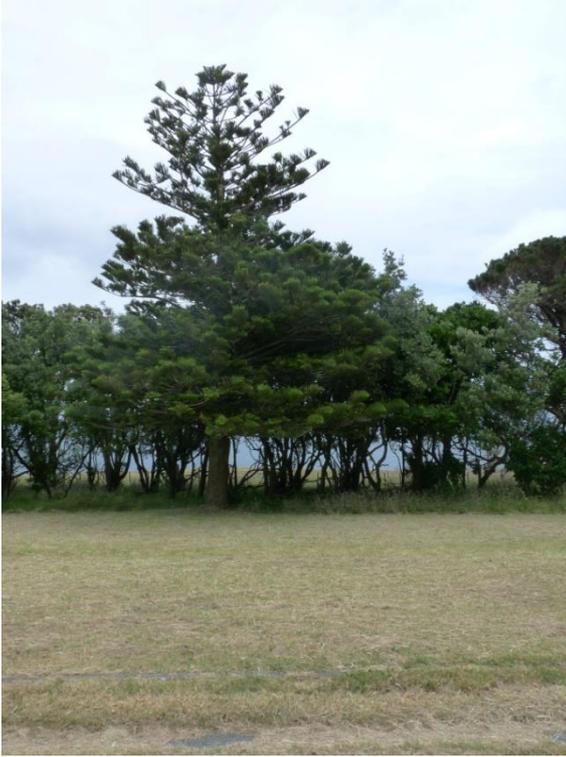
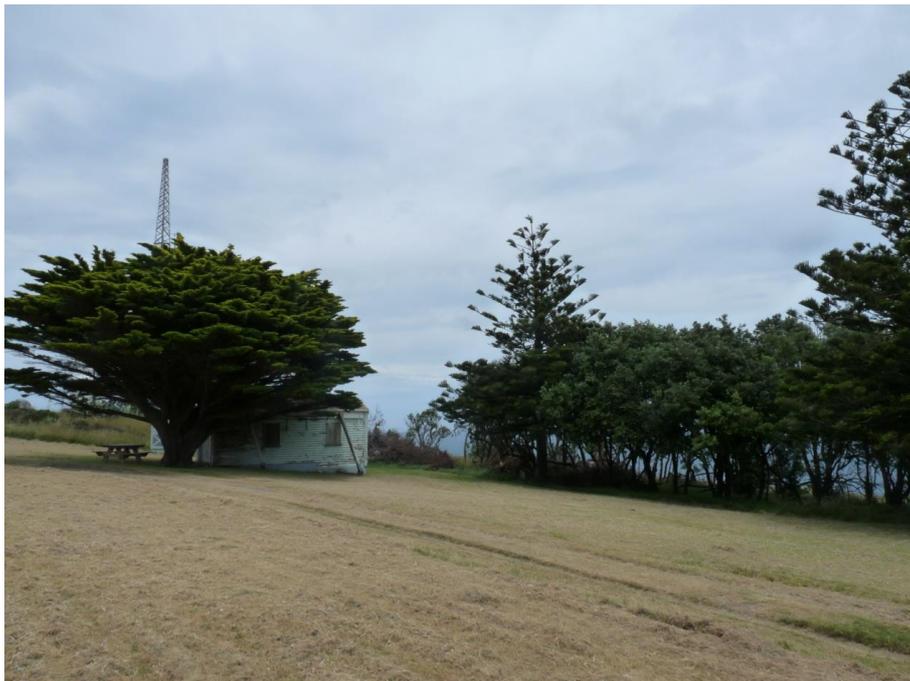
Golden macrocarpa and Norfolk Island pines contribute distinctive landscape elements
Distinctive form of Norfolk Island pine extending above shelterbelt

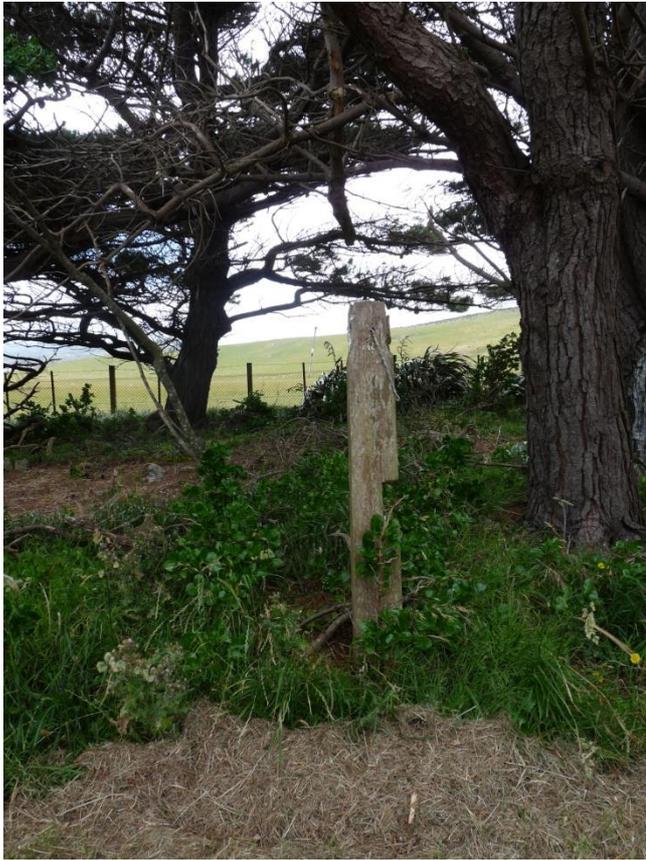
- sections of original picket fencing, some of which is in reasonably good condition and also a few original hardwood posts with mortises for rails remain.

Example of one of the few remaining original fence posts
