Environment Committee

Order Paper for the meeting of the Environment Committee to be held in the Council Chamber, Greater Wellington Regional Council, Level 2, 15 Walter Street, Te Aro, Wellington on:

Te Kāuru Upper Ruamāhanga catchment

1. What is this Floodplain Management Plan?

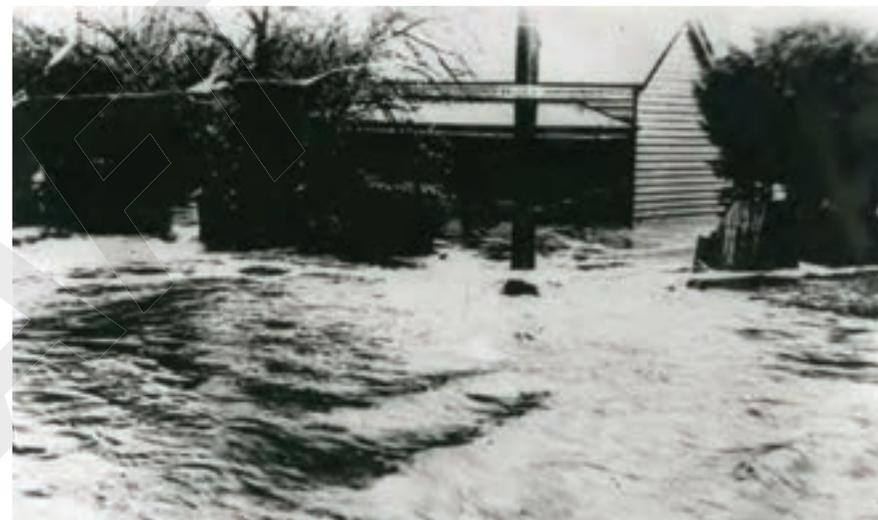
Flooding of Bruce Street 1934

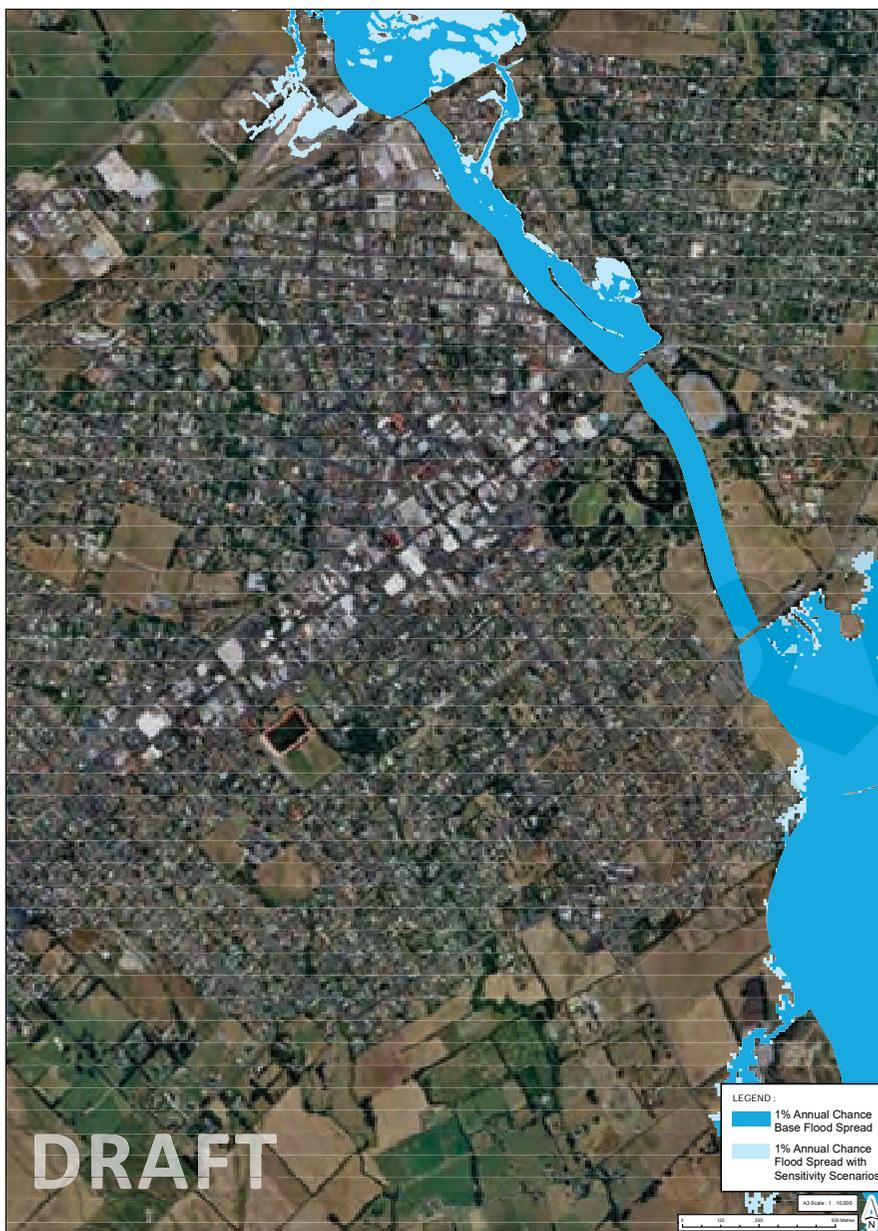
Waipoua River: DRAFT Current 1% Annual Chance Flood Spread with Sensitivity Scenarios and Base Flood Spread

Further downstream, flooding is also predicted to impact approximately 30 properties along River Road, at the confluence of the Waipoua and Ruamāhanga Rivers. Here the depths are predicted to be predominantly less than 0.4m.

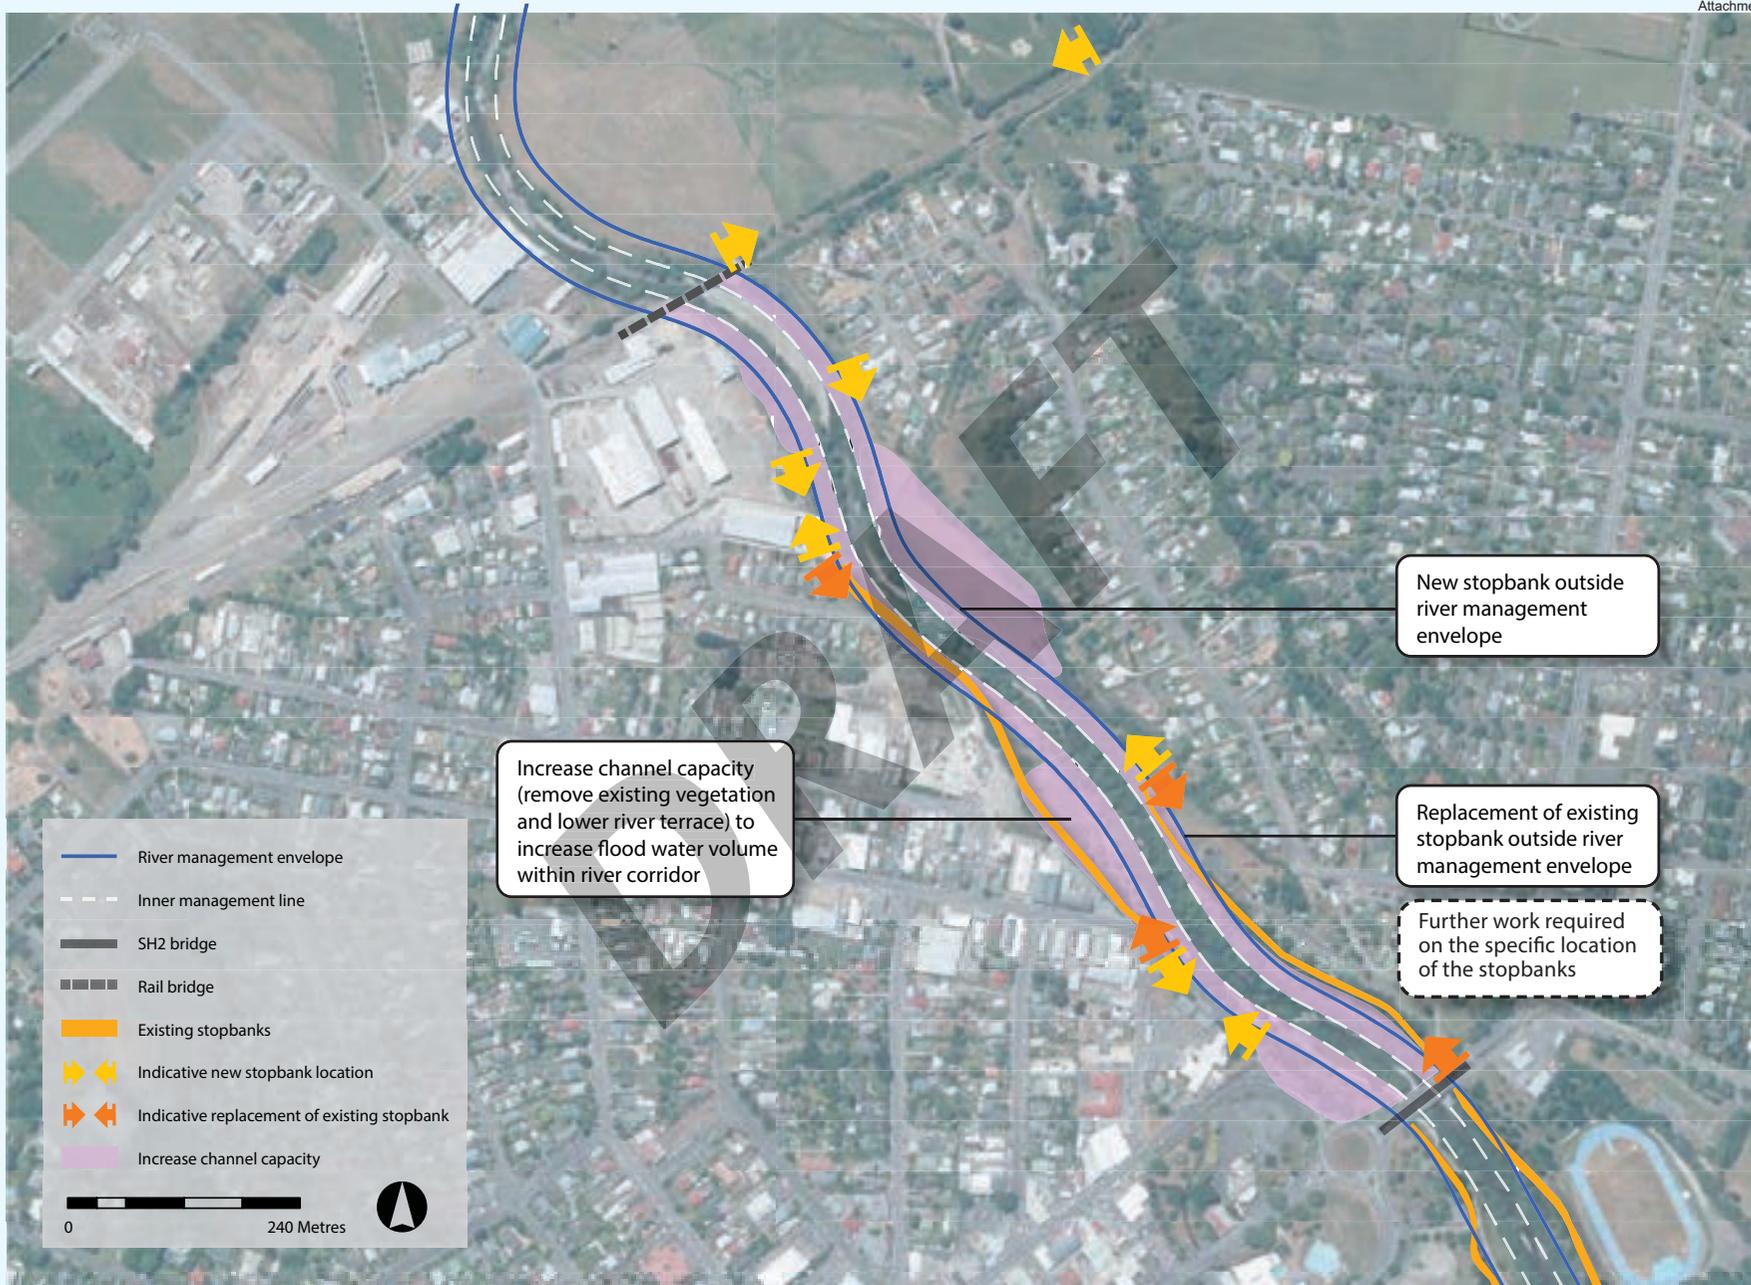
Response Stage 2 - Increase channel capacity with new and replaced stopbanks

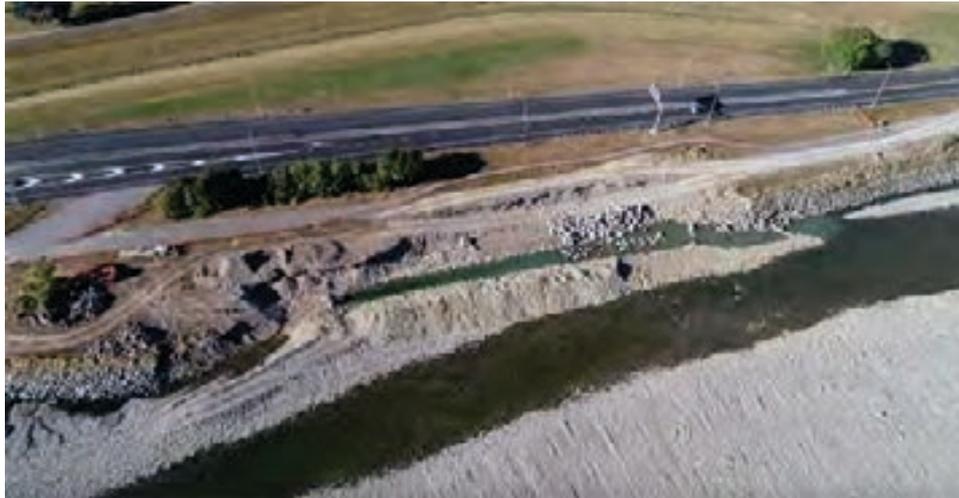
Gibbons Street (Hutt River) Erosion Repair, works commenced

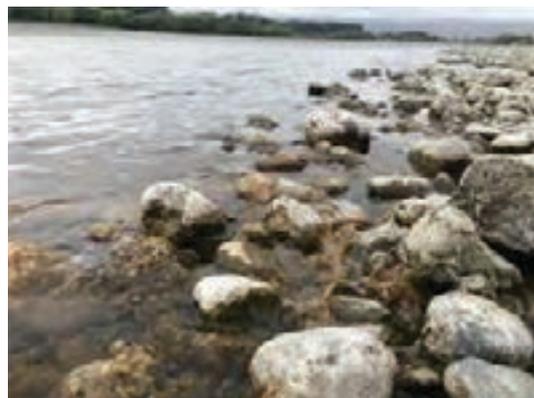
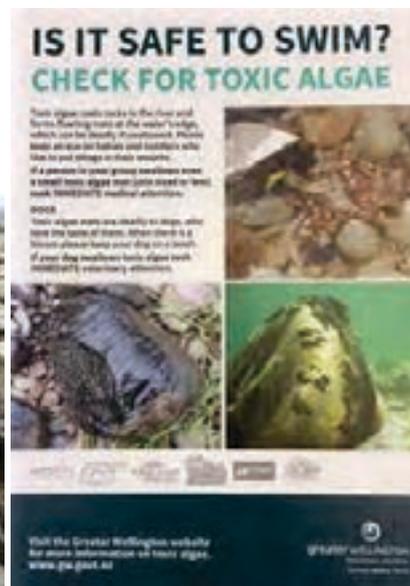
Left: detached mats of toxic algae, Ōtaki River. Right: Educational sign

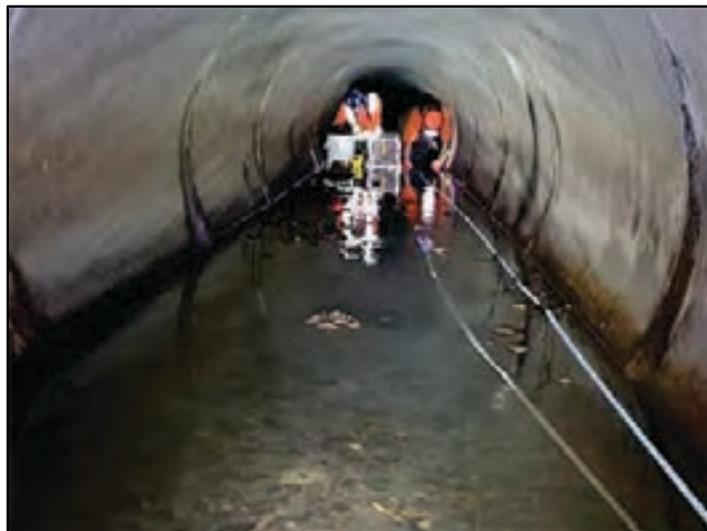
Sampling in piped stream under Miramar Park

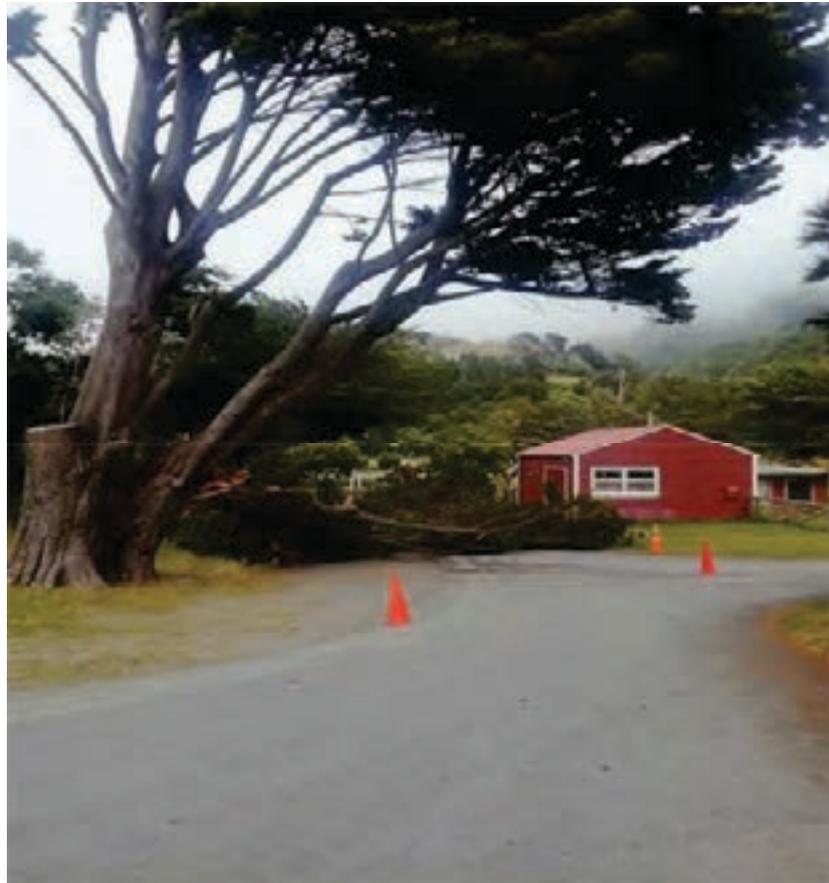
Damaged Macracarpa, which was eventually felled

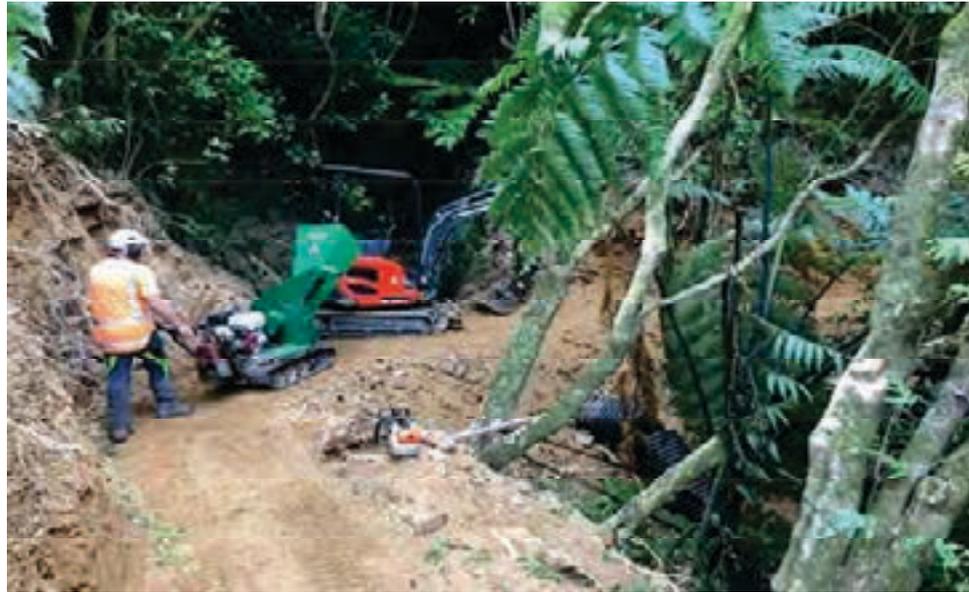
Construction of new Hill Rd-Old Coach Rd track underway

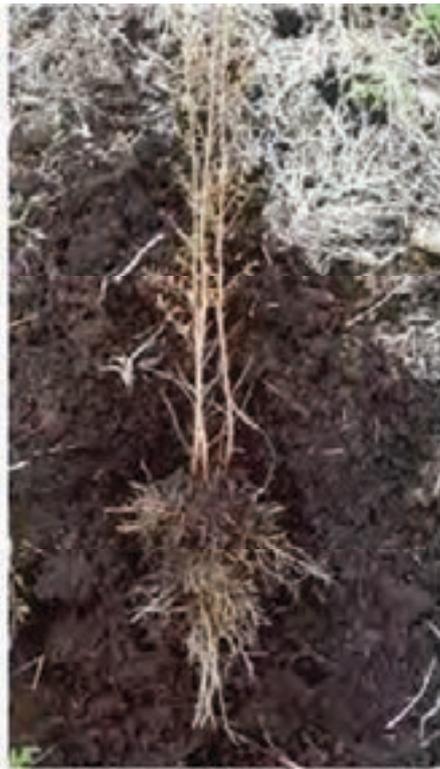
Manuka seedling killed by frost. This seedling was excavated and shows the excellent root growth occurring 3 months after planting.

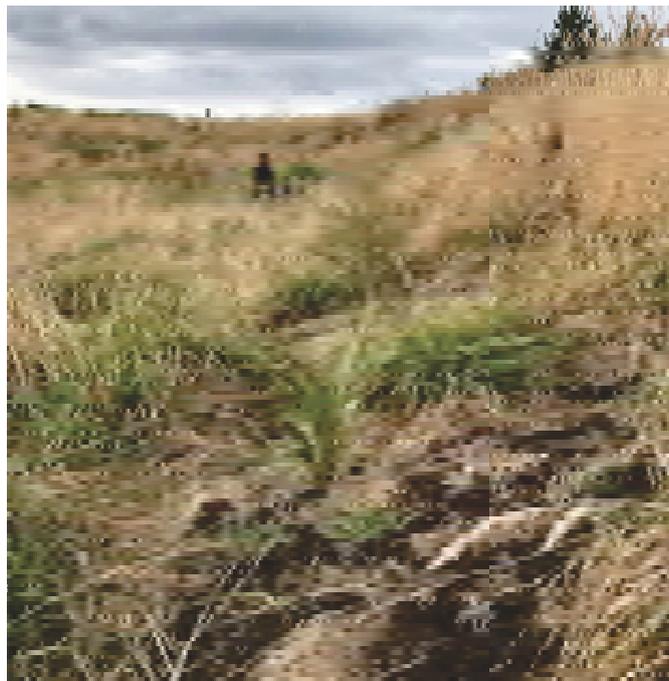
2018 plantings showing good growth
